# FINAL REPORT

2023-0053

**MDM-1 M FOX, SP-8000**

**Toruń aerodrome (EPTO), 4 August 2023**

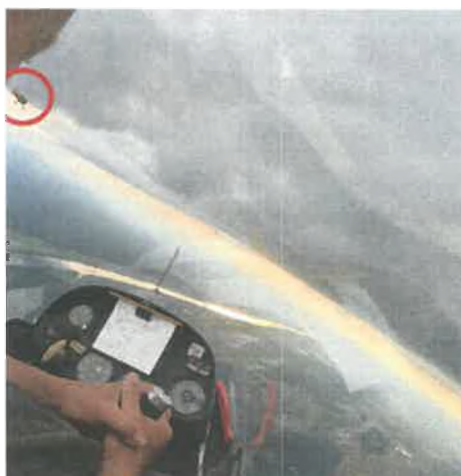
Figure 2. The position of the aeroplane at 6 s after the glider release [source: the pilot's camera]

After the release of the glider, the aeroplane pilot maintained the heading and agreed flight altitude, despite receiving an acknowledgement from the ground that the glider had released the tow line. The pilot did not turn right immediately to leave the zone as fast as possible. It was inconsistent with the earlier arrangements. During that time, the aeroplane flew at the speed of 70 kt, covered the distance of around 360 m, flying away from the glider and the zone axis to the left (in the southerly direction – Fig. 2).

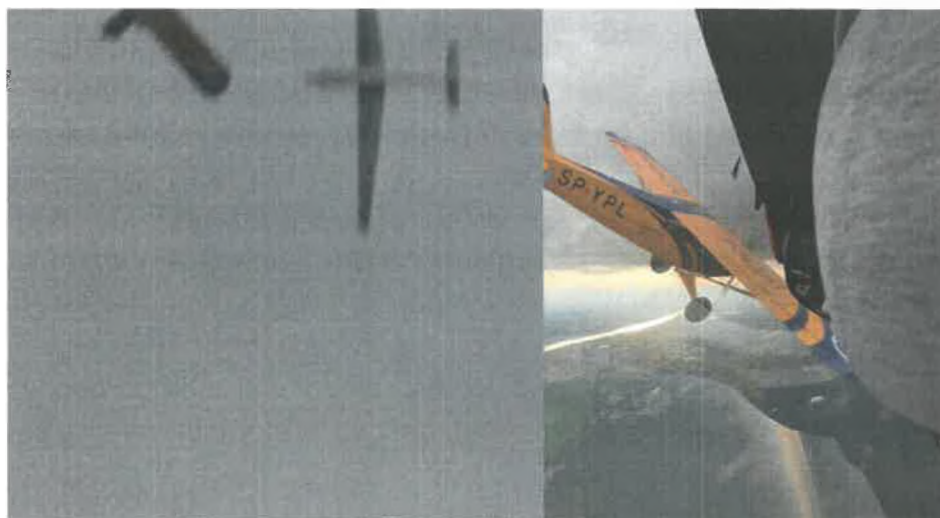
Figure 3. The aeroplane in descent 16 s after the glider release. [source: the organiser's camera and the pilot's camera]

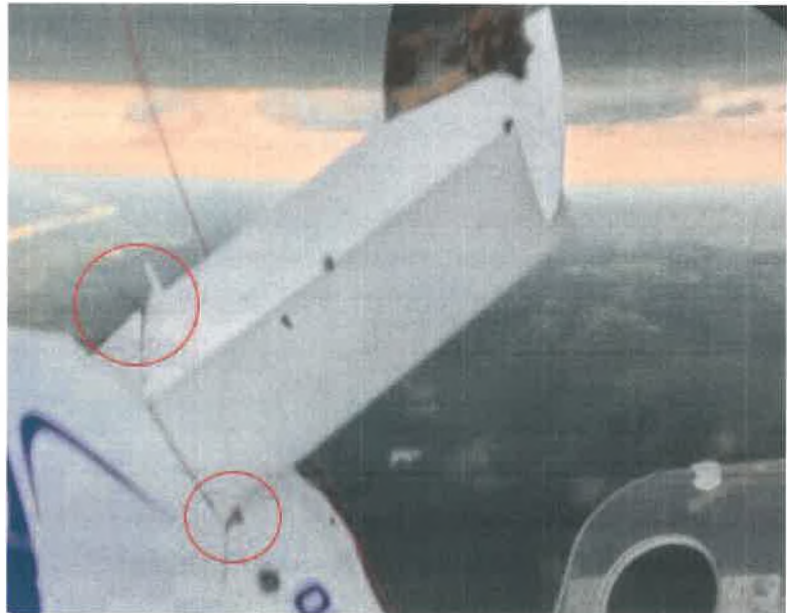
The end of the tow line with the attachment ring coiled around the glider's tail, became jammed in the slit between the right wing and the fuselage, blocking the elevator in the full down position (Fig. 4). There was a strong jerk, after which the safety device installed on the line was torn off, and the aeroplane's heading changed suddenly right by around 30°.

Figure 4. A view of the elevator blocked by the tow line.  
[source: a camera installed on the cabin fairing]

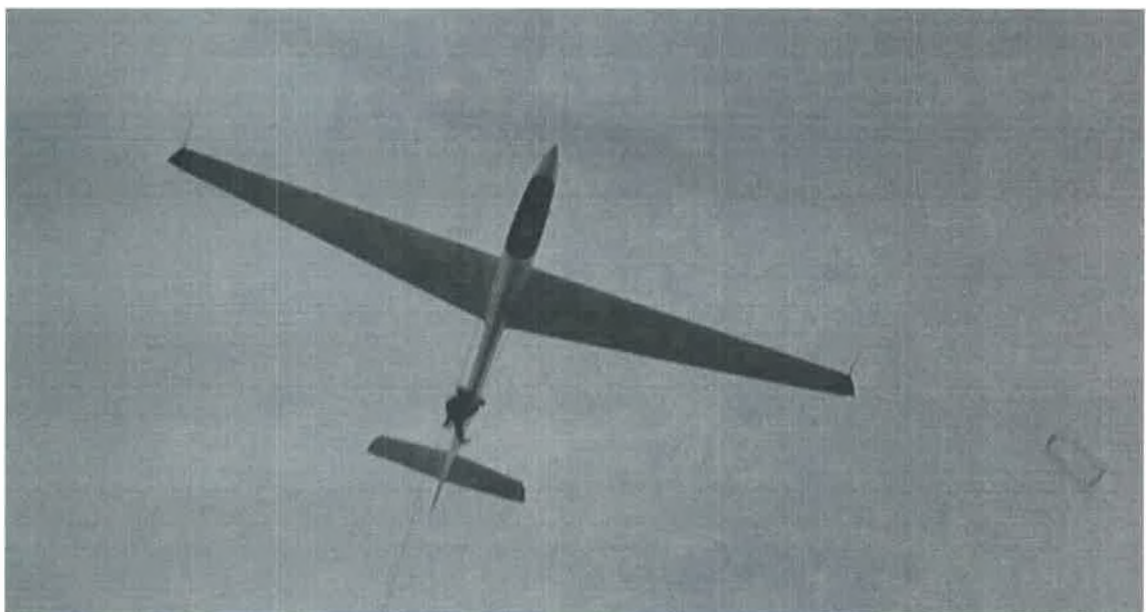
The glider made a right turn by around 180° in inverted flight, ¼ barrel roll, and during a transition into a dive (at the height of 1080 m) the glider pilot jettisoned the cabin fairing, unbuckled the safety belts and made an emergency parachute jump (Figure 5). He landed on the north-eastern part of the aerodrome.

Figure 5. Emergency parachute jump by the glider pilot [source: the organiser's camera]

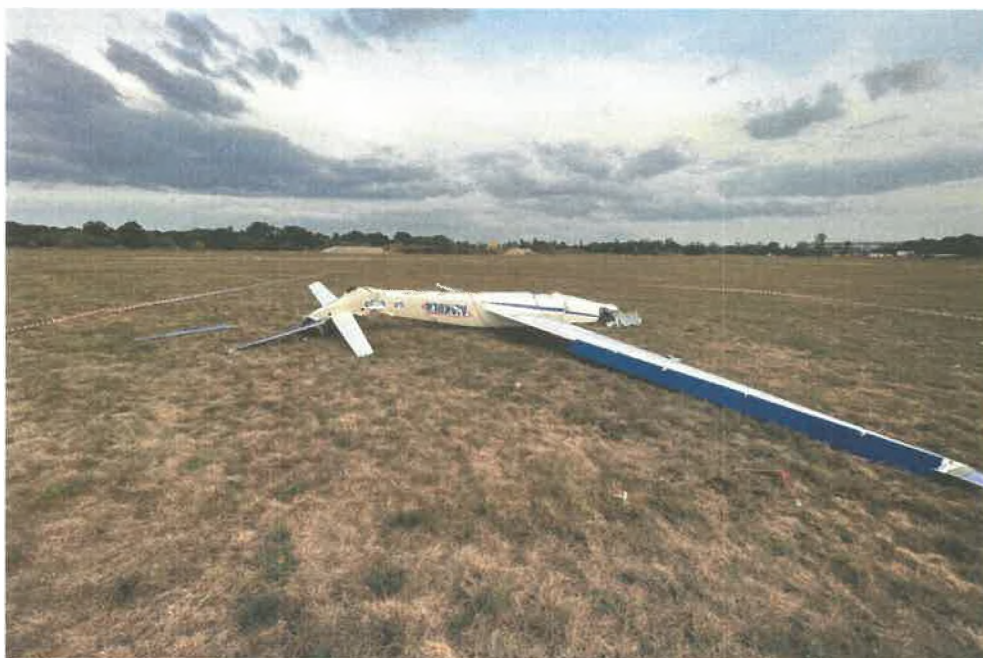
The glider was destroyed as a result of the collision with the ground (Fig. 6).

Figure 6. The glider after the accident [source: Michał Klimaszewski]

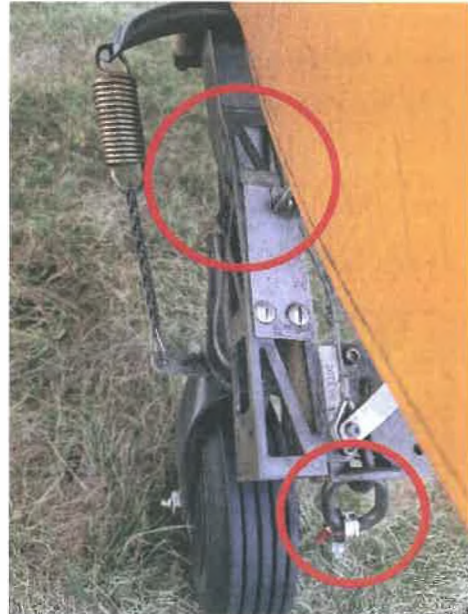
The tow hook mounting on the aeroplane's tail was deformed (Fig. 7).

Figure 7. The deformed tow hook mounting and torn off safety device are marked with red circles

The jerk on the aeroplane's tail, when the tow line was getting tightened and the safety device cracked, caused damage to the truss on which the tow hook was mounted.

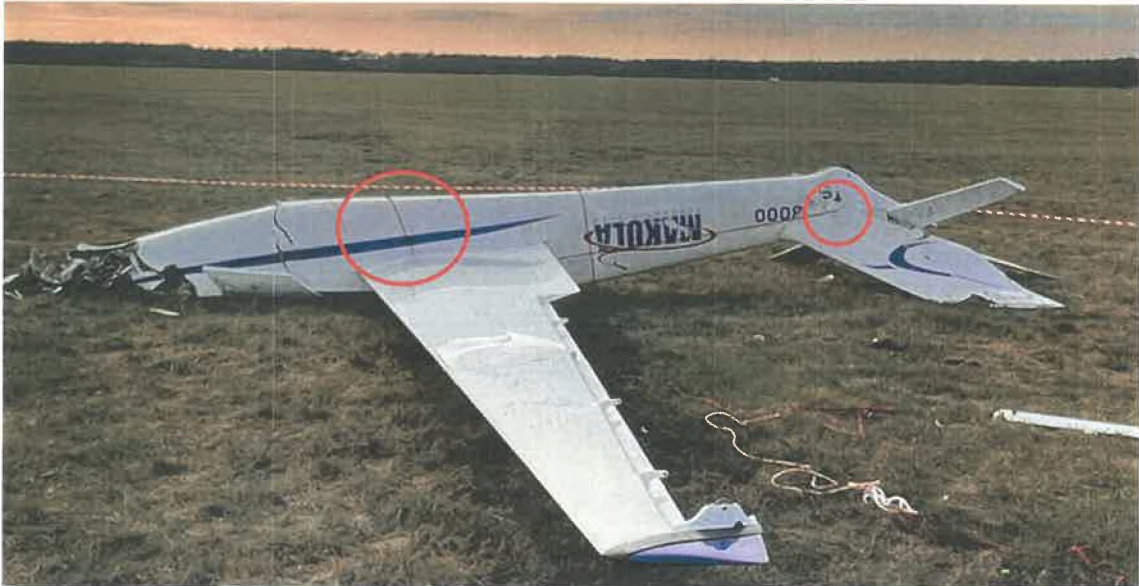
The tow line was 50 m long. The glider caught on it with its right wing. The length of the line that had got behind the wing moved along the fuselage to the rear, on the vertical stabiliser to the horizontal stabiliser, slipped into the slit between the rudder and the fuselage, and proceeded the left side of the fuselage. Subsequently, the end of the line bearing attachment ring, coming from the underside of the stabiliser, caught on the slit between the halves of the elevator. When the line tightened, the elevator was fully deflected down, and the tight line slipped into the slit of the fuselage-wing connection and got stuck. Following this, the safety device installed on the tow line on the aeroplane side was torn off. While the glider was falling, after the pilot egressed the cabin, the line wrapped around the fuselage (Fig. 10).

Figure 10. The wreckage of the glider with the tow line visible  
[source: Michał Klimaszewski]

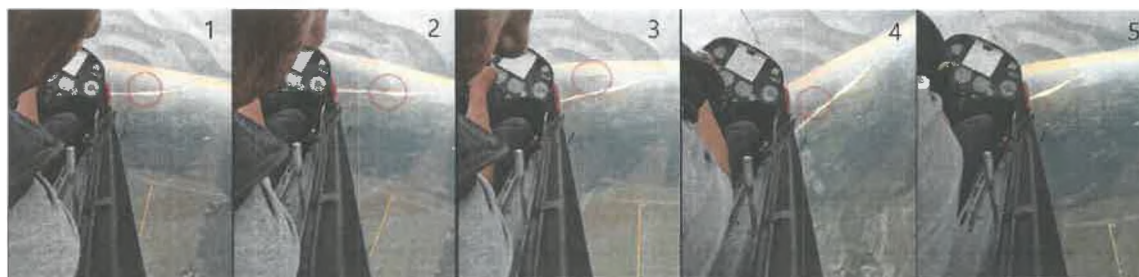
The final phase of the tow into the zone and the realising of the glider is shown in time-lapse images from the video recorded by the camera mounted in the glider's cockpit (Fig. 11). As can be seen, the aircraft was moving away from the zone axis to the left, in a southerly direction.

The yellow line shows the direction of the main zone axis. Photo 4 shows the moment when the glider pilot performed realeasing, and photo 5 shows the correction of the flight dirction to the zone axis.

Figure 11. Time-lapse photographs of the final phase of the glider's towing and releasing [source: pilot's camera].

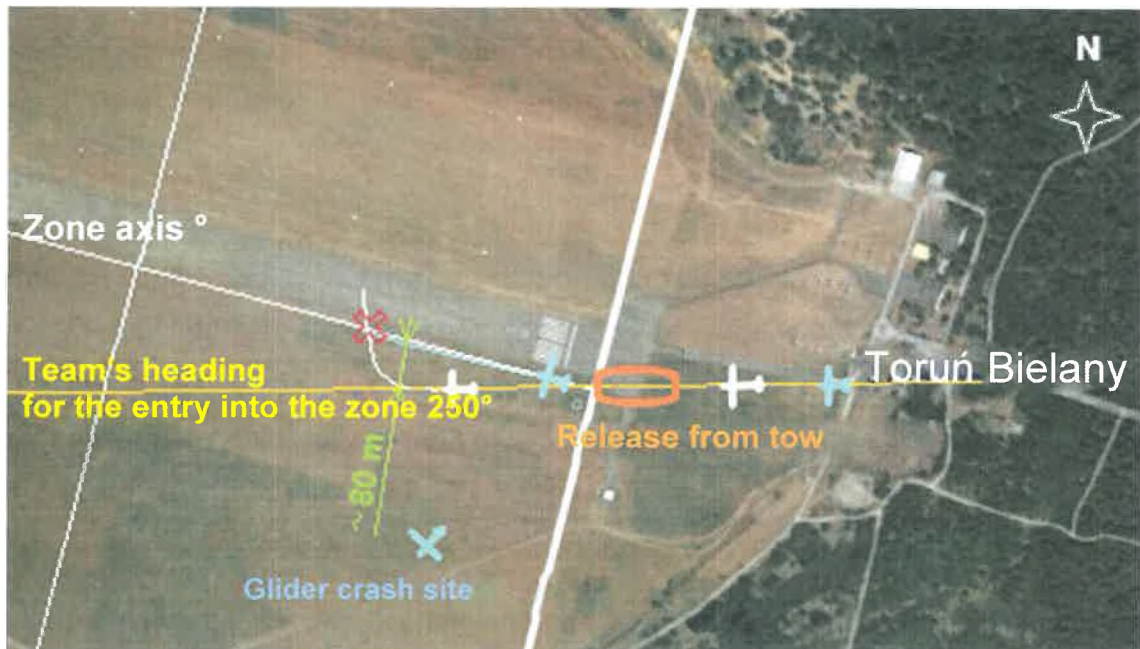
A sketch showing the approximate course of the incident was made on the basis of the video recorded by the camera in the glider's cabin (Figure 12).

Figure 12. A sketch of the occurrence. [source: Geoportal/PKBWL]

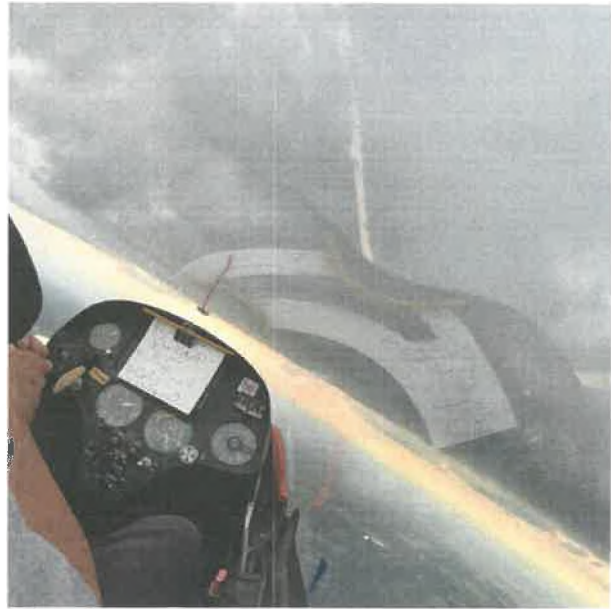
The glider pilot could have subconsciously interpreted such a situation to assume that the aeroplane pilot had been cleared to descend on the southerly circuit, and that he could begin his sequence safely. He had free space in the direction in which he was beginning his sequence (Fig. 12). It must be noted that an aerobatic flight during a contest is always accompanied by strong pressure relating to the desire to get the highest score possible. The pilot focuses on performing their task, and it is the responsibility of the organiser to ensure free space for safe execution of a sequence.

Figure 13. Beginning of the sequence  
[source: the pilot's camera]
