FINAL REPORT

of the State Commission on Aircraft Accidents Investigation

2023-0061

Aeroplane, Extra NG, SP-HMM

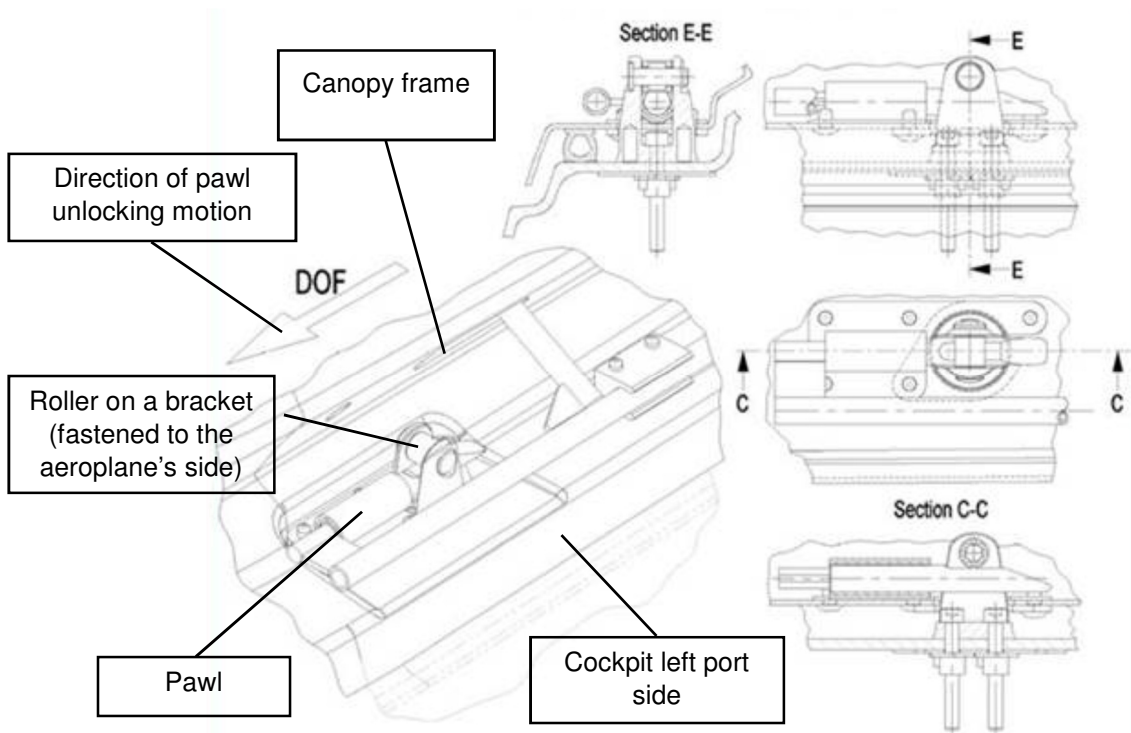
Fig. 2. Cockpit forward lock assembly fitting mechanism aboard the Extra NG
[source: Extra GmbH/BFU]

The operation of the mechanism locking and securing the canopy against spontaneous opening is shown below (Fig. 2).

- 2) The cockpit locking mechanism was operating properly. The air flow around the cockpit in flight alone did not cause the mechanism to unlatch and unlock.

- 1) The design of the cockpit canopy latching system technically did not preclude its partial engagement, in case the pilot has not made sure that rear slider handle is in the locked position which is indicated by a placard (max. aft locking position).
- 2) The canopy locks might not have been engaged and secured fully prior to the flight.
- 3) The action of aerodynamic forces drawing the canopy from the fuselage in high-velocity flight, coupled with canopy vibration, could have increased the load on each partially engaged canopy lock, thereby leading to the displacement of the locks towards their fully open position.

- 2) The cockpit canopy locking mechanism was modified on the Extra NG aeroplane, SP-HMM, S/N NG026, pursuant to Engineering Change ECO-NG-22-09 and ECO-NG-23-07. The modifications introduced, among others, a change in the shape (contour) of the pawls, which now results in additional retention of the latches in the locked position, combined with the installation of an additional spring which increases the hold-down force on the pawls in their locked position.
