State Commission on Aircraft Accidents Investigation
INCIDENT 2022/2455
RESOLUTION
of 15th September 2023

Type and model of aircraft:	Airplane, Boeing 737-800 / Airplane, Cessna 525
Registration marks:	SP-LWF / T7-ACA
Date of occurrence:	24 th May 2022
Place of occurrence:	EPWA

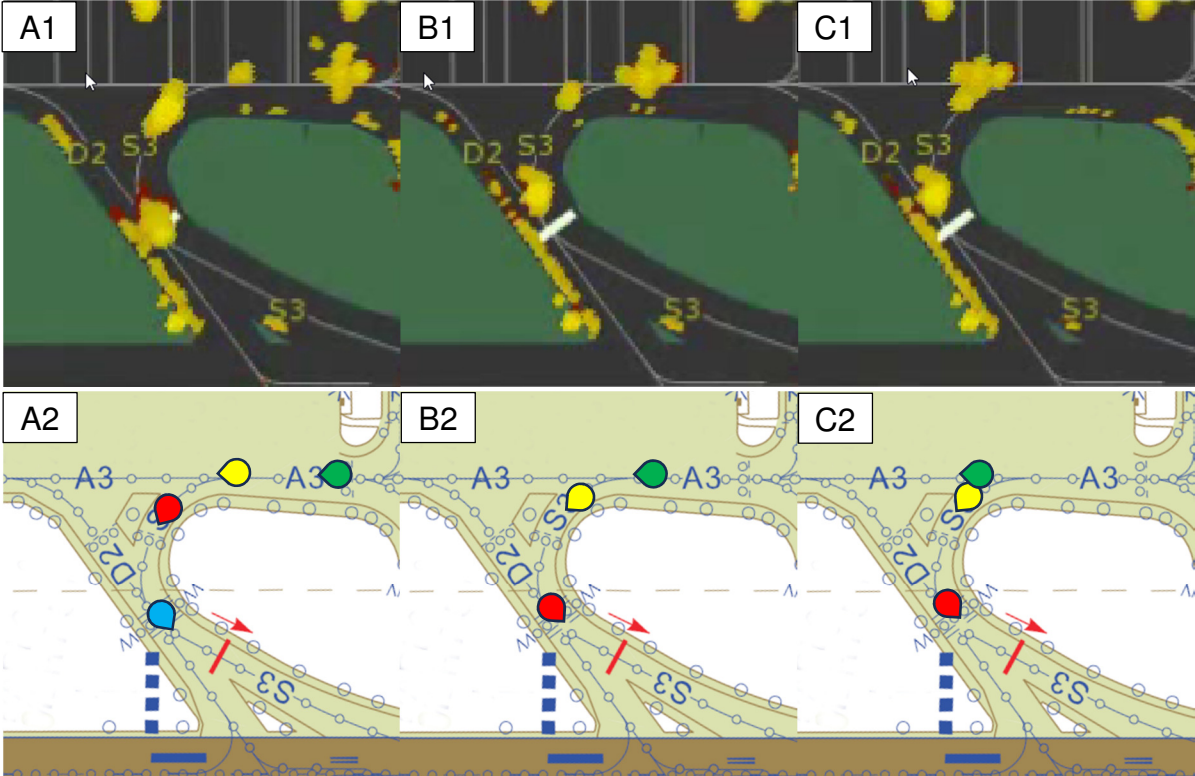
Figure 1. Locations of Cessna and Boeing airplanes before and during the collision
[source: PANSA⁵, PKBWL]

Airplanes: ● Embraer, ● De Havilland, ● Cessna, ● Boeing.
A1, B1 C1 –SMR⁴ imagery, A2, B2, C2 –EPWA airport diagram.
A1, A2 – Boeing airplane stopping behind Cessna airplane on TWY A3, 08:15:23 hours
B1, B2 – Cessna airplane stopping at the intersection of TWY A3 and S3, 08:16:53 hours
C1, C2 – airplanes collision, 08:17:10 hours

The GND controller was located approximately 1,500 meters from the point where the planes collided. The GND controller was provided with SMR imagery to support the observation of the airport's maneuvering field. In this imagery, the Cessna and Boeing aircraft were clearly visible (Figure 1. A1-C1), and their shapes reflected their actual horizontal sizes.

SMR imaging allowed for consideration of the stop of the Cessna airplane at the intersection of TWY A3 and S3 (Figure 1. B1) as a collision with traffic on TWY A3. The Boeing crew and GND controller did not exchange observations regarding the position of the Cessna airplane.
