State Commission on Aircraft Accidents Investigation (PKBWL)

FINAL REPORT

2022/5615

Aeroklub Zagłębia Miedziowego
Socata-Groupe Aerospaciale, Socata-Ralley 235
E-D airplane, SP-WOP
Lubin, 24 September 2022

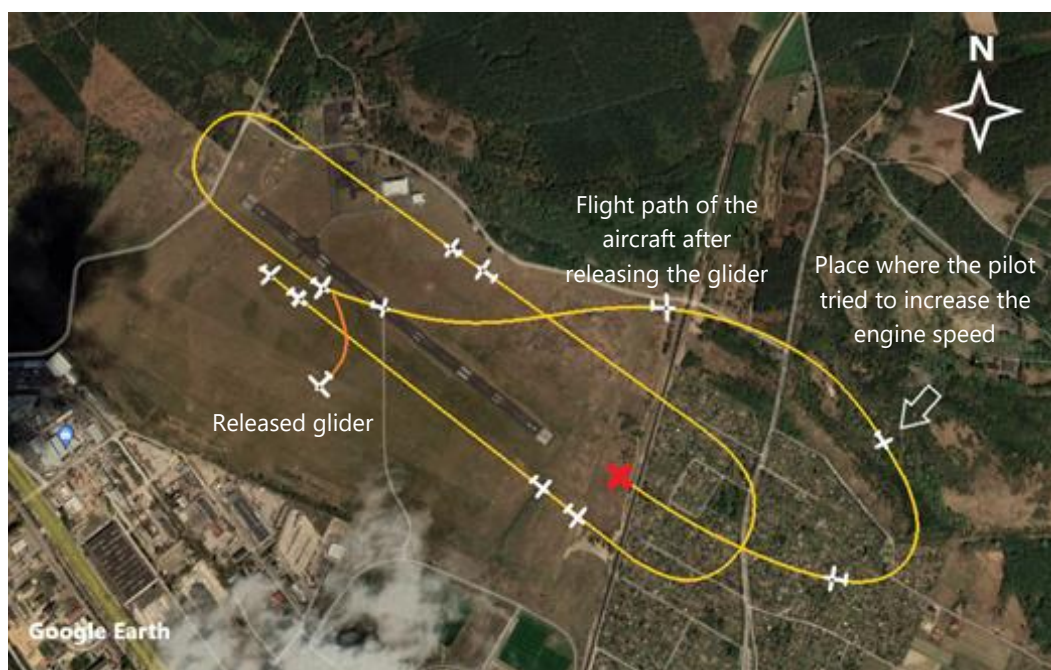
Figure 1. Approximate sketch of airplane flight trajectory

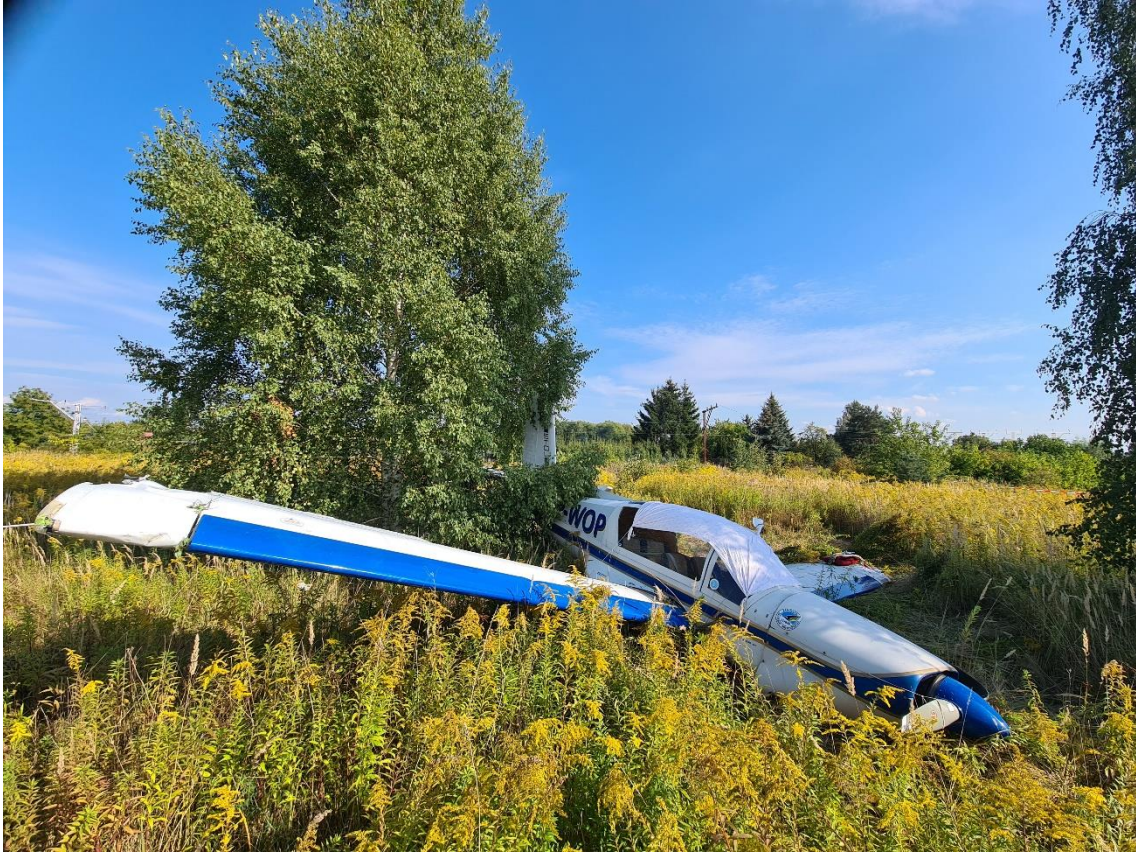
Figure 2. Socata-Ralley 235 E-D airplane at place of emergency landing

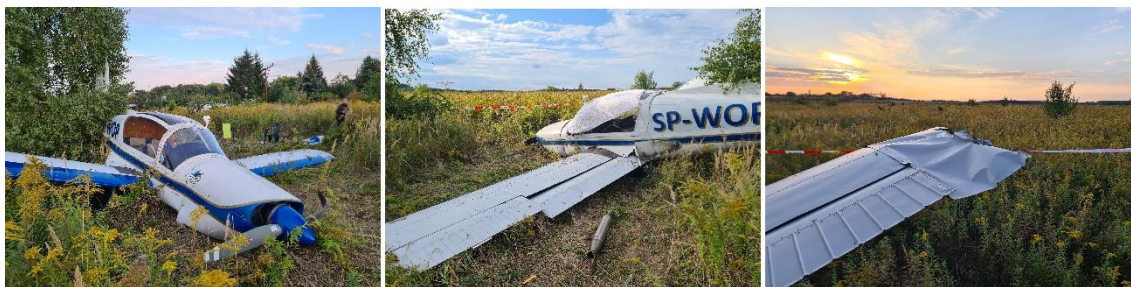
As a result of the occurrence, the aircraft was destroyed (Fig. 3) The front landing gear strut and right main landing gear were broken off. The propeller, the front part of the fuselage, the tip of the right wing and the left wing were damaged. The elevator was slightly damaged.

Figure 3. Socata-Ralley 235 E-D – aircraft wreck (visible damage to the structure)

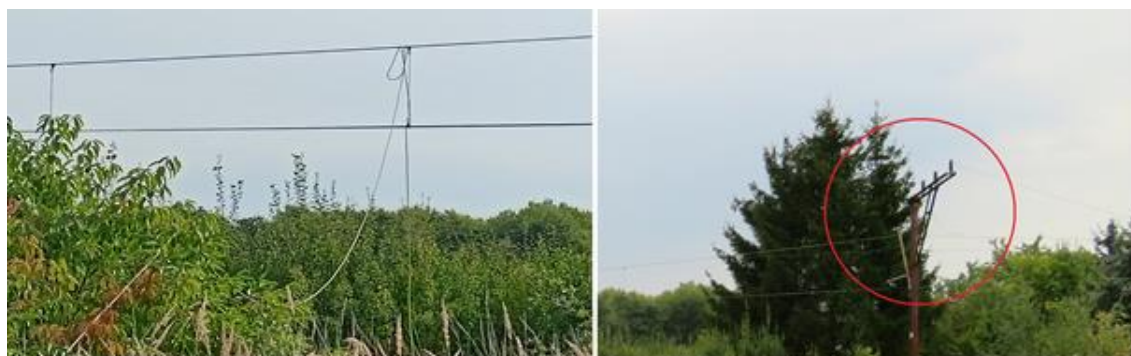
During the final phase of the emergency landing approach, the aircraft broke the wires of the railway electric traction line (Fig. 4).

Figure 4. Damaged railway electric traction line
[source: Aero Club Zagłębia Miedziowego]

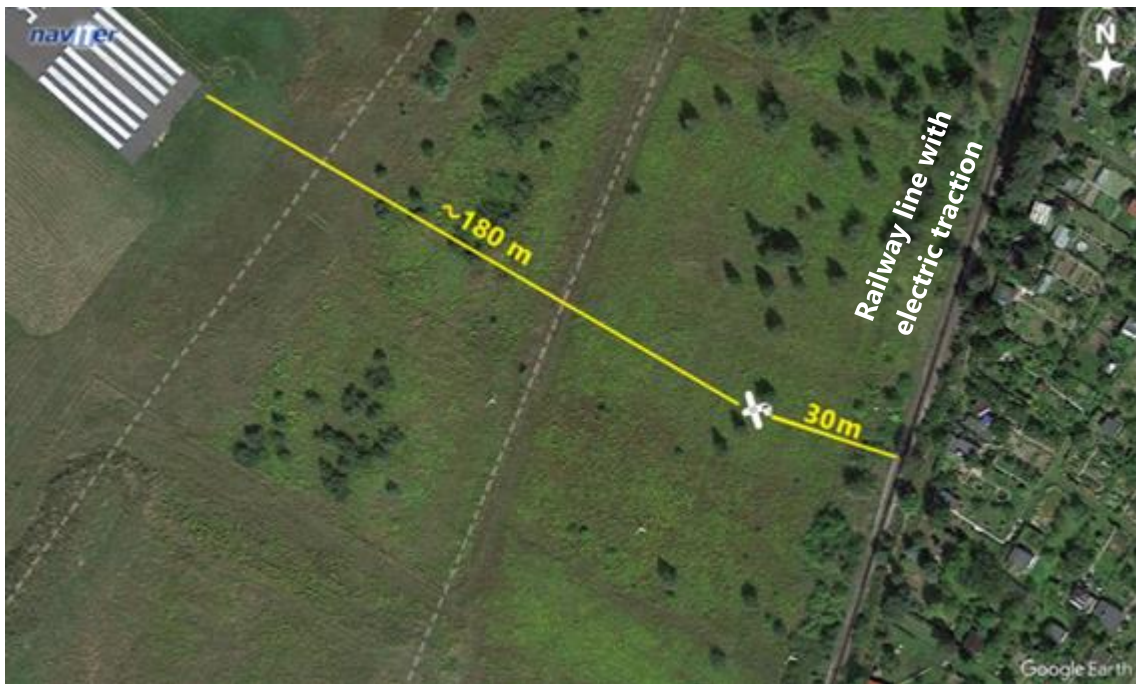
The pilot made an emergency landing approach from the east direction, from above the garden allotments. In the vicinity of garden allotments, there was no suitable place to make a safe emergency landing. The pilot attempted to reach the airport. In the final phase of the flight, he raised the aircraft's nose, which caused a drop in speed. In order to land at a lower speed, the pilot deployed the take-off flaps. Prior to touchdown, the aircraft mushed to the left wing. Touchdown occurred about 30 meters behind the railway line. After touchdown, the aircraft turned to the left and stopped after a short landing run about 180 m before the threshold of runway 31, deviated from the landing direction by about 45° (Fig. 7). Since the pilot did not disconnect the tow rope, it hung on the electric traction wires (Fig.4).

Figure 7. Place of occurrence

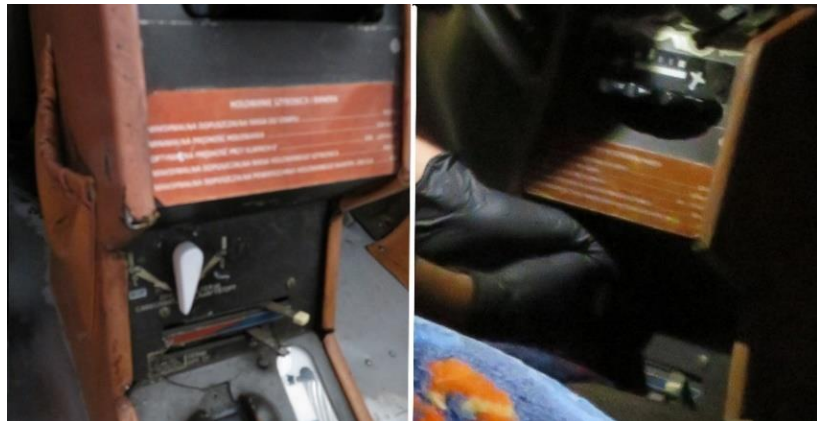
During the inspection of the aircraft after the occurrence, the fuel valve lever was locked in the "closed" position. It was possible to turn to the "open" position with a lot of force (Fig. 8) Most likely, the valve locked during the emergency landing due to structural deformation. This indicates that the fuel valve was closed during the flight before the emergency landing.

Figure 8.
Location of the fuel valve lever after the occurrence.
Attempt to change the location of the fuel valve lever.

The pilot's seat was moved as far forward as possible. Since the fuel valve lever is located under the notch in the centre panel (Fig. 8), controlling its position was difficult. After releasing the glider, the pilot most likely unconsciously closed the fuel supply to the engine.
