FINAL REPORT

ACCIDENT 2022/6240

STATE COMMISSION ON AIRCRAFT ACCIDENTS
INVESTIGATION

AIRCRAFT – GLIDER MDM-1 „Fox”, SP-3828

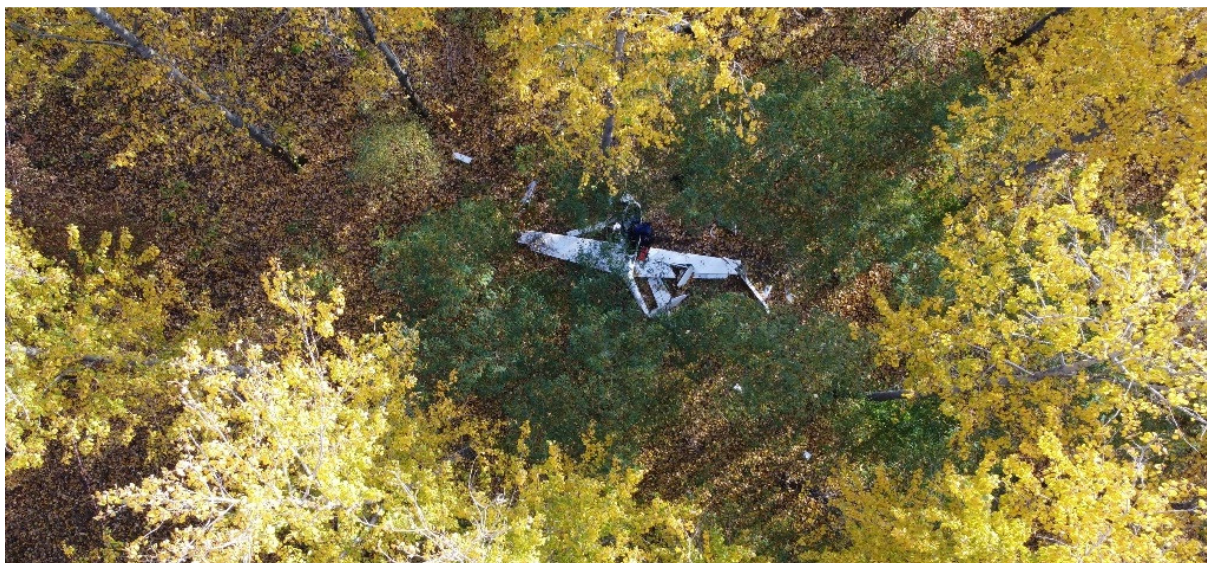
The witnesses to the occurrence who were at the aerodrome notified the accident to the rescue services. After around 3 minutes, they found the crashed glider (Fig. 2). The pilot and the instructor were found in the cockpit but showed no signs of life. The rescue services that arrived on site confirmed their deaths. The glider was destroyed.

Fig. 2 The wreckage of the glider on the accident site; the photograph was taken from a drone
 [source: PKBWL]

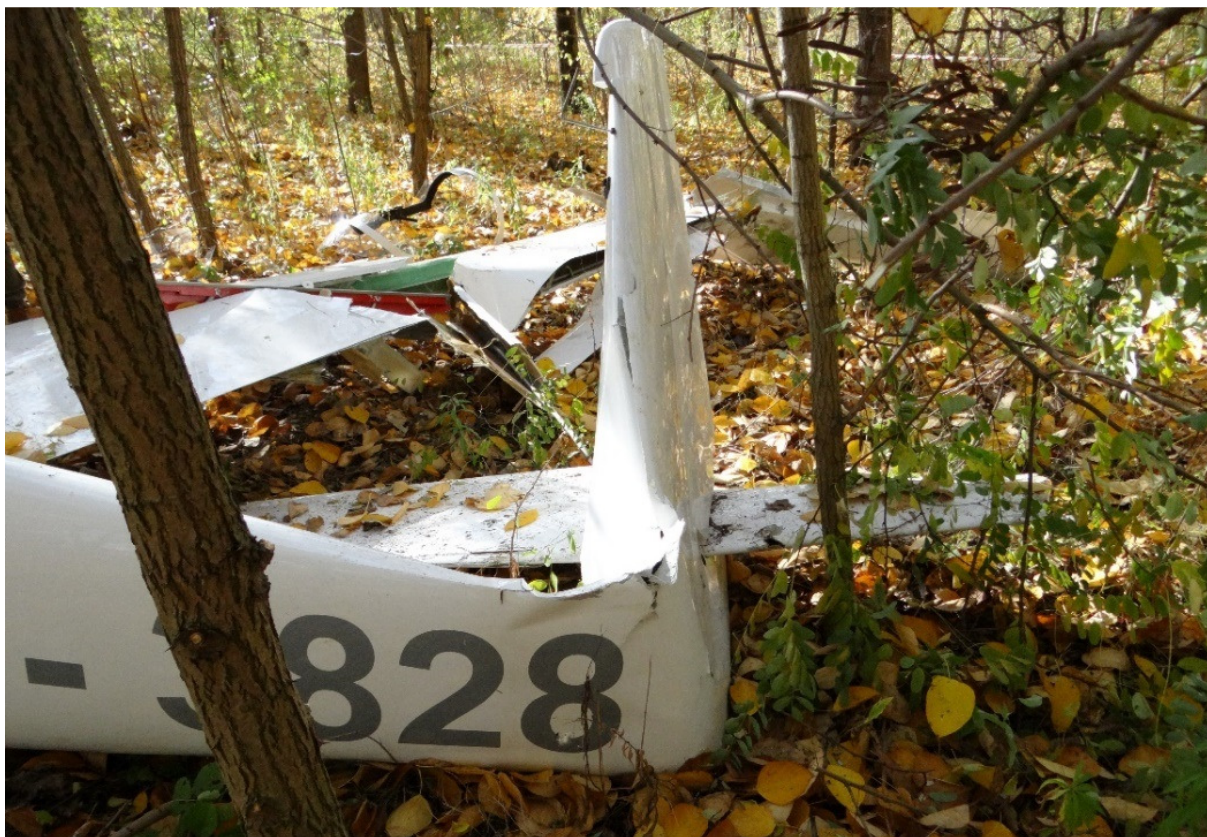
The wings and the horizontal stabiliser were destroyed, but did not detach from the fuselage. The fuselage broke in the section behind the wings and at its transition into the vertical stabiliser.

Fig. 3 The crushed and broken tail, and the torn right wing [source: PKBWL]

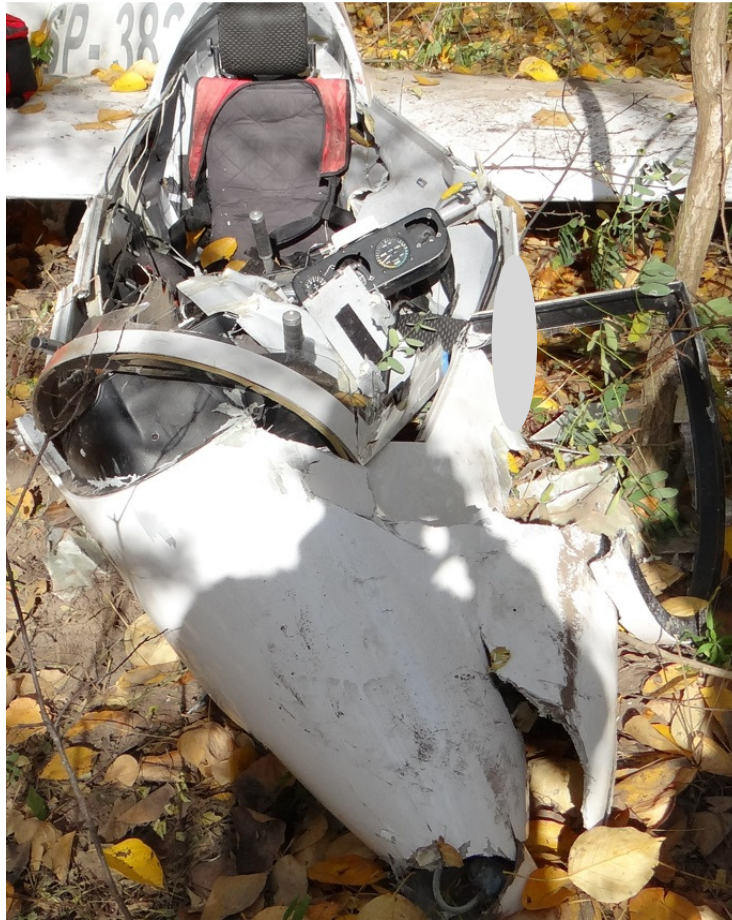
The cockpit was broken in the front seat area, and was crushed and torn open. The composite structures of the nose, floor, sides, both instrument panels and canopy, as well as the glider control systems were completely destroyed.

Fig. 4 Destruction to the glider's cockpit [source: PKBWL]

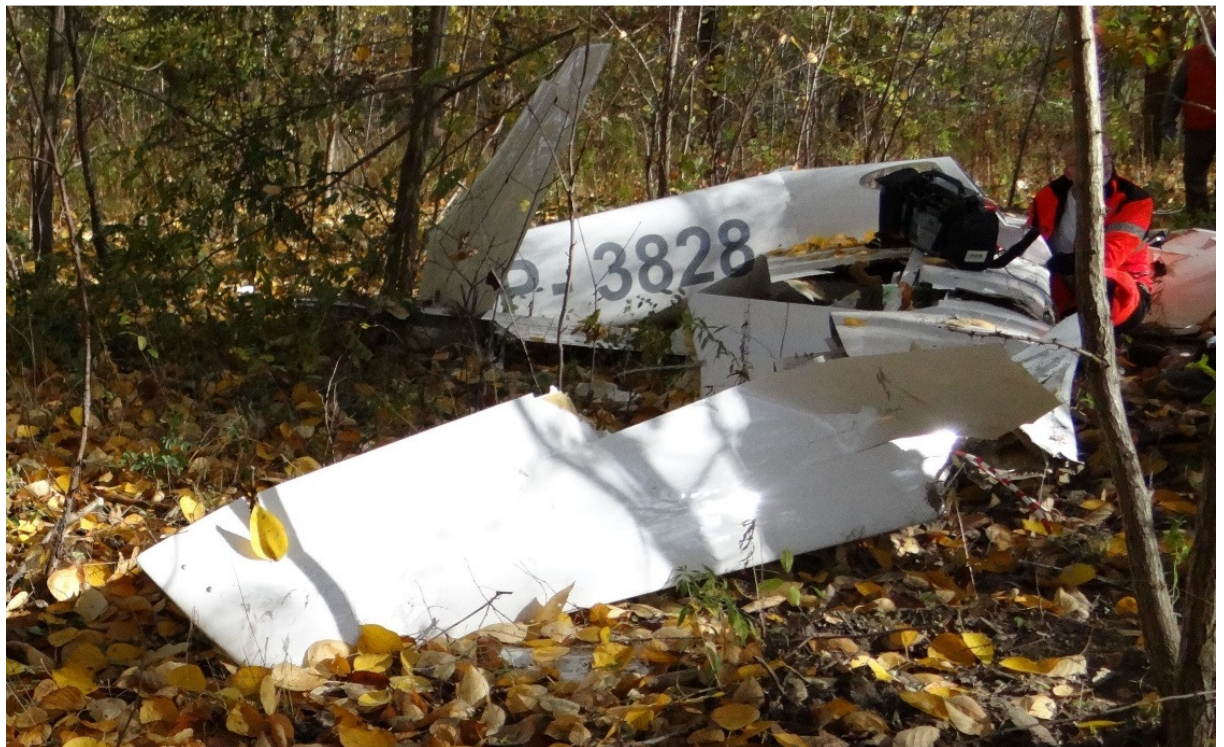
Fig. 5 The wreckage of the glider at the crash site – a view from the right wing [source: PKBWL]

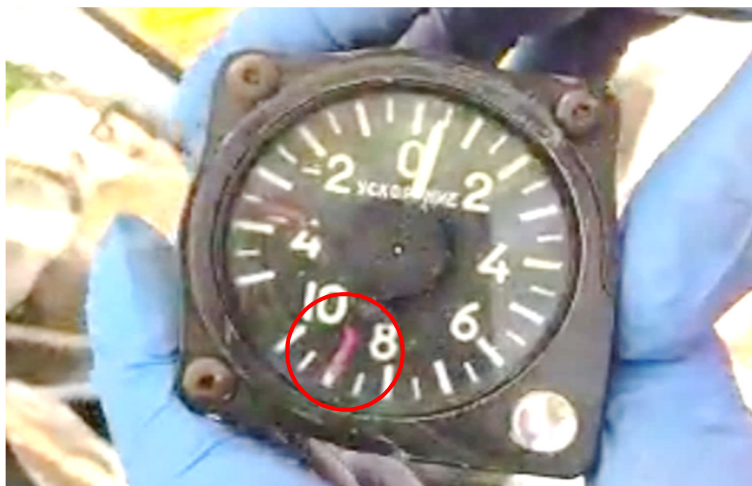
An AM-10 g-meter with an indication range of +10g/-5g (Fig. 13) was installed on the instrument panel in front of the trainee pilot's seat. During the occurrence, the device was ripped out from the instrument panel.

The pointers (red colour) of the device are designed to stop at the maximum positive and negative g-load values reached in flight - the pointer stopped at +9 g. This is an unreliable value because the g-load during the collision with the ground was several times greater and off the instrument's scale.

Fig. 13 The g-meter found in the wreckage – a frame from a video recording from the accident site
[source: PKBWL]

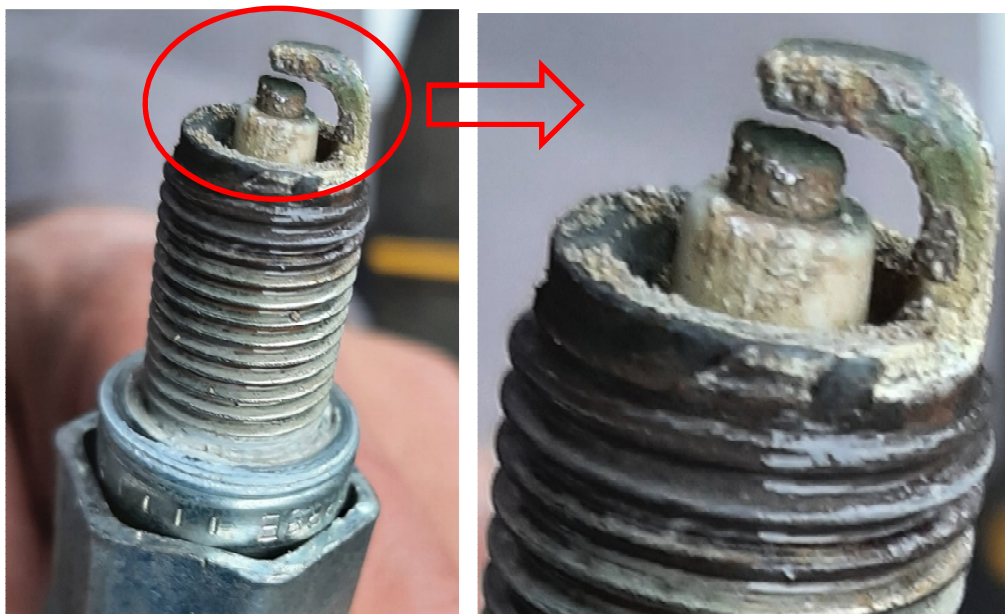
1. In cylinder no. 1 there was a minimal compression, and there were a significant carbon deposits on both spark plugs (Fig. 14).

Fig. 14 Carbon deposit on the electrode of the spark plug of cylinder no. 1 [source: PKBWL]

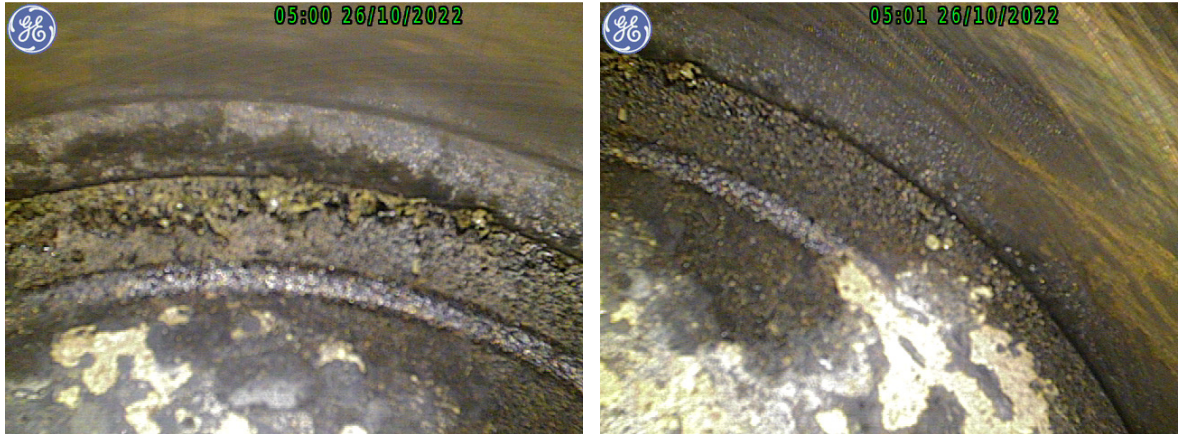
2. The electrodes of cylinders no. 2, 3 and 4 did not have any carbon deposits, but their colour was light grey.
3. The NGK DCPR7E spark plugs installed in the engine did not meet the recommendation provided in the Rotax Service Manual (instruction no. SI-912 i-013 / SI-912-027 / SI-914-028) concerning the use of 297656-type spark plugs (double-electrode spark plugs). However, BRP Rotax notes in the said document that it is not obligatory to use the new type of spark plugs.
4. There were significant carbon deposits in all cylinders. The condition of the interior of cylinder no. 1 is shown in Fig. 15.

Fig. 15 Borescope camera photographs of the interior of cylinder no. 1 [source: PKBWL]

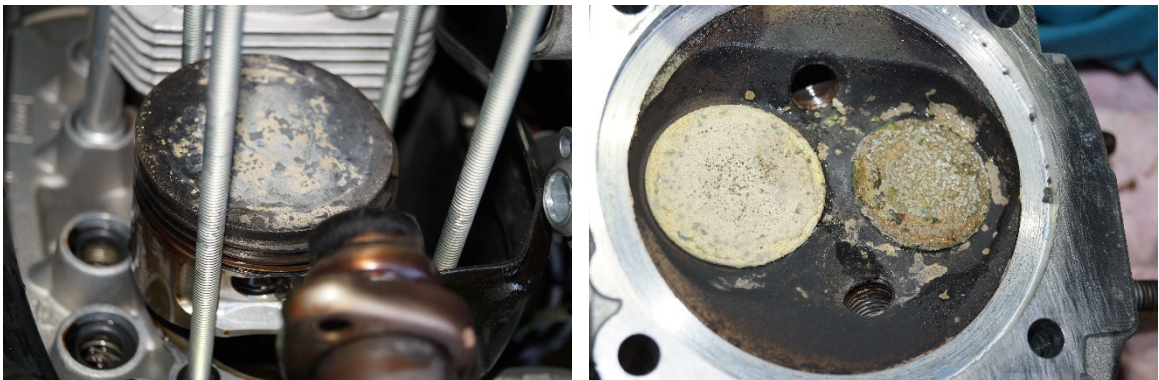
5. In order to directly examine the condition of the combustion chamber and piston, the cylinder head and the body of cylinder no. 1 were disassembled, exposing the piston. Numerous carbon deposits were found on the bottom. The condition of the piston bottom (left) and the head valves (right) is shown in Fig. 16. White "ceramic" carbon deposit was found in the head. The same deposit was found on the surface of both valves and on the exhaust valve stem.

Fig. 16 The piston of cylinder no. no 1 and cylinder head valves [source: PKBWL]

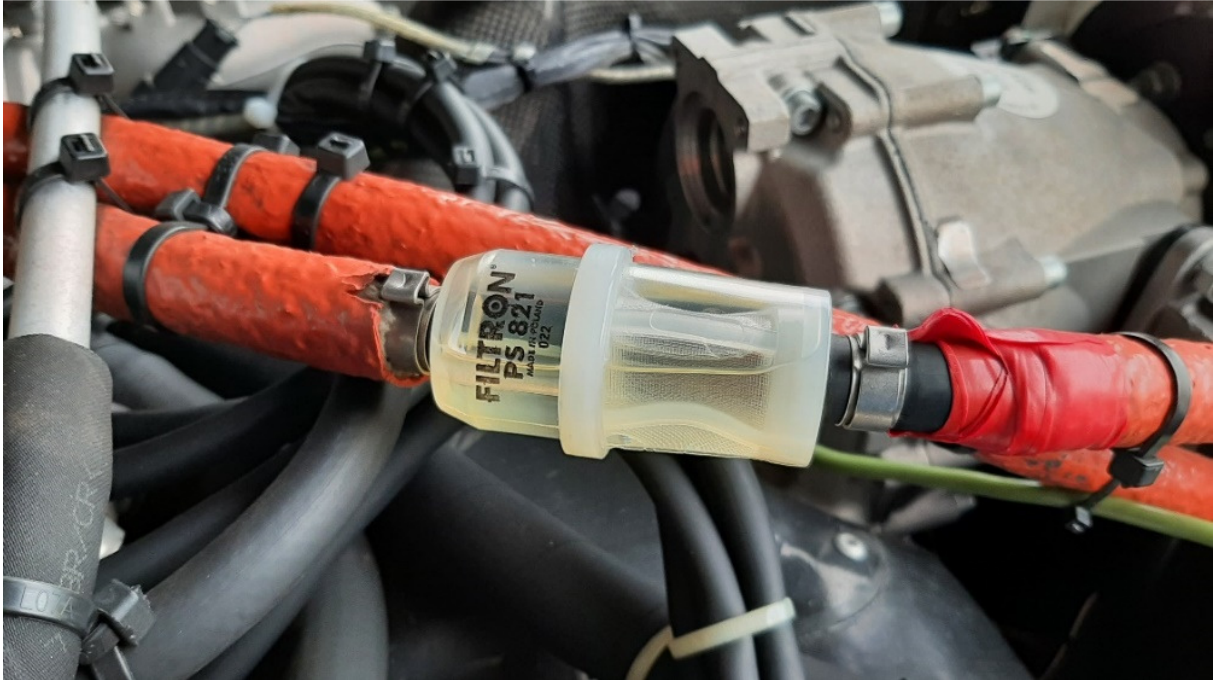
6. No damage to piston rings in cylinder no. 1 was found. The condition of the piston rings was described as correct.
7. Visual assessment of the quality of the fuel (unleaded 95 petrol), drained twice from the aeroplane's settlers, showed that the fuel was clean, clear and without any water inclusions.
8. Fuel was found to be present in the fuel filter installed in the engine compartment (Fig. 17).

Fig. 17 Fuel in the filter on the engine [source: PKBWL]

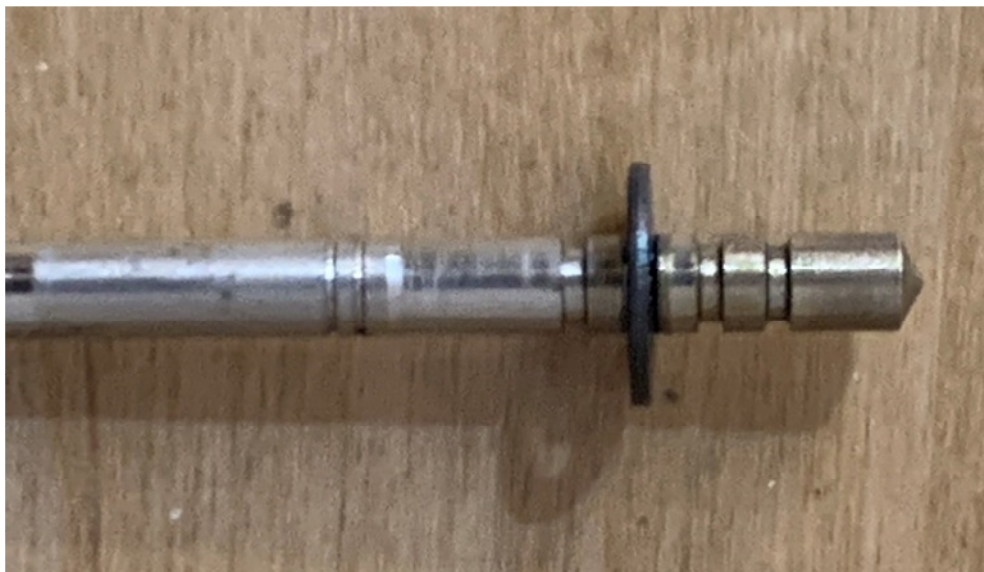
- Both engine carburetors were opened, and no irregularities were found inside. Based on a visual assessment, the condition of the needles and throttles was found to be correct. The carburettor needles were uninstalled together with the membranes. It was confirmed that the needle settings (Fig. 18), and thus the calibration of the carburettor, met the recommendations of the engine manufacturer (Maintenance Manual. Base maintenance, "Fuel Systems and Distribution", doc. no. 73-00-10, Edition 2 of September 2022).

Fig. 18 The carburettor needle and its setting [source: PKBWL]

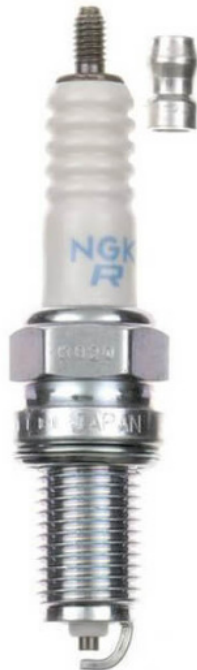
Installed in the cylinders were spark plugs other than recommended in the Rotax Service Manual issued in March 2017. NGK DCPR7E spark plugs (with a single electrode, Fig. 22) were recommended earlier and are still universally used in Rotax engines. However, the manufacturer recommends using double-electrode spark plugs (P/N 297656, Fig. 23), arguing that it is required by the standardisation of the equipment. No indication has been provided to state that a reason for the change might be possible build-up of carbon deposits on earlier used NGK spark plugs. The Commission has not established any link between build-up of carbon deposits and the type of the spark plugs used.

Fig. 22 An NGK DCPR7E spark plug
