State Commission on Aircraft Accidents Investigation

PRELIMINARY REPORT

2023-0069

Private user, recreational flight
FLYSYNTHESIS ITALY, ULL STORCH CL, OK-
TUV 61
Brzeska Wola, 19 September 2023

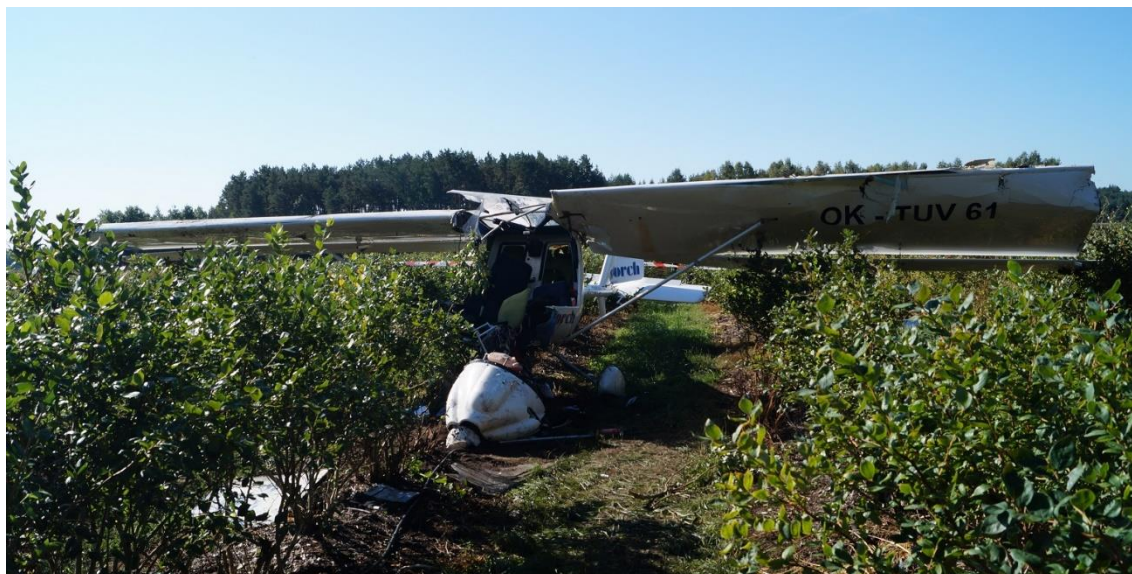
Figure 1. The Storch CL OK-TUV 61 at the accident scene

The aeroplane was destroyed. As a result of the collision with the ground and as a consequence of the action of recovering the pilot from the fuselage carried out by the Fire Service, the front section of the aeroplane was detached from the rest of the airframe. The front fairing and the cockpit doors on both sides were torn out from the wreckage during the rescue action. The accident caused the engine together with the firewall were detached from the fuselage, and the instrument panel was destroyed.

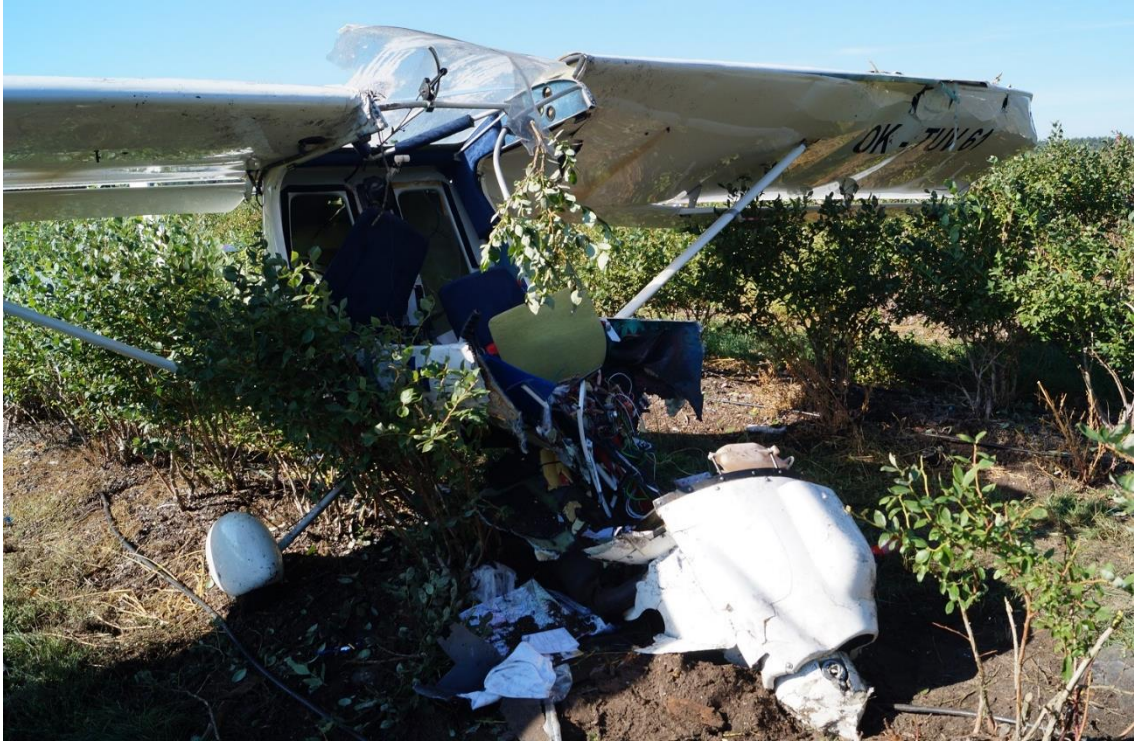
Figure 2. The Storch CL OK-TUV 61 at the accident scene

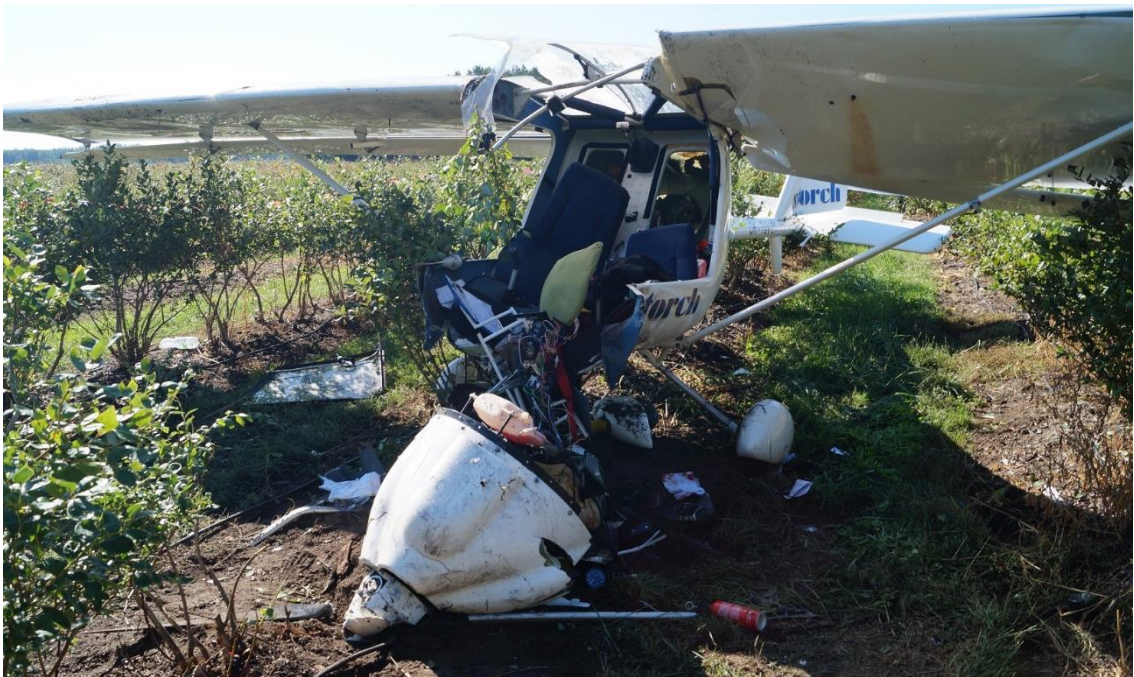
Figure 3. The Storch CL OK-TUV 61 at the accident scene

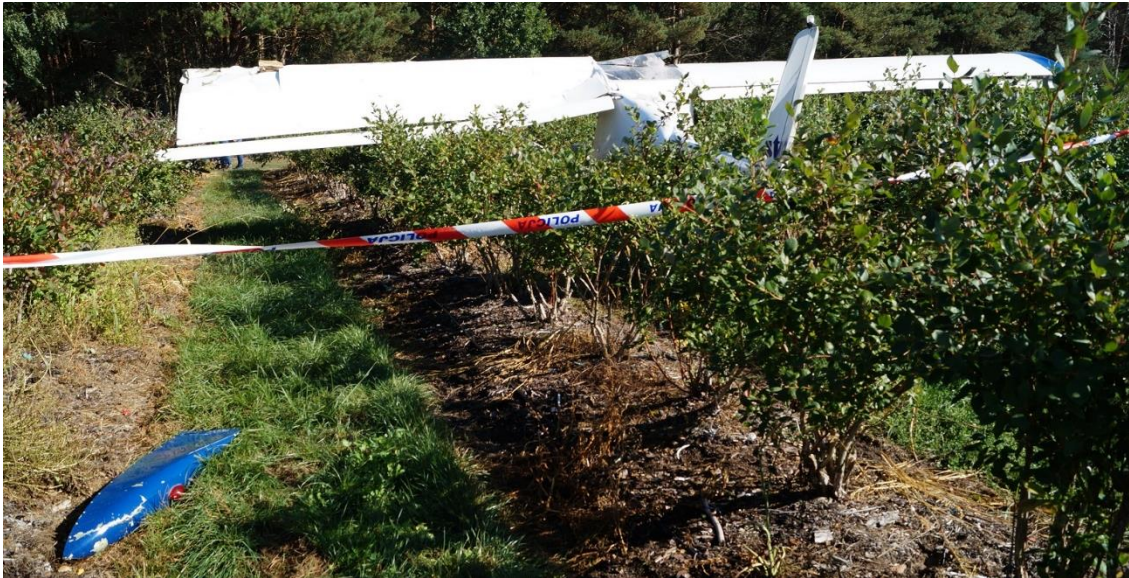
The wings of the aeroplane remained in place, secured to the centre section of the wing and supported by the wing struts extending from the fuselage. The fairing of the left wing tip separated from the wing.

Figure 4. The Storch CL OK-TUV 61 at the accident scene. The left wing tip fairing can be seen in the bottom left corner of the picture

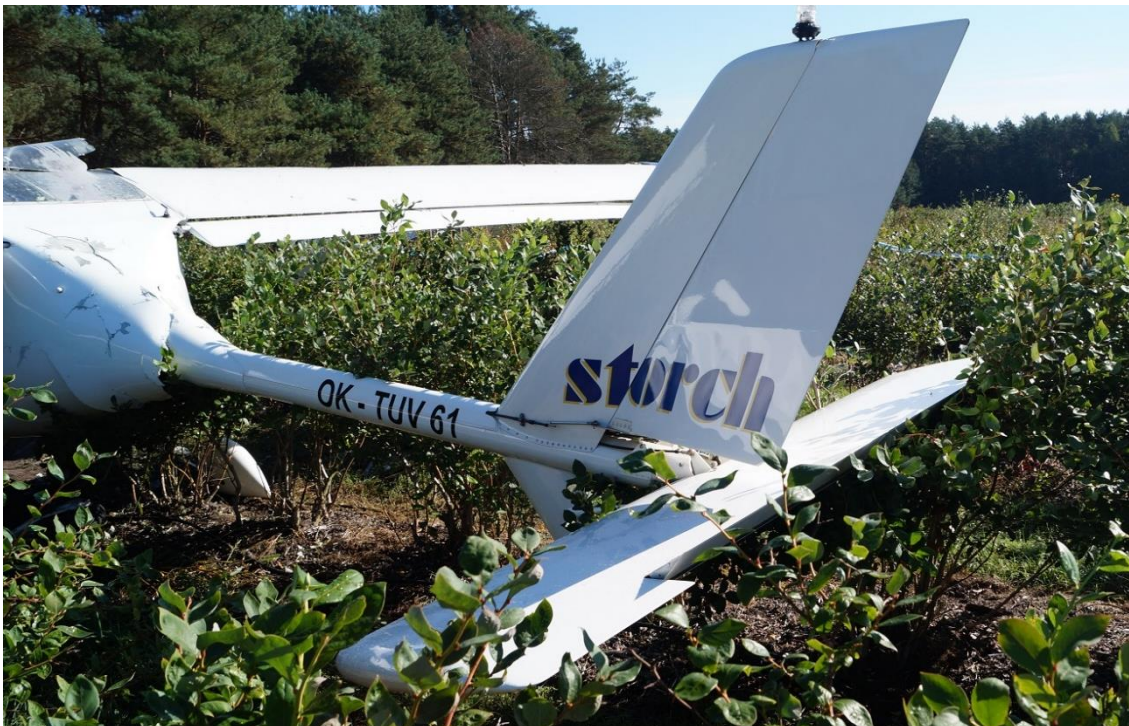
The aeroplane's main landing gear remained in place, and the front landing gear leg broke and separated from the wreckage. The tubular tail beam of the airframe fractured at the beam-fuselage transition.

Figure 5. The Storch CL OK-TUV 61 at the accident scene – the tail section of the airframe

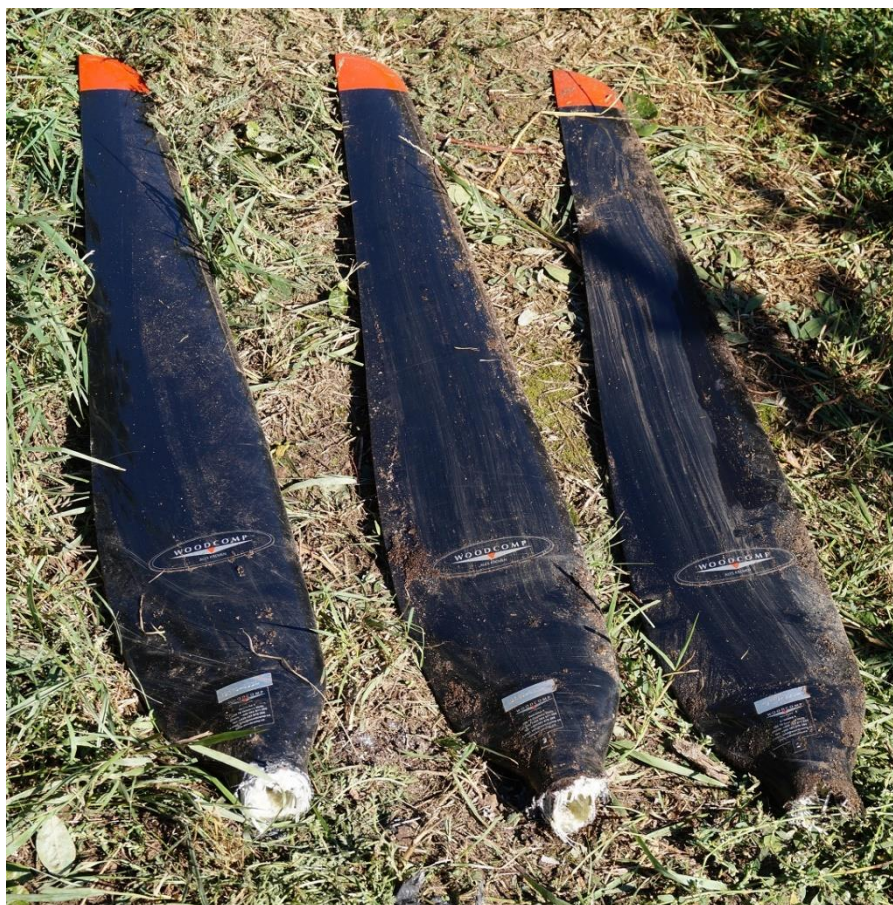
The tail unit remained mostly undamaged after the accident. Three propeller blades at the nose of the aeroplane broke off from the hub at their root and remained under the aircraft engine. The position and condition of the propeller

blades show that the aeroplane's engine was not running at the time of the aeroplane's collision with the ground.

Figure 6. The propeller blades of the Storch CL OK-TUV 61 recovered from under the wreckage.

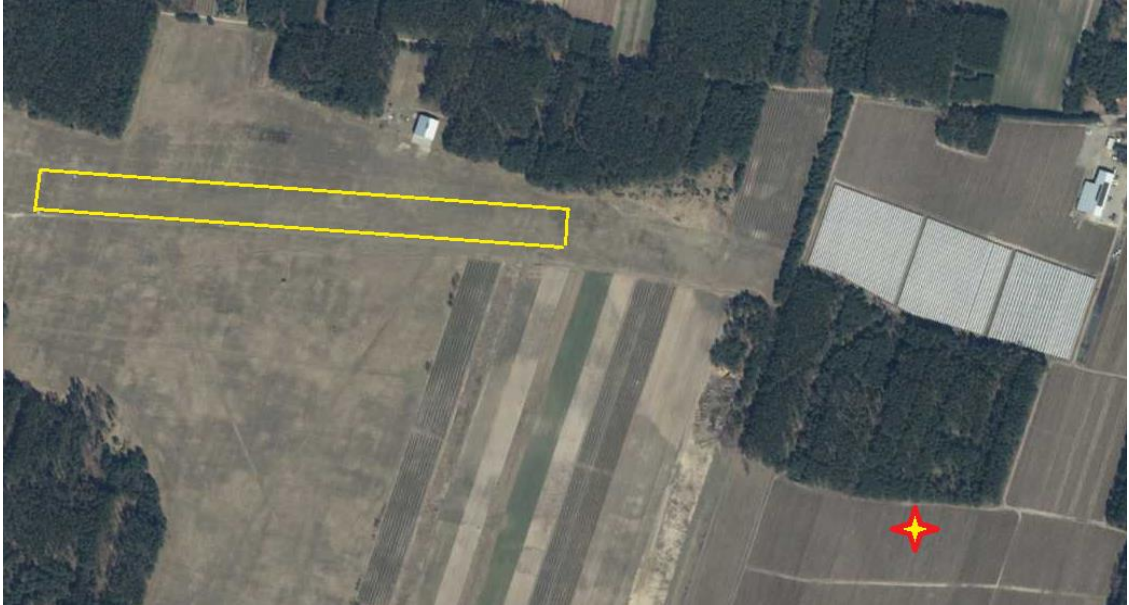
The collision of the aircraft with the ground occurred at a blueberry plantation adjoining the Brzeska Wola airfield. The aircraft collided with the ground in a near vertical position, with its nose down, without banking. The front of the aeroplane stuck into the soft soil, as a result of which the aeroplane's propeller blades were broken off from the hub and remained under the wreckage, pressed to the ground and uniformly arranged at every 120°. The fire service unit that arrived at the accident scene lowered the aeroplane's tail and cut the cabin open in order to recover the pilot from the wreckage. Most of the airframe along with the wings, struts, tail beam and tail unit kept their integrity. The main landing gear also survived in good condition.

Figure 8. The site of the Storch CL OK-TUV 61 collision with the ground is marked with the asterisk, and the location of the runway of the Brzeska Wola airfield is marked with the yellow rectangle [source: Geoportal]

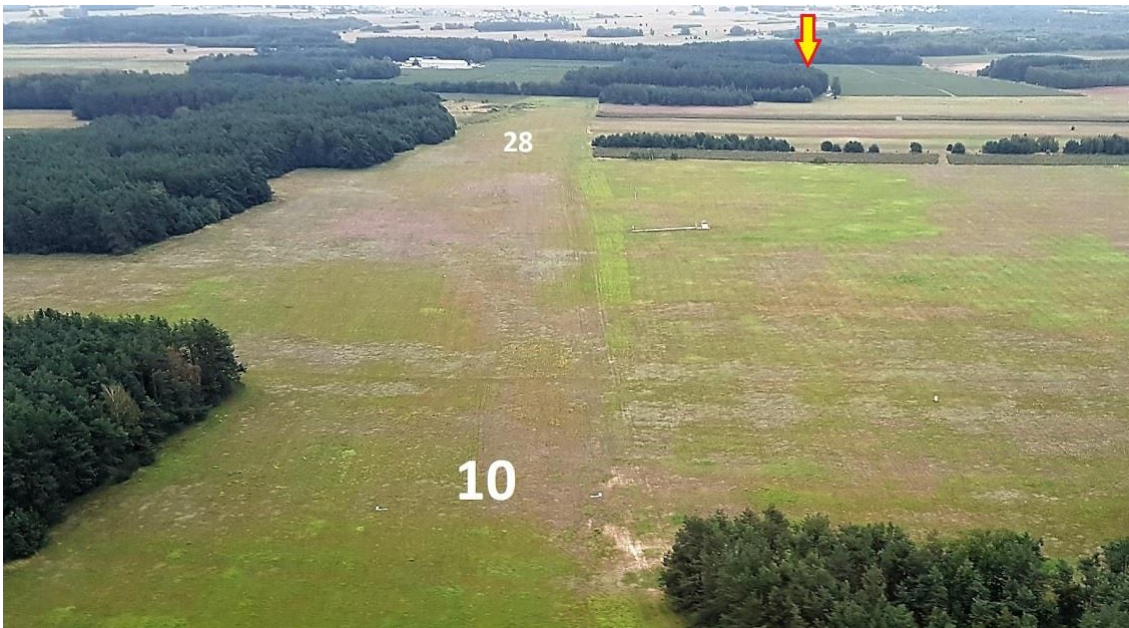
Figure 9. The runway of the Brzeska Wola airfield. The arrow indicates the site of the Storch CL OK-TUV 61 collision with the ground [source: lotniska.dlapilota.pl]

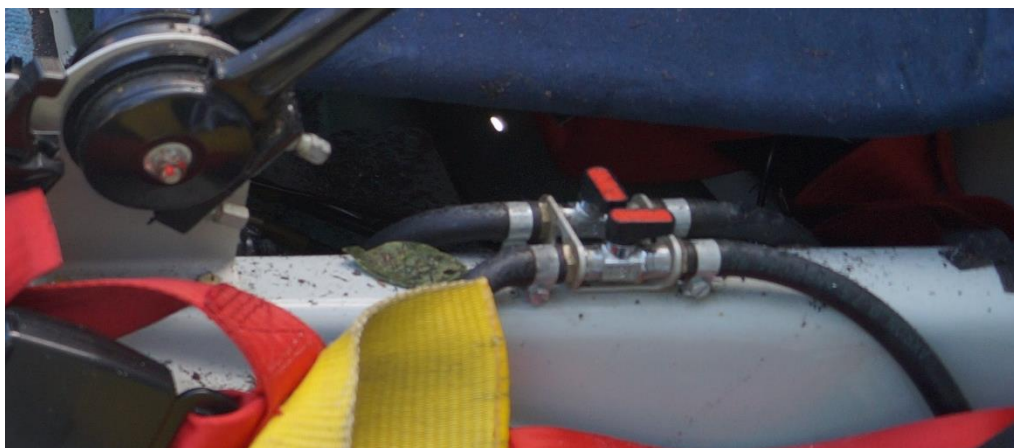
- c) the aeroplane's fuel tanks were checked and fuel samples were taken and preserved for a potential future analysis. Approximately 5 l of fuel was found in the right tank. Approximately 0.2 l of fuel was found in the left tank, however the fuel line coming out of the left tank was broken during the accident. At the moment of the accident, the aeroplane's engine was being supplied from the left fuel tank;

Figure 10. The fuel cocks of the Storch CL OK-TUV 61 after the accident. The closed right tank fuel cock and open left tank fuel cock can be seen.

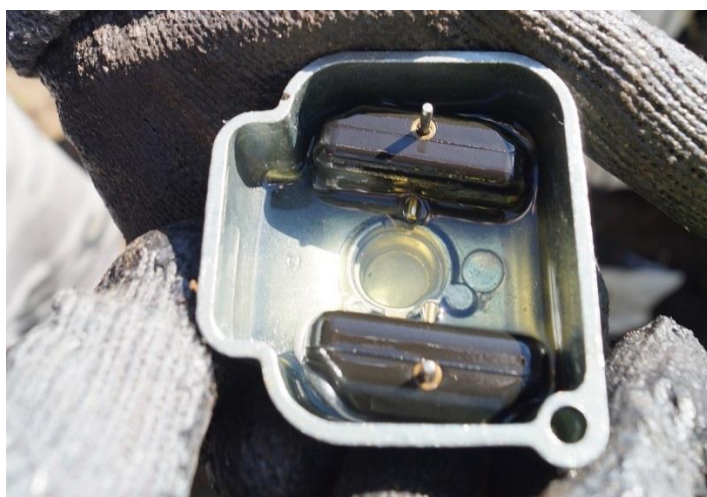
- d) the engine covers were dismantled and ignition plugs were screwed out (the colour and amount of carbon deposits was assessed as correct);
- e) the carburettor float chambers were disconnected to check if the engine was supplied with fuel at the time of the accident. Fuel was found in the float chambers of both carburettors.

Figure 11. The carburettor float chamber of the Storch CL OK-TUV 61 with fuel found inside
