State Commission on Aircraft Accidents Investigation

FINAL REPORT

2023-0024

CH 601, OK-KUA15 .

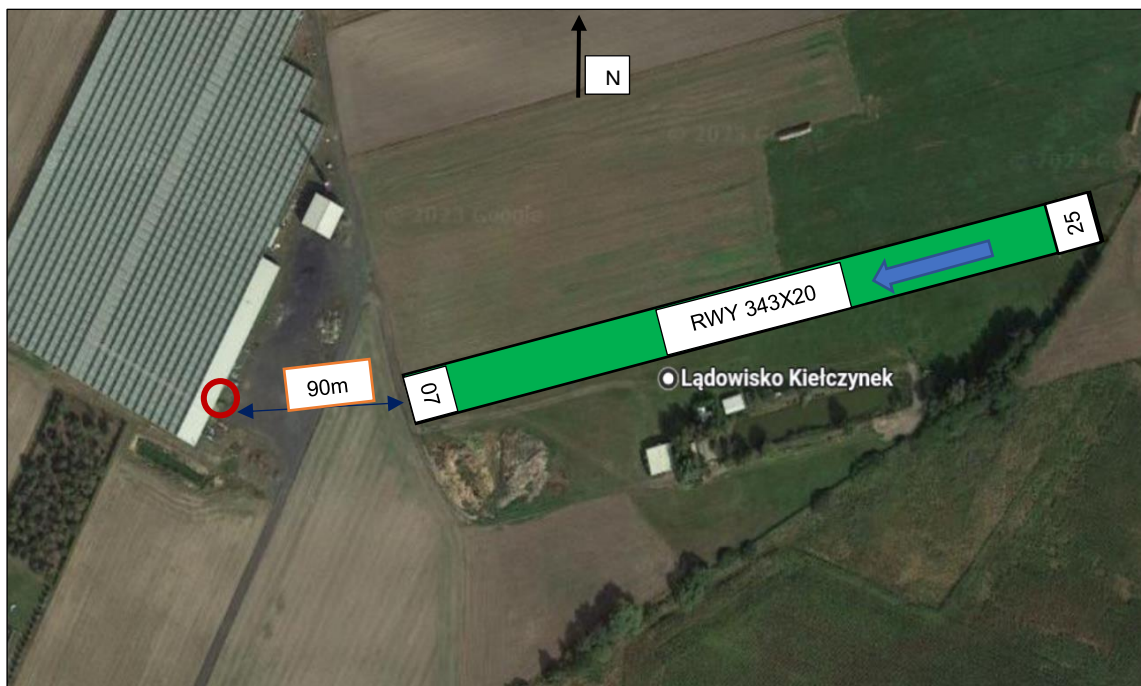
Figure 1. The accident area – the blue arrow indicates the direction of the flight, while the red circle shows the place where the aeroplane collided with the building.

The aeroplane lifted off from the grass runway after about 270 m. Having noticed that he was flying towards a lighting pole located at the greenhouse, the pilot decided to evade it making a right turn and pulling the control stick slightly towards himself. The aeroplane climbed to approximately 4 m over the RWY but started banking sideways, first to the right and then to the left, after which it was stalled, turned right suddenly and collided with the roof of a building.

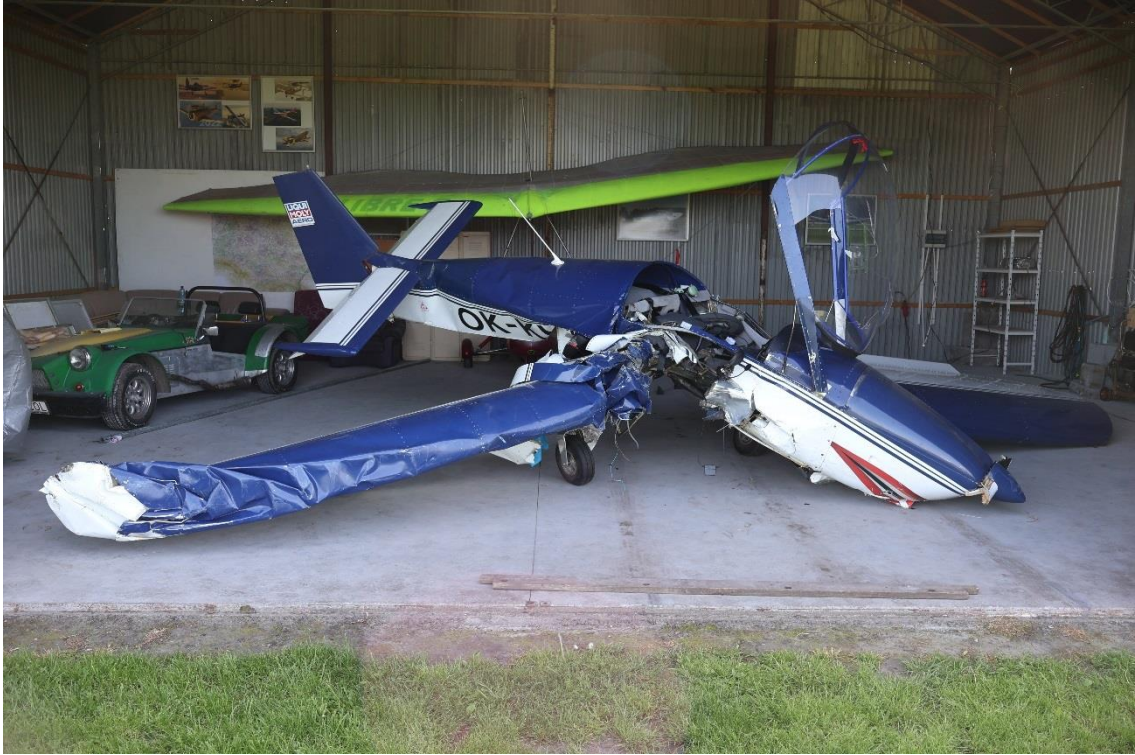
The aeroplane was destroyed as a result of the accident. All damage to the aeroplane was caused by the collision with the outbuilding. The wreckage is shown in Fig. 2.

Figure 2. The wreckage after being moved to the hangar.

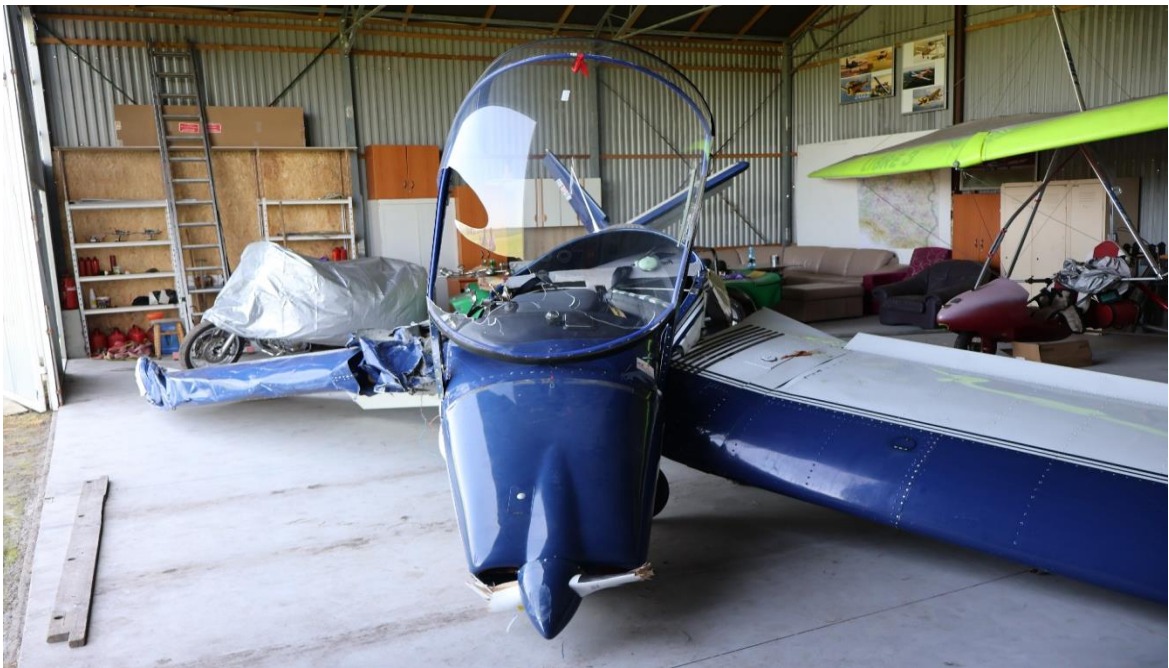
Figure 4. The view of the damage to the propeller and left wing of the aeroplane.

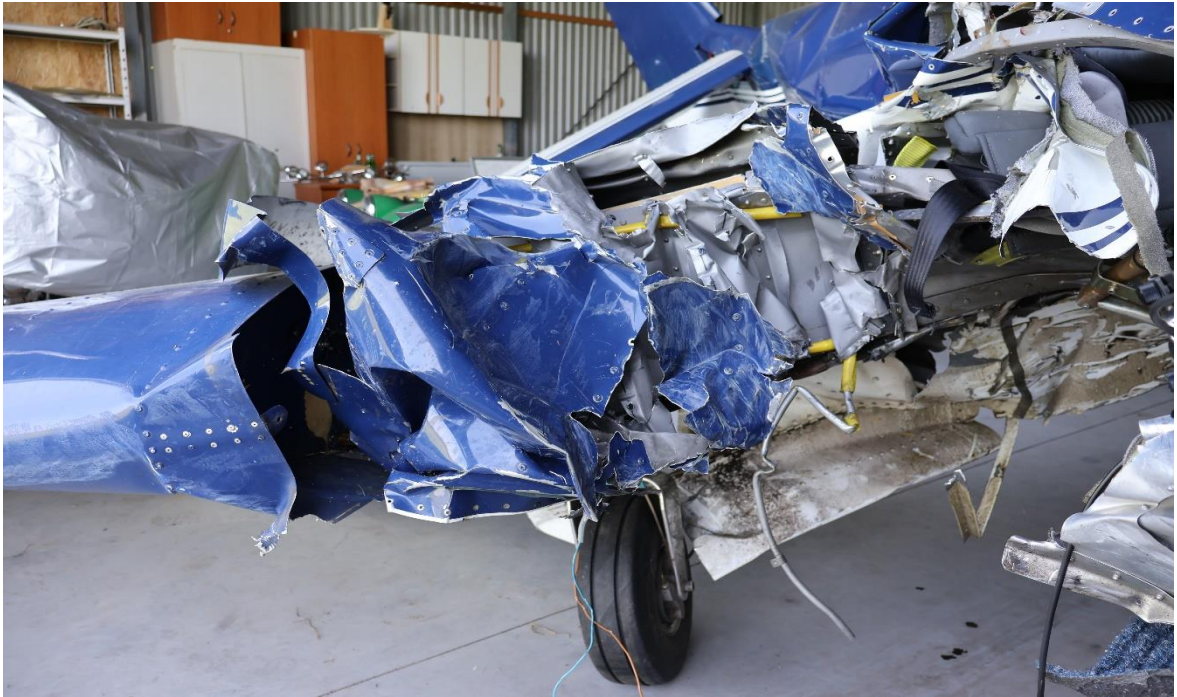
The edge of the outbuilding's roof was damaged.

Figure 5. The damage caused by the aeroplane's impact on the edge of the roof.

An inspection of damage to the wreckage and building shows that the edge of the roof made of metal sandwich panels cushioned the force of the impact.

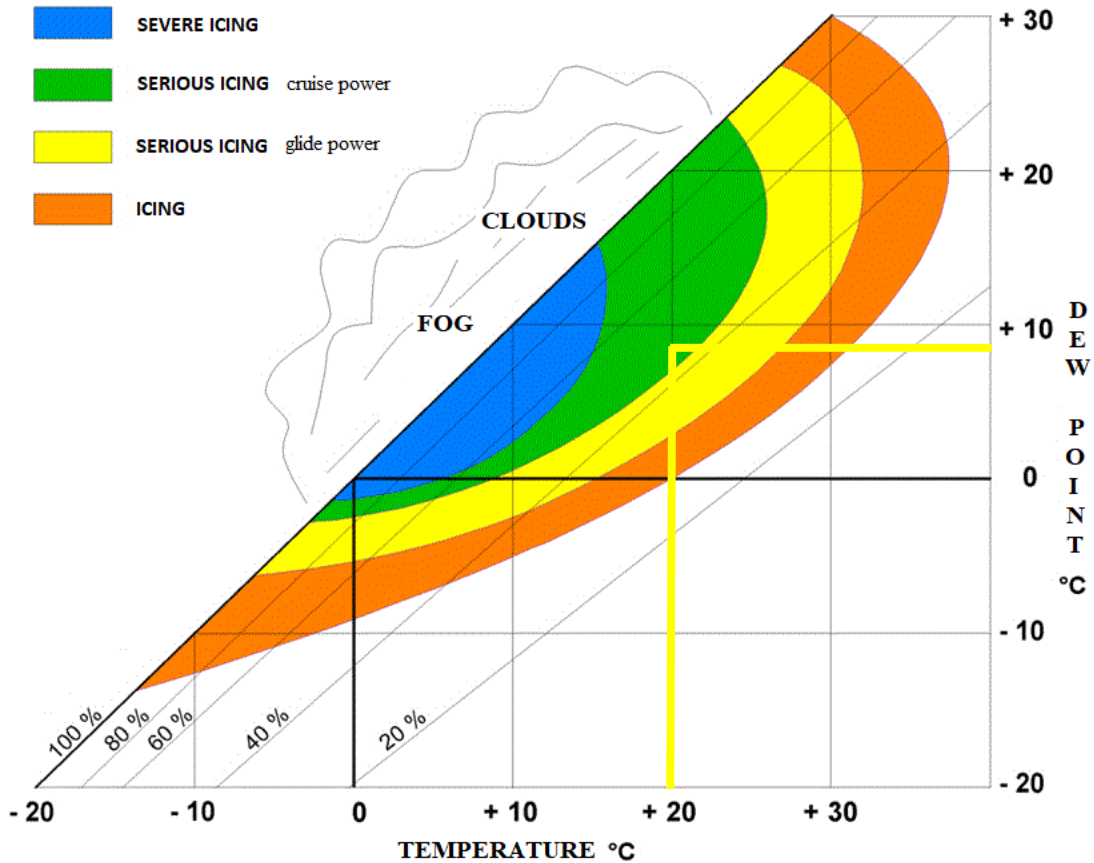
Figure 6. A chart showing the carburettor icing probability [source: the Internet] Internet]

The chart shows clearly that carburettor icing was likely during the occurrence at any stage of the flight.

It is likely that the meteorological conditions had caused carburettor icing, thus causing a decrease in the engine power and lower thrust generated by the propeller, leading to a longer take-off run.
