# FINAL REPORT

**Occurrence No.: 2374/16**

**Aircraft: Hummingbird 300 LS helicopter, SP-YLN**

**6 September 2016**

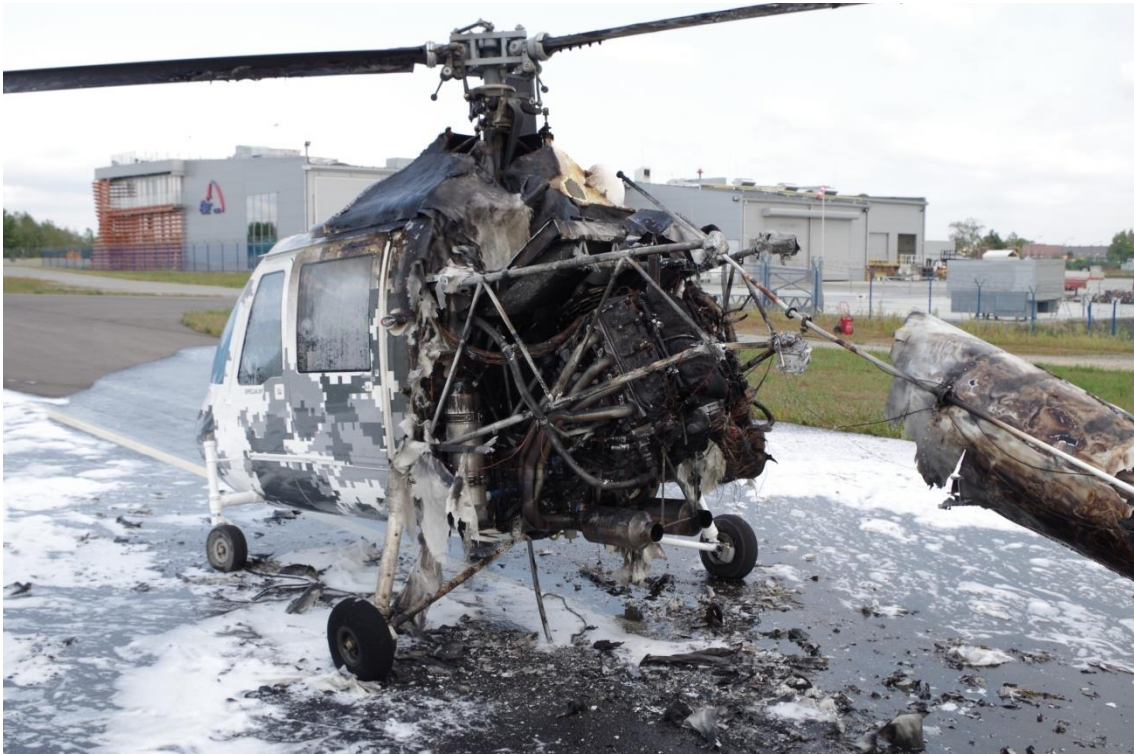
The fire zone included the rear part of the fuselage, engine compartment, main rotor gearbox, main rotor blades, tail beam and the left rear wheel of the landing gear. The fire caused melting of the fuselage skin, destruction and separation of the tail beam and partial evaporating or change into slag some elements of the engine. The fuel tank and the front part of the helicopter fuselage were outside the fire zone.

Figure 4. Helicopter after firefighting action of Airport Fire Brigade (photo: Operator)

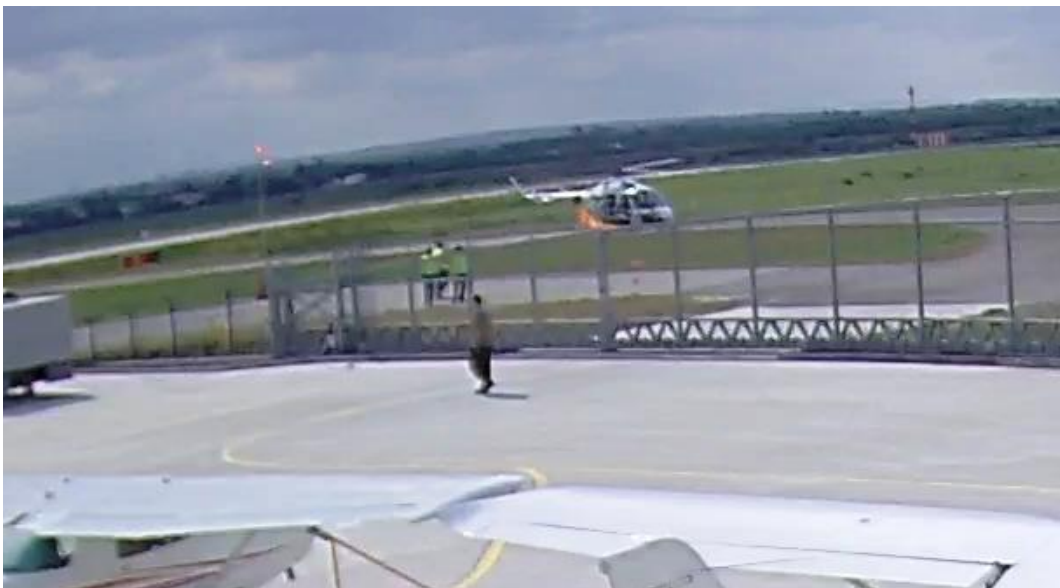
Figure 5. Beginning of the helicopter fire (photo from Operator surveillance camera)

In the course of the engine cooling the engine compartment caught fire. In the initial phase of the fire portable extinguishers located in the area of tests were used. There was 215 liters of gas on board before take-off.

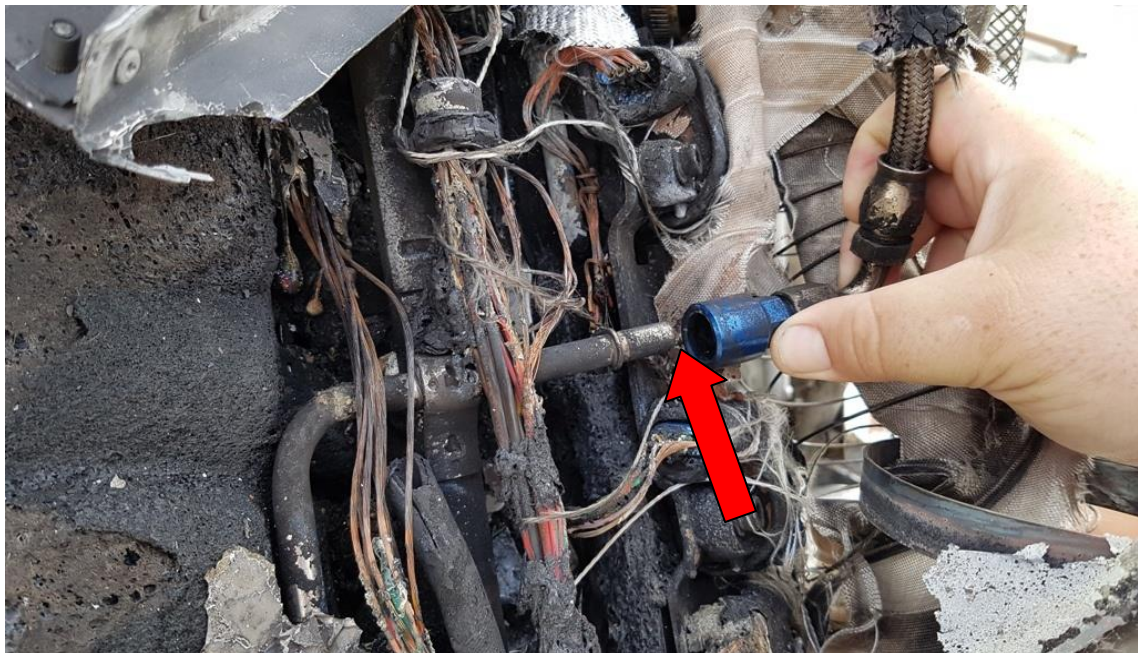
During a visual inspection special attention was paid to the technical condition of the quick connector P/N 640850 in the fuel line supplying fuel to the engine injection rail.

It was found that a plastic insert designed to prevent the connector from disconnection was missing. Following the finding, the Commission decided to conduct a thermal test of the quick connector on a test stand. New connectors P/N 640850 purchased from manufacturer were used for the thermal tests.

Figure 7. Disconnected fuel line supplying the injection rail is indicated by red arrow (photo: SCAAI)

7. During visual inspection of the helicopter wreckage, except for other damage, the disconnected quick connector of the fuel line near the injection rail and the lack of continuity of the oil line between the oil filter and the engine block were found.

**The most probable cause of the accident was unsealing of the quick connector in the fuel system which led to a fire.**

1. The Commission recommends that the Manufacturer considers measures aimed at replacing quick connectors in the fuel system of all Hummingbird 300LS helicopters with connectors resistant to disconnection.
2. The Commission recommends that the Manufacturer considers introducing fire alarm system in engine compartment of Hummingbird 300LS helicopter.

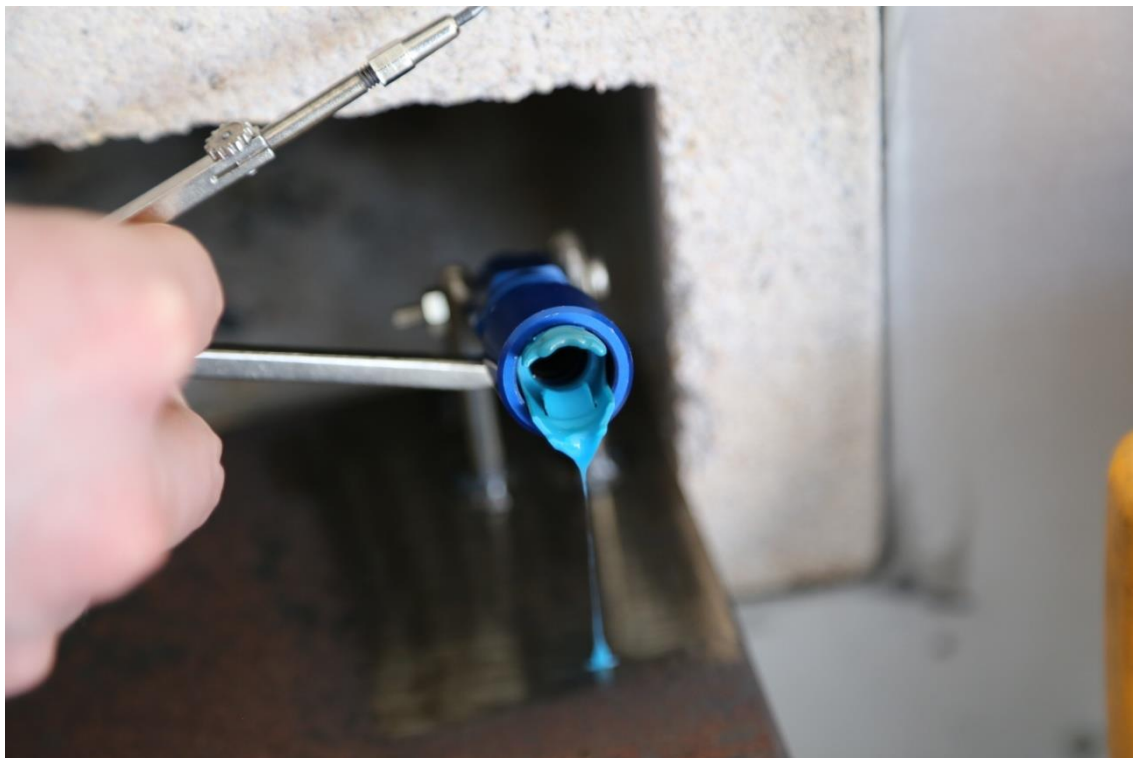
The first connector was gradually heated, starting from 31,6°C. **At the temperature of 212°C melting and flow of the plastic insert** preventing the connector from being disconnected was observed (Figure 11).

Figure 11. The plastic insert after the first test (photo: SCAAI)

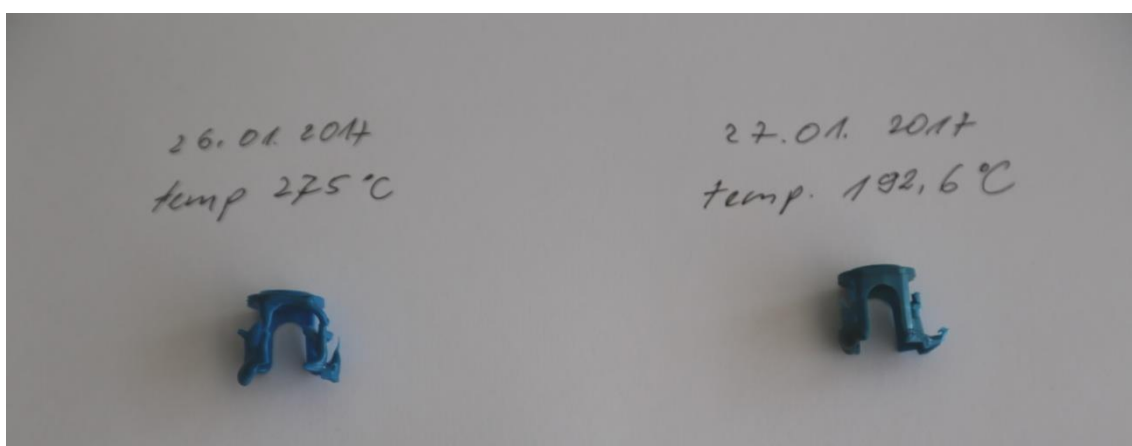
Then the second test was carried out on a new connector. It was placed at the temperature of 117,3°C and then it was subjected to further heating. **After reaching the temperature of 275°C, the tested quick connector disconnected.**

In the next test, the third connector was placed on the test stand and it was gradually heated starting from the temperature of 21°C. The connector was preheated to 120°C and then the temperature was increased by 20°C every 10 minutes. At the temperature of 167°C the beginning of softening of the plastic insert was observed. **At the temperature of 192,6°C, the tested quick connector was completely disconnected.**

Figure 12. The plastic inserts after the second and the third test (photo: SCAAI)

- partial melting (deformation) of the plastic insert designed to prevent the connector from disconnection;
- no signs of temperature impact on the metal elements of the connector (connection pipe and female part of the connector).

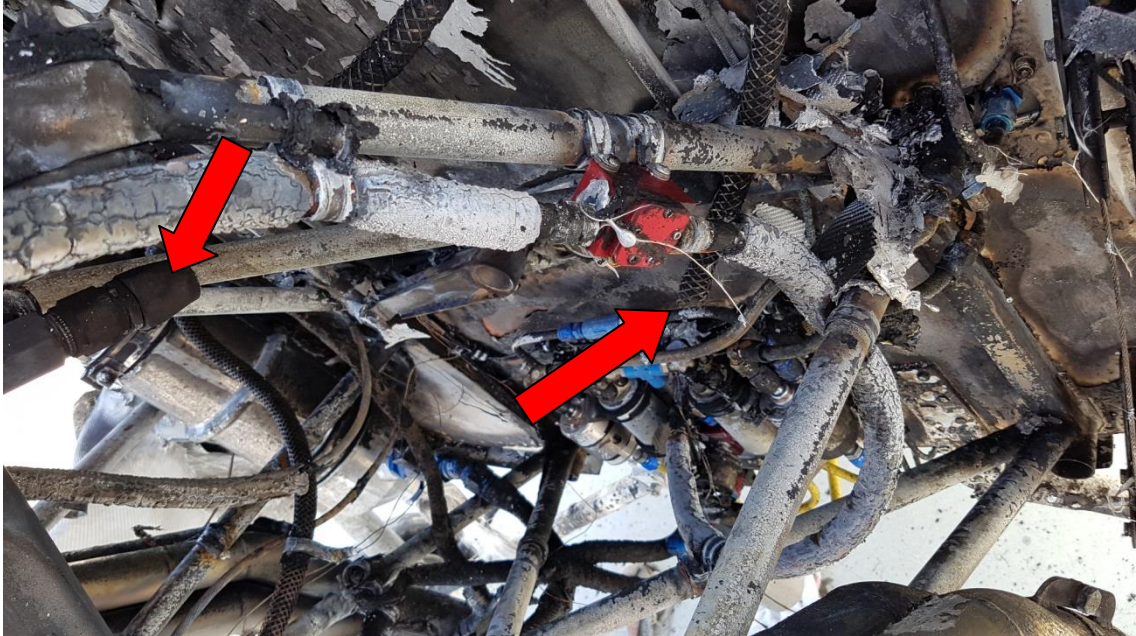
Figure 13. Damaged oil line separated from the engine block connection pipe (the pipe marked with the red arrow on the left). The end of the separated line indicated by the arrow on the right. The other end of the line (invisible on the photo) is connected to the oil filter (photo: SCAAI)

- effects of high temperature on all surfaces - traces of charring and melting. It was found that the connection of the oil line with the oil filter was continuous and the oil line was not connected with the engine block;
- no abnormalities were found in the tested elements of the oil filter, such as: filter cartridge, internal seals, springs and engine oil residues.

In view of the above, the Commission considered that the observed failure (discontinuity) of the oil line had a secondary nature and was caused by fire or the fire-fighting action.

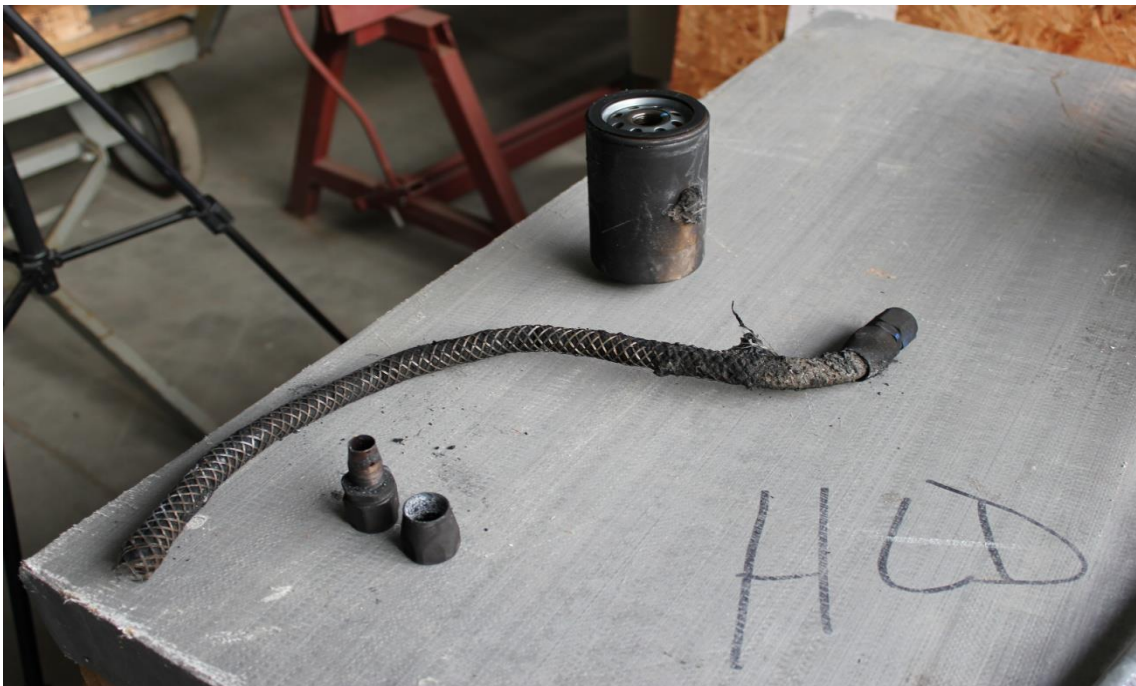
Figure 14. Damaged oil line, connection pipe removed from the engine block and oil filter (photo: SCAAI)

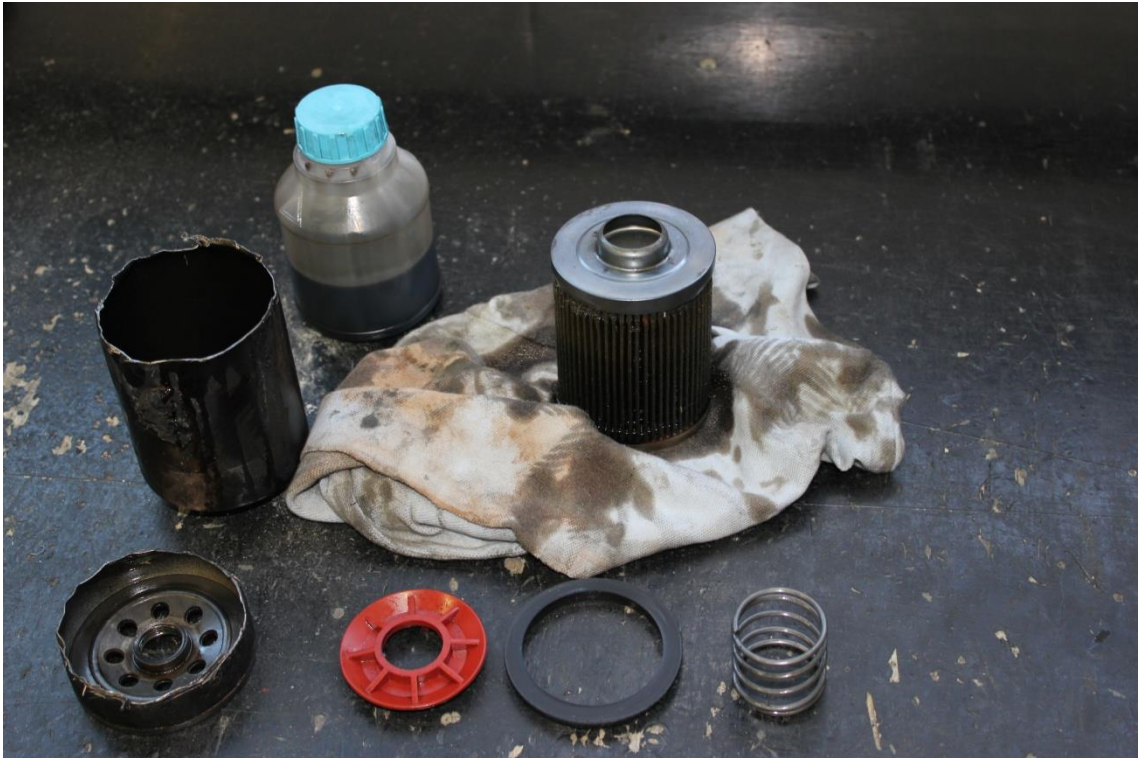
Figure 15. Disassembled oil filter – in the bottle oil from the filter (photo: SCAAI)

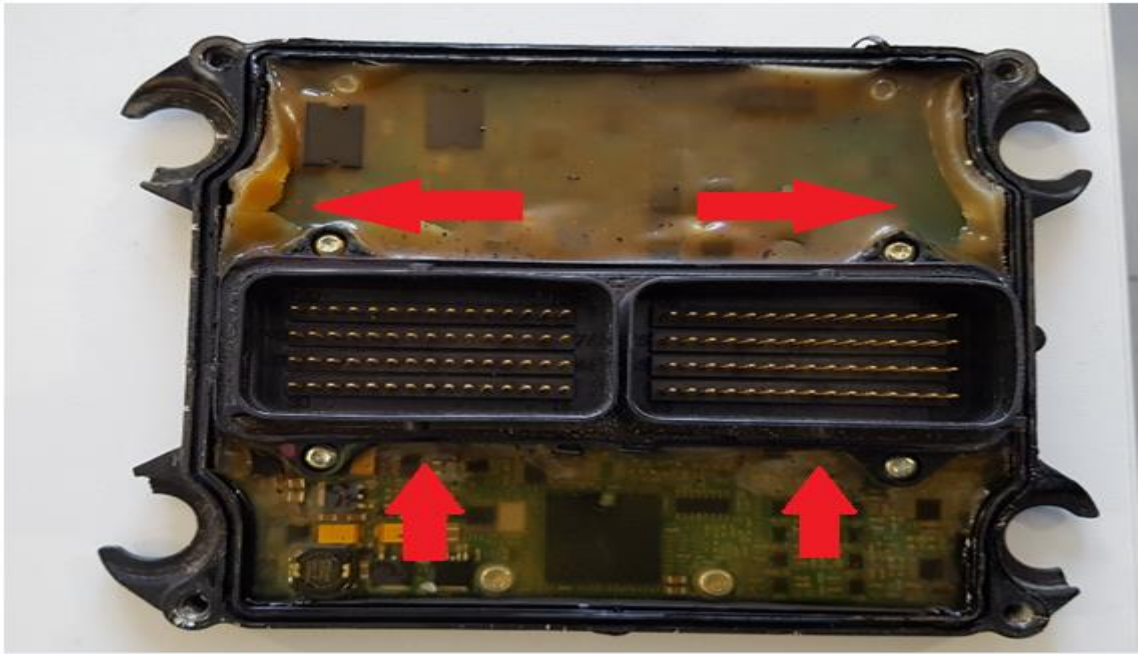
The Commission attempted to read out the ECM from the LS7 engine installed on the helicopter. Since no data from the ECM could be retrieved, its housing was removed and it was found that its electronic components were separated from the main board. Loose elements (due to melted solder connections) were protected.

Figure 17. Opened ECU of LS7 engine. The red arrows show the parts damaged by high temperature (photo: SCAAI)

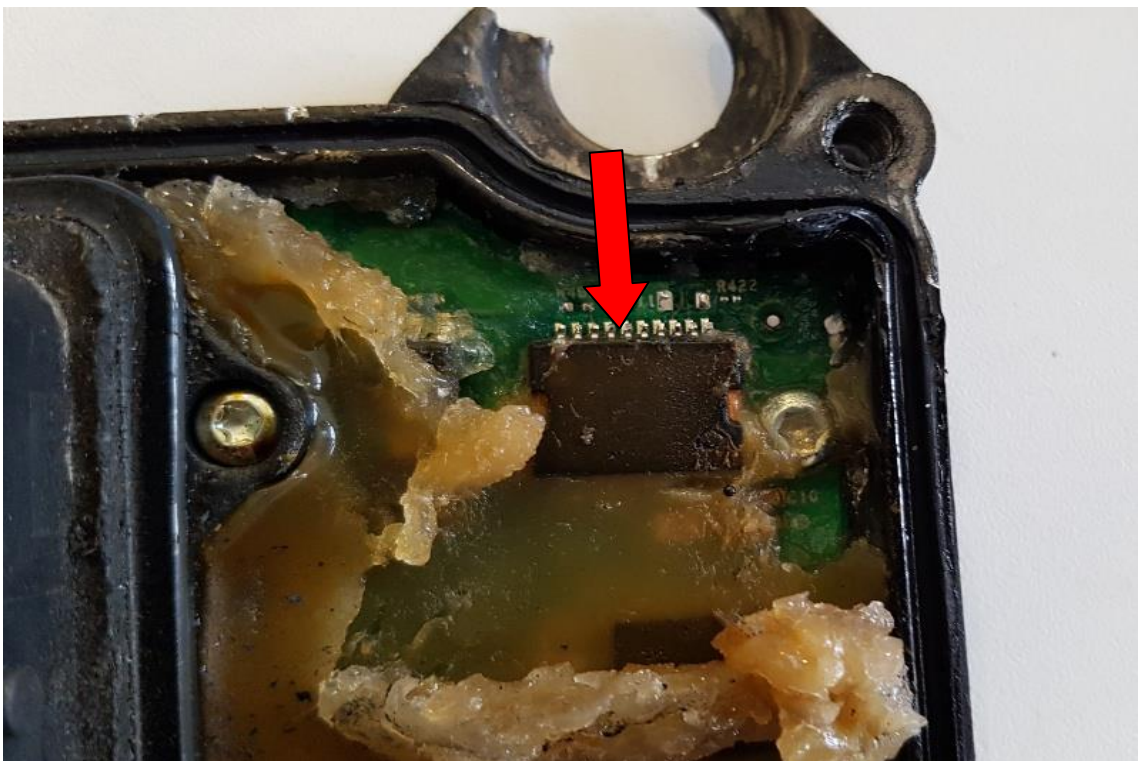
Figure 18. Part of ECM after removing protecting gel. The red arrow indicates place where electronic elements were soldered prior to the accident (photo: SCAAI)
