**REPUBLIC OF SERBIA
CENTER FOR INVESTIGATION
OF ACCIDENTS IN TRANSPORT**

FINAL REPORT ON ACCIDENT INVESTIGATION

Aircraft: Embraer E190-200LR
Registration: OY-GDC
Year of manufacture: 2008
Serial No.: MSN 190000204
Owner: Marathon Airlines S.A., Republic of Greece
User: Air Serbia
Accident location: “Nikola Tesla” Airport, Belgrade
Accident date: February 18th, 2024
Accident time: 17.39 (LT)
Flight phase: Take-off

August, 2025

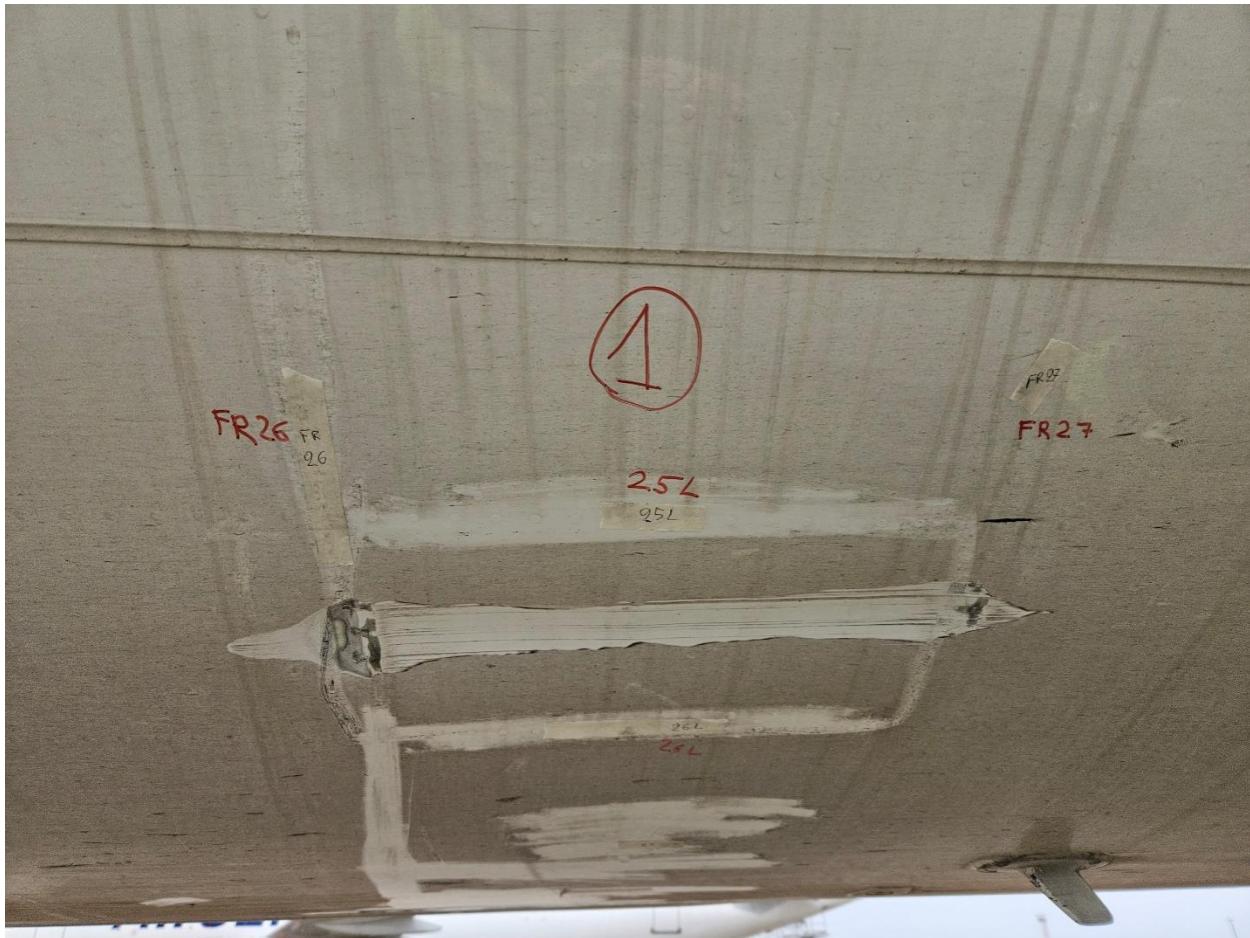
Figure 1. Zone 1 – Left side of the aircraft fuselage – initial contact between the fuselage and the airfield lighting in the area between fuselage frames 26 and 27 and along stringer 25L

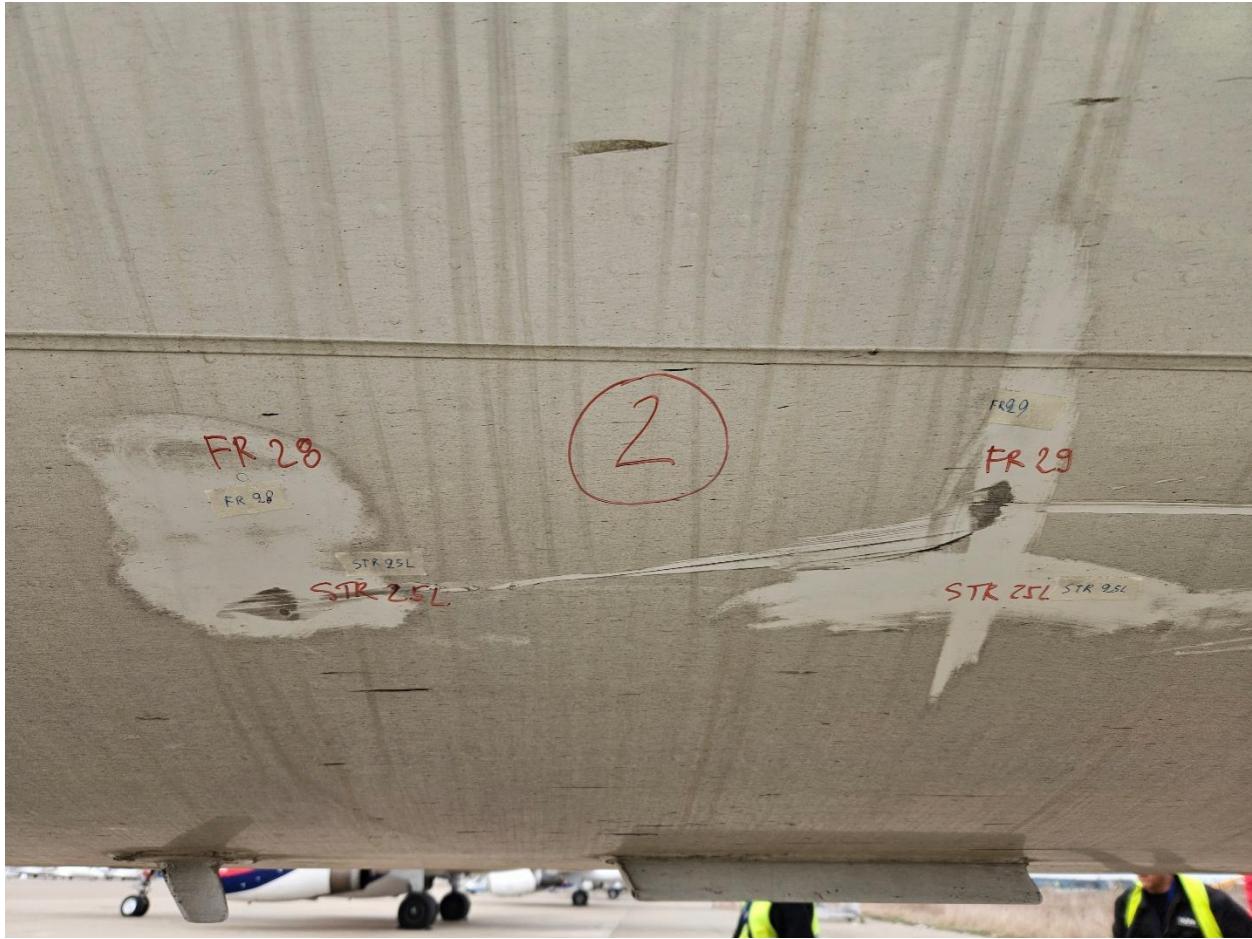
Figure 2. Zone 2 – Left side of the aircraft fuselage – second contact between the fuselage and the airfield lighting in the area between fuselage frames 28 and 29 and along stringer 25L

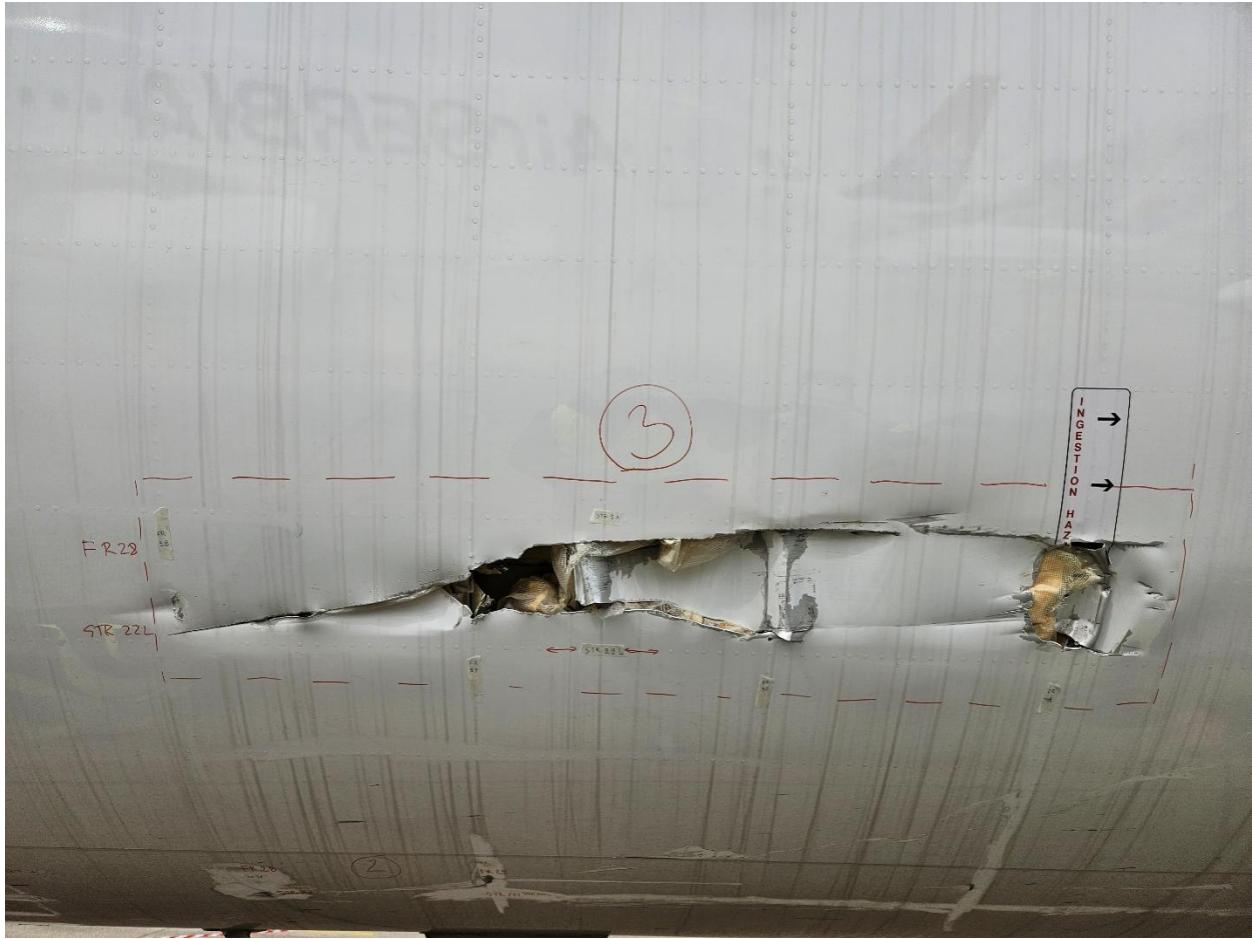
Figure 3. Zone 3 – Left side of the aircraft fuselage – continued contact between the fuselage and airfield equipment in the area between fuselage frames 28 and 31 and along stringer 22L

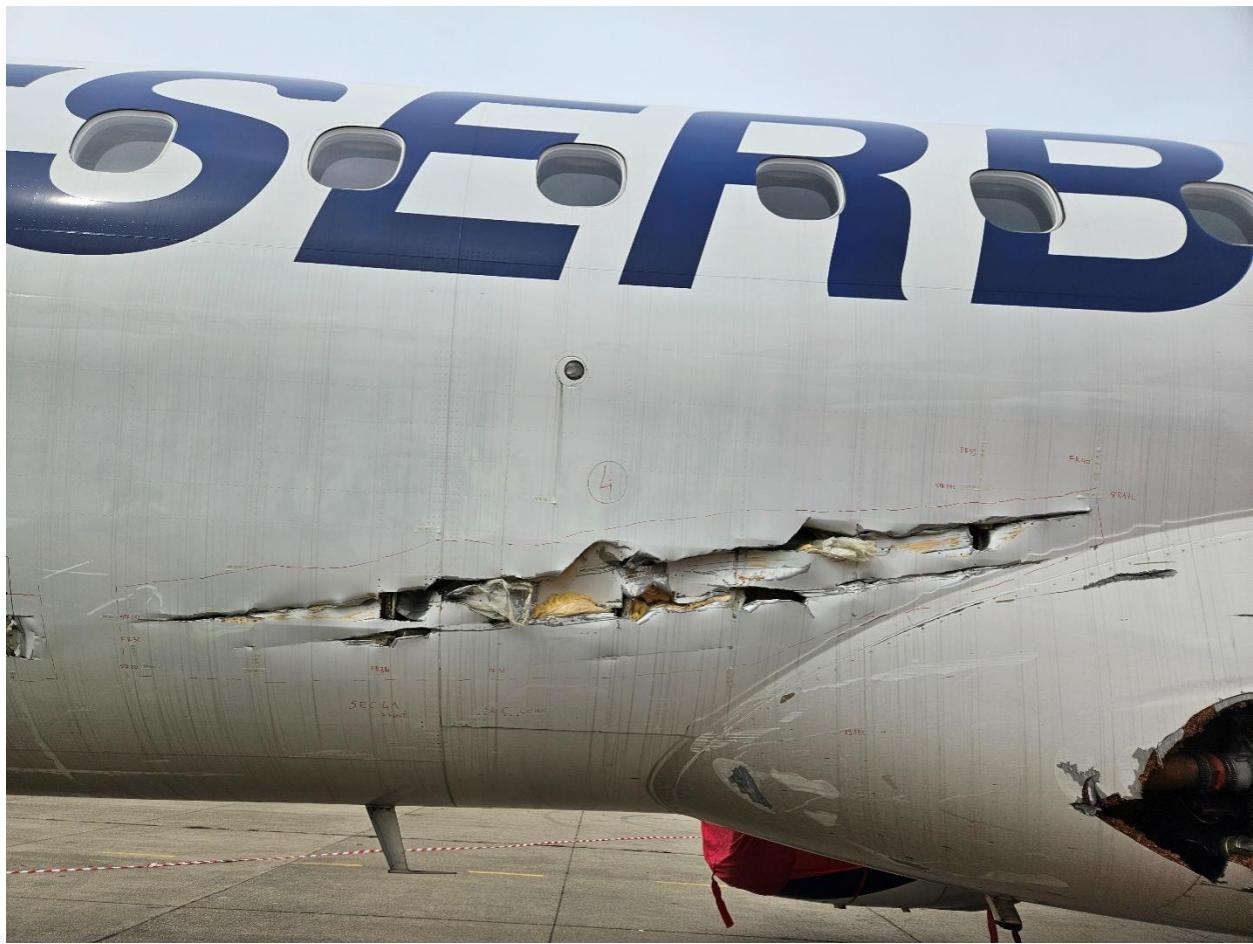
Figure 4. Zone 4 – Left side of the aircraft fuselage – continued contact between the fuselage and airfield equipment in the area between fuselage frames 32 and 40 and between stringers 17L and 22L

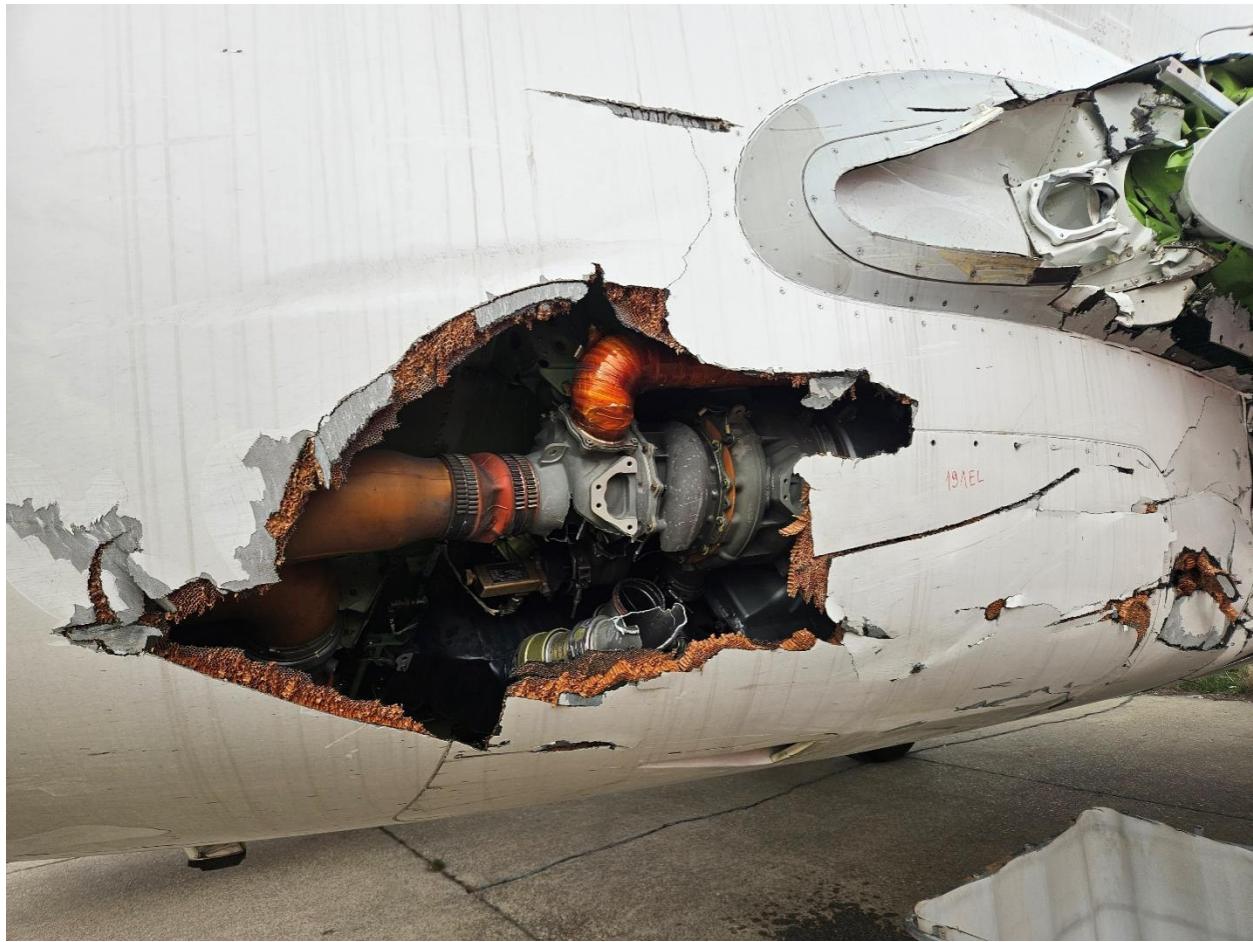
Figure 5. Damage to the composite panel in the lower wing-to-fuselage fairing area

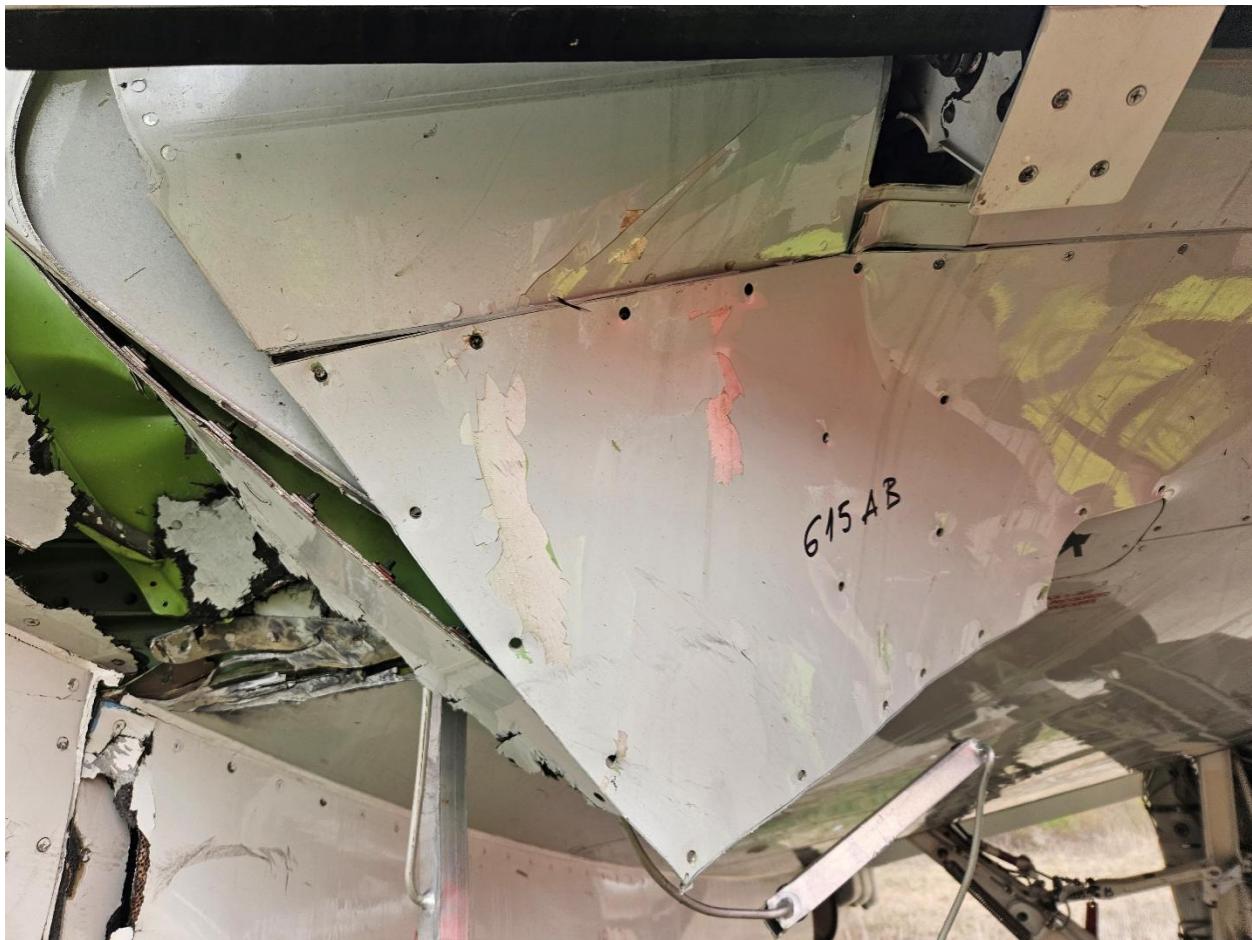
Figure 6. Damage to the lower skin of the left wing

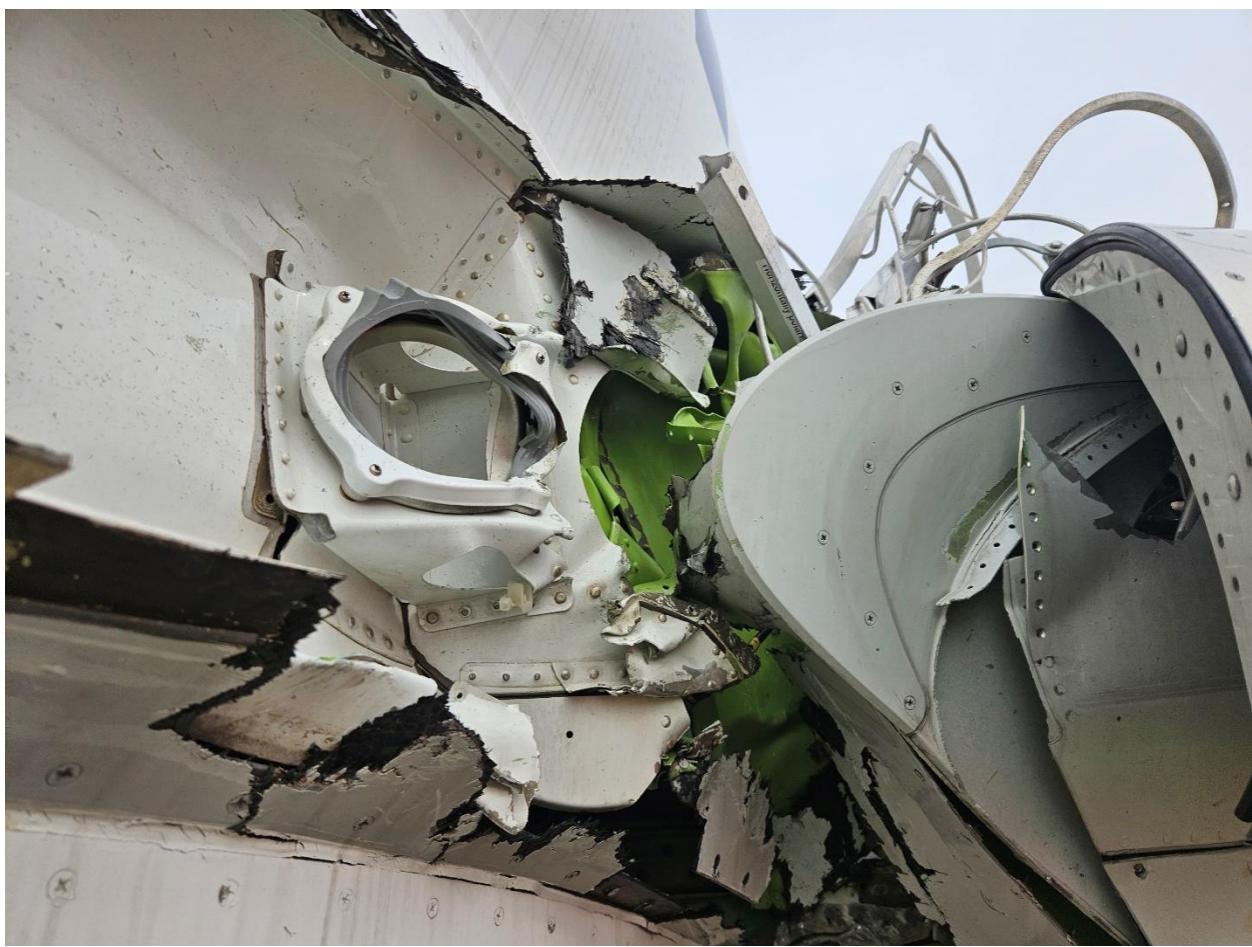
Figure 7. Impact area of the airport antenna mast at the root of the left wing

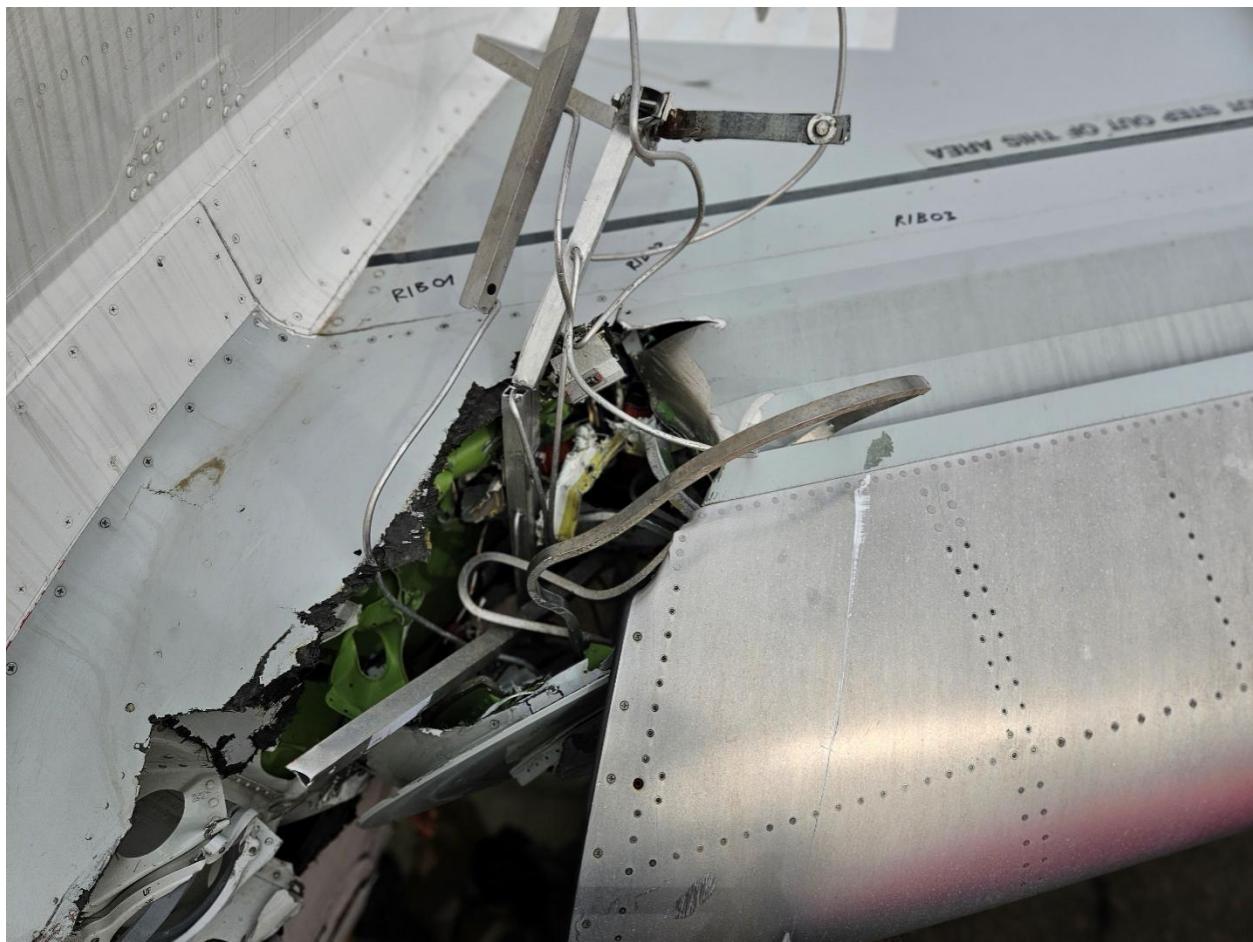
Figure 8. Parts of the airport antenna lodged in the wing root between ribs 1 and 3 of the left wing

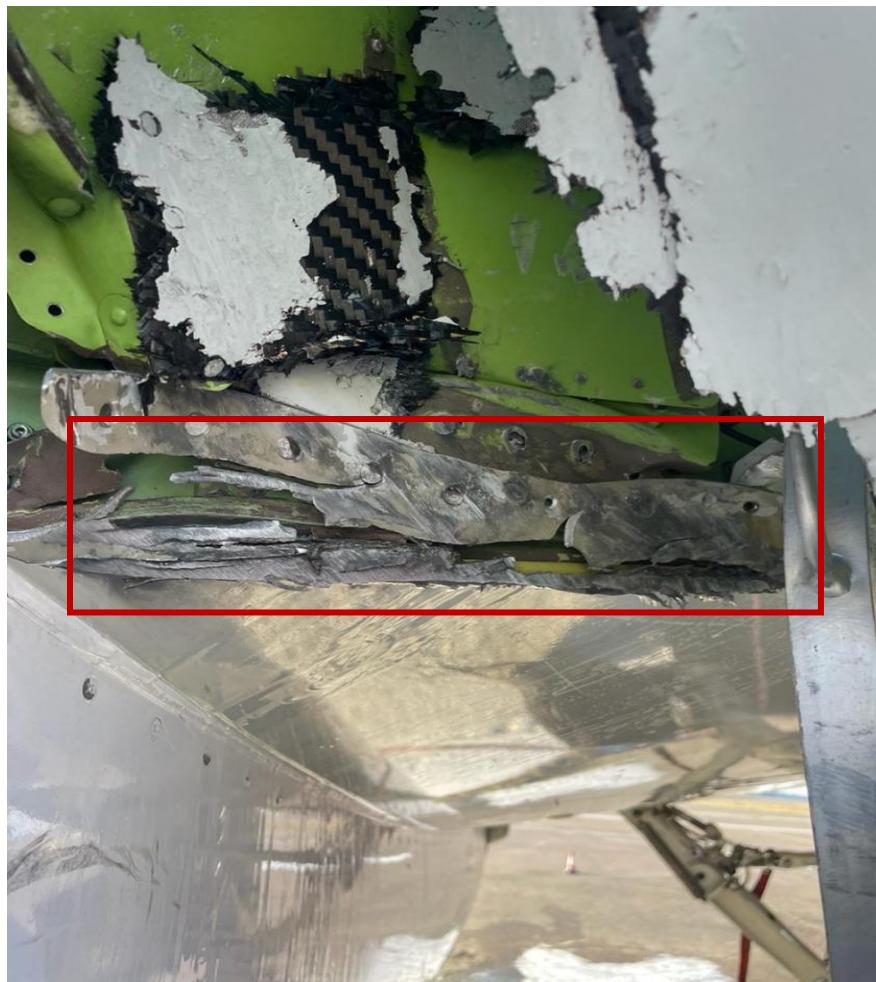
Figure 9. Damage to the connection between the lower wing skin and the front spar of the left wing between ribs 1 and 2. The marked area indicates the damage through which fuel leakage from the left-wing tank occurred.

- The full extent of the aircraft damage became evident to airport services only after the aircraft was parked at stand C2, where a significant fuel leak was noticed at the junction between the front spar and the lower wing skin. At that moment, passengers were already in the process of disembarking.

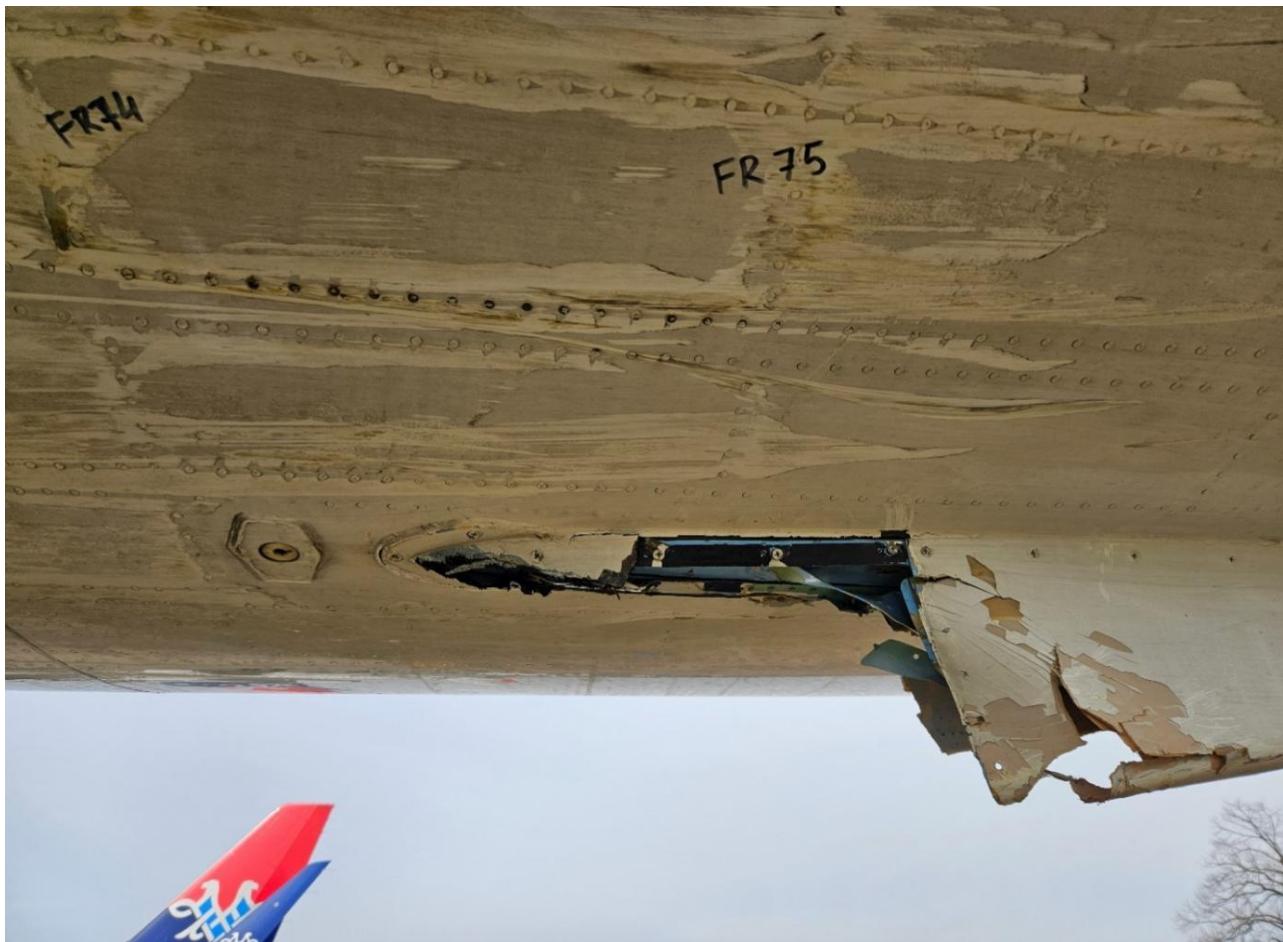
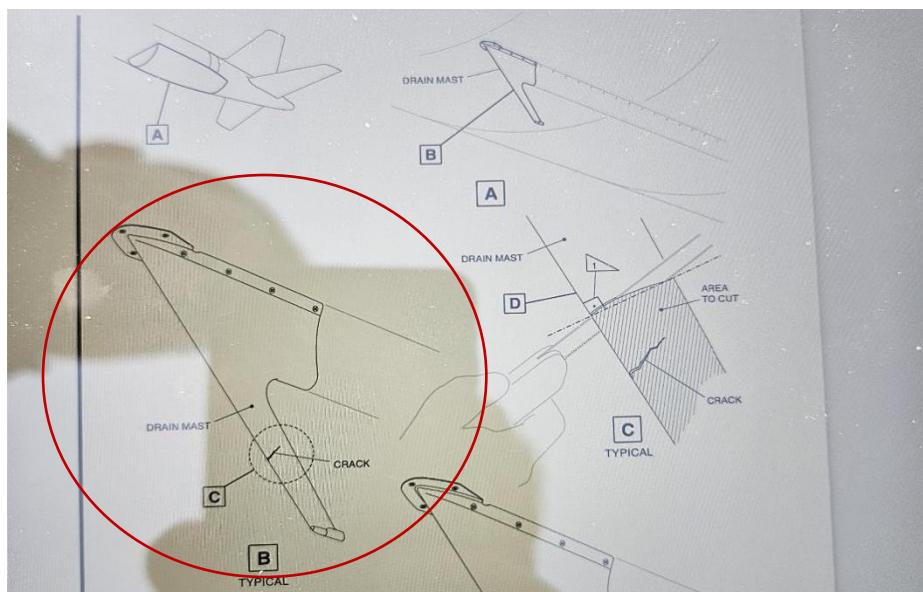
Figure 10. Damage to the lower fuselage skin in the area from fuselage frame 74 to frame 75 and a broken drain mast

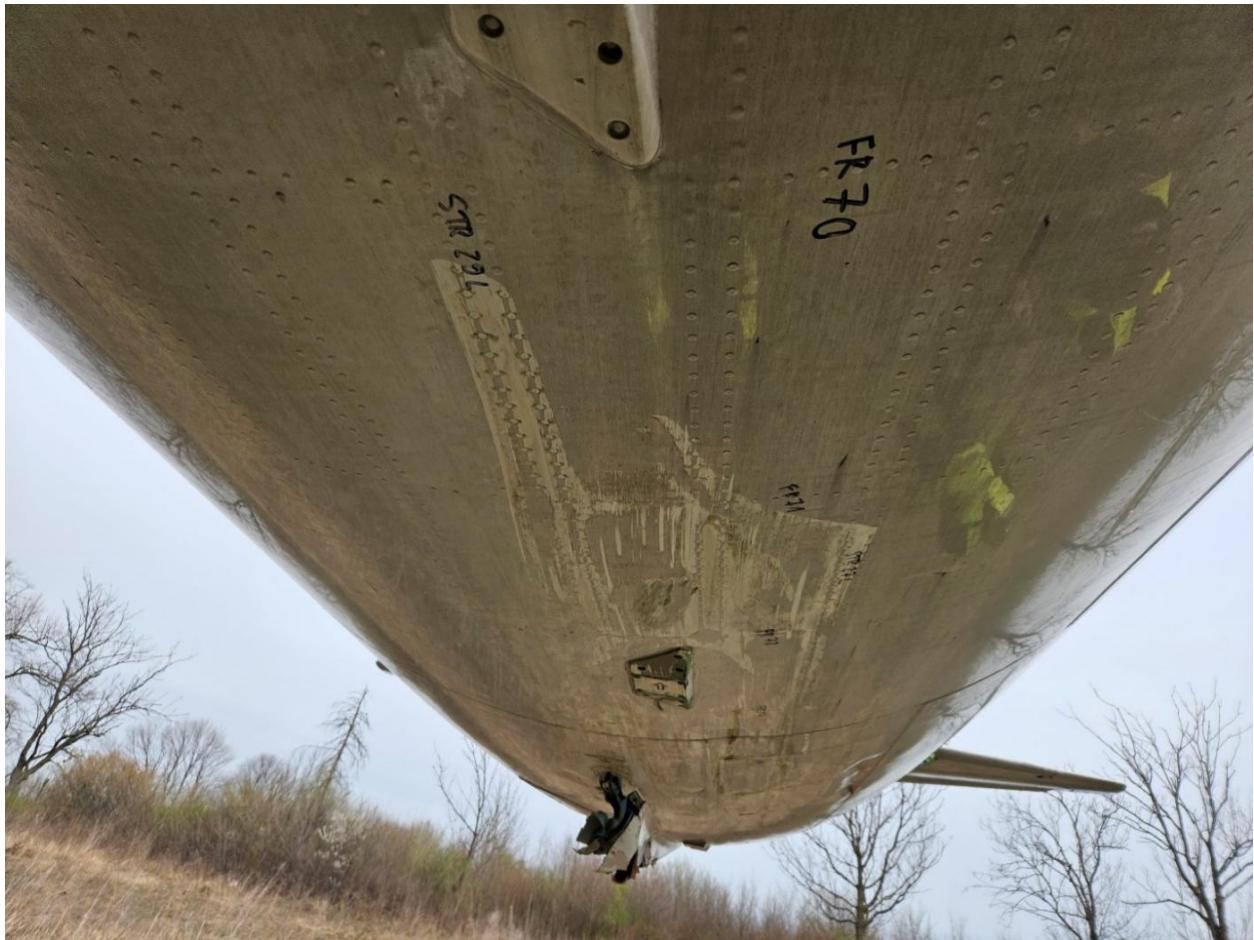
Figure 11. Damage to the lower fuselage skin in the area from fuselage frame 75 to frame 76 between stringers 27L and 29R

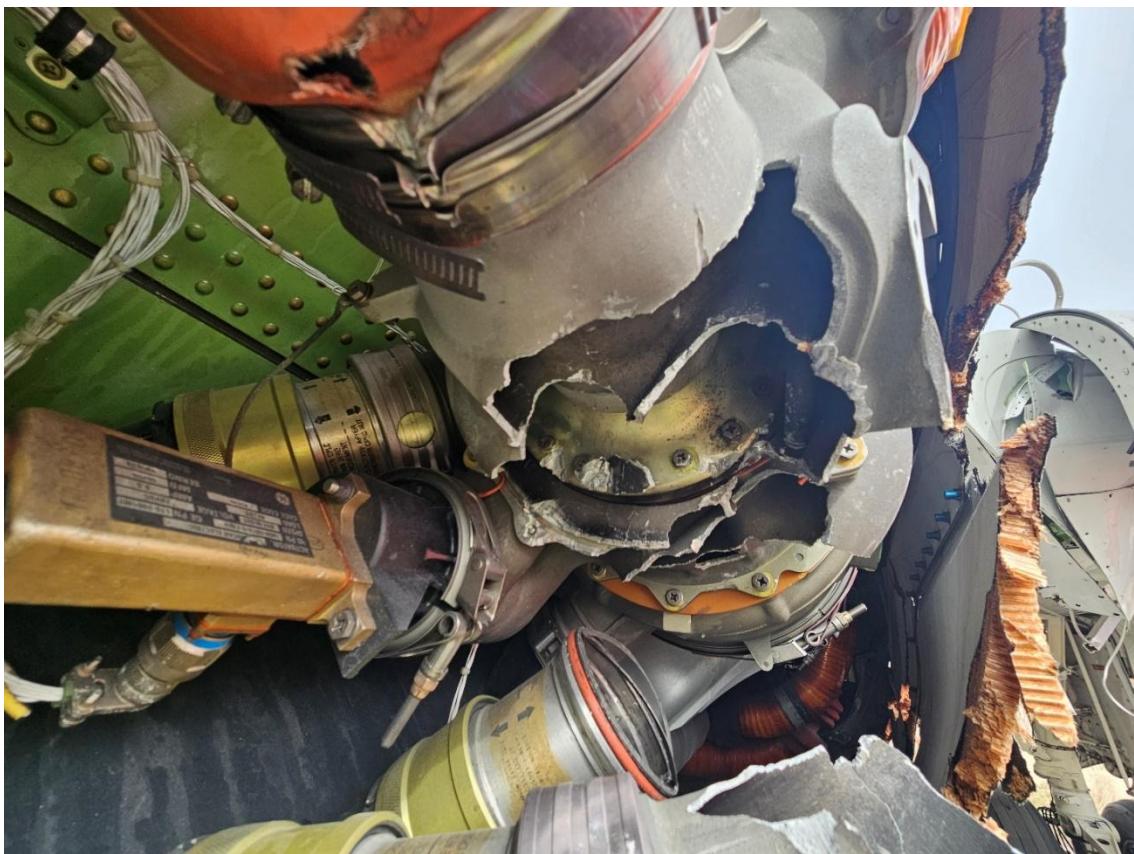
Figure 12. Damage to the left air conditioning system

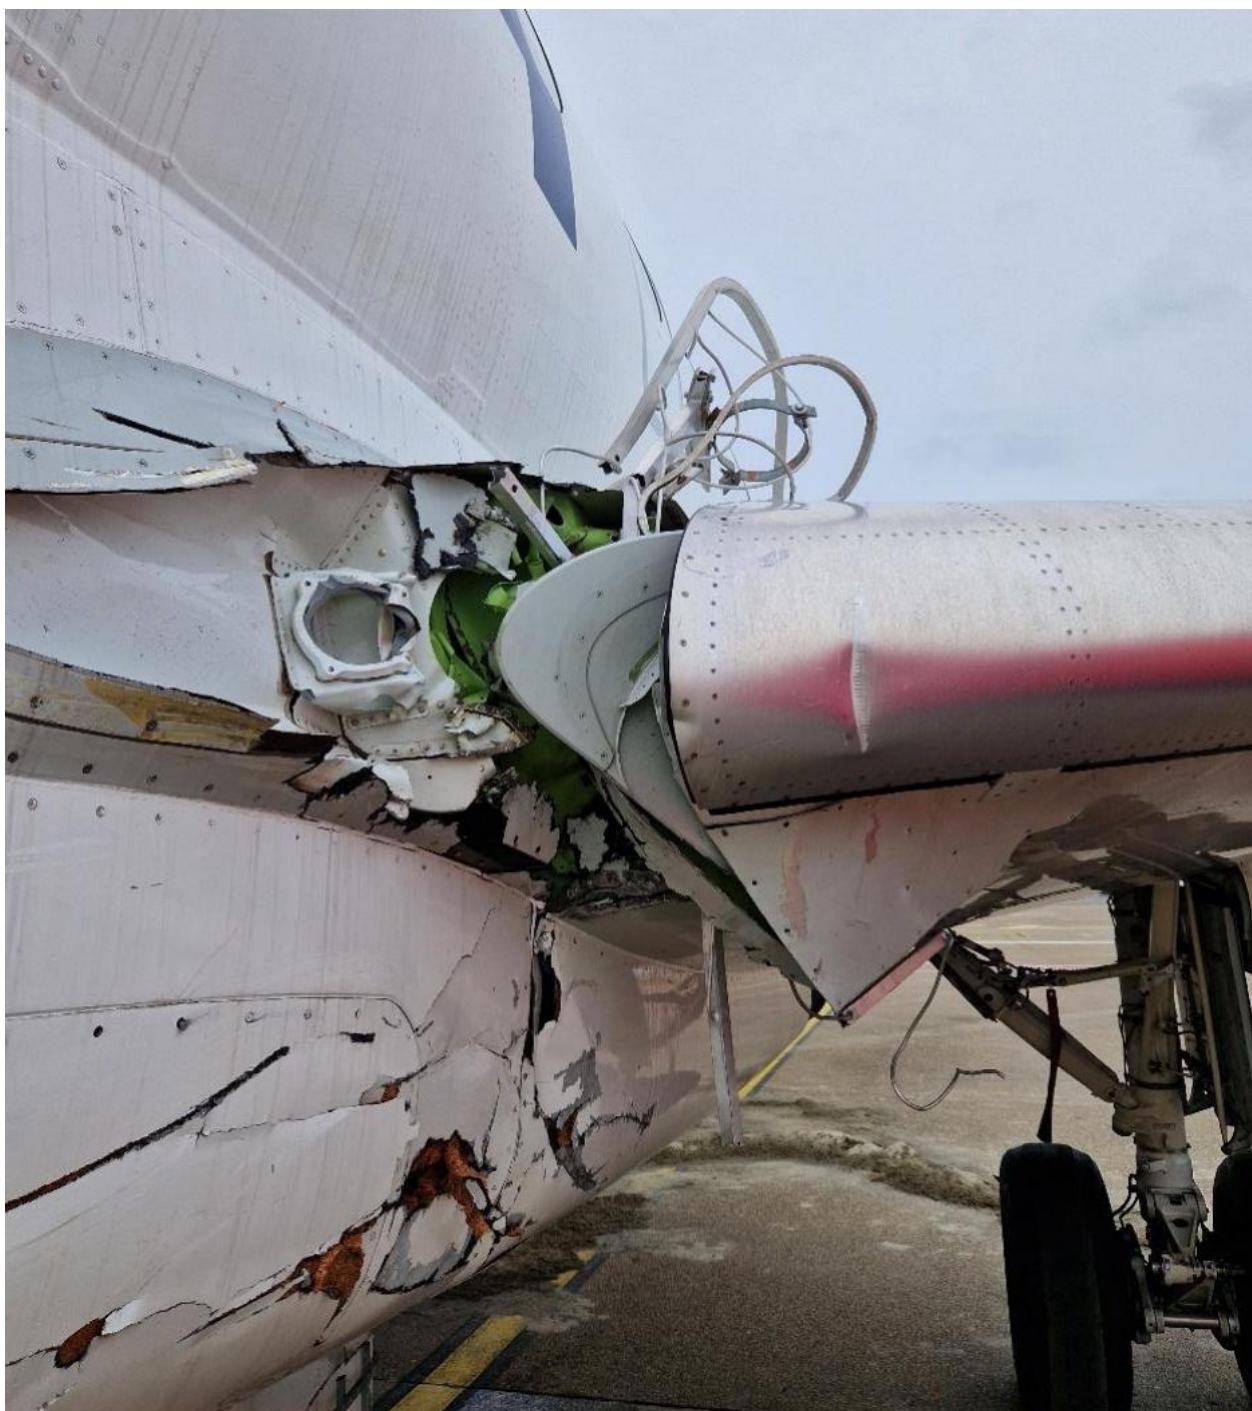
Figure 13. Damage to the leading edge of the left wing as well as the wing-to-fuselage joint on the left side

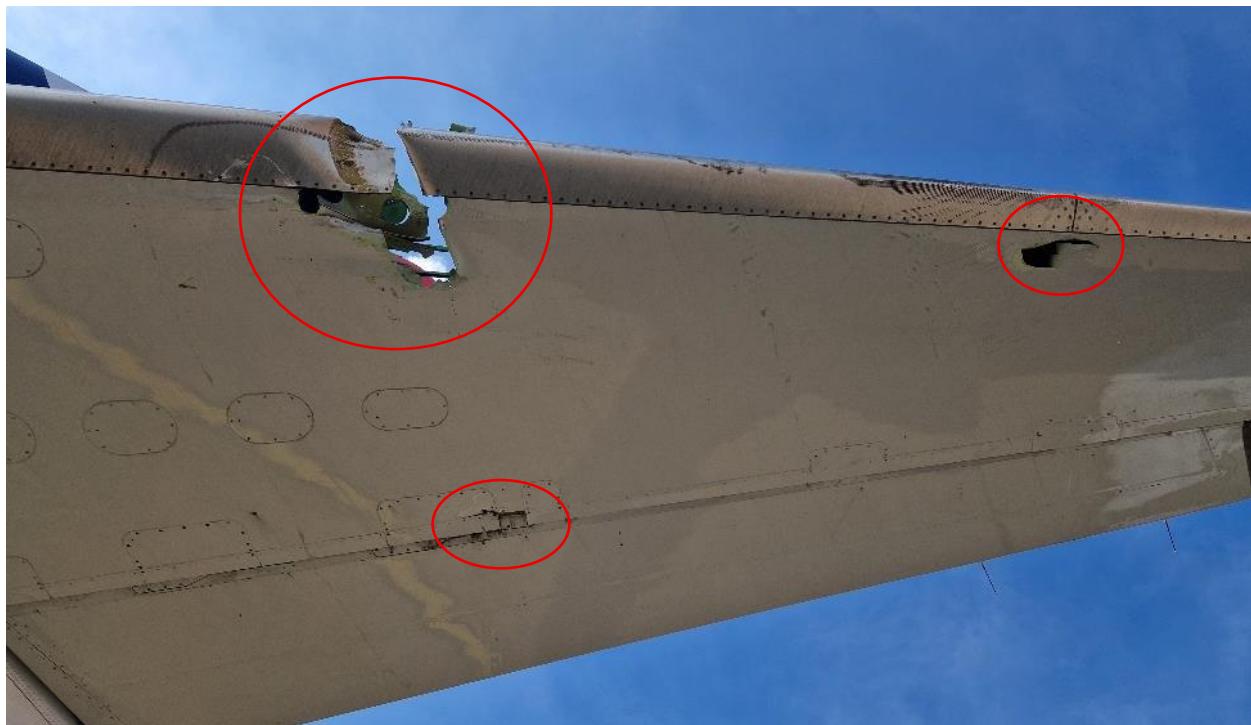
Figure 14. Damage to the leading edge between ribs 8 and 9 and to the lower skin of the left horizontal stabilizer

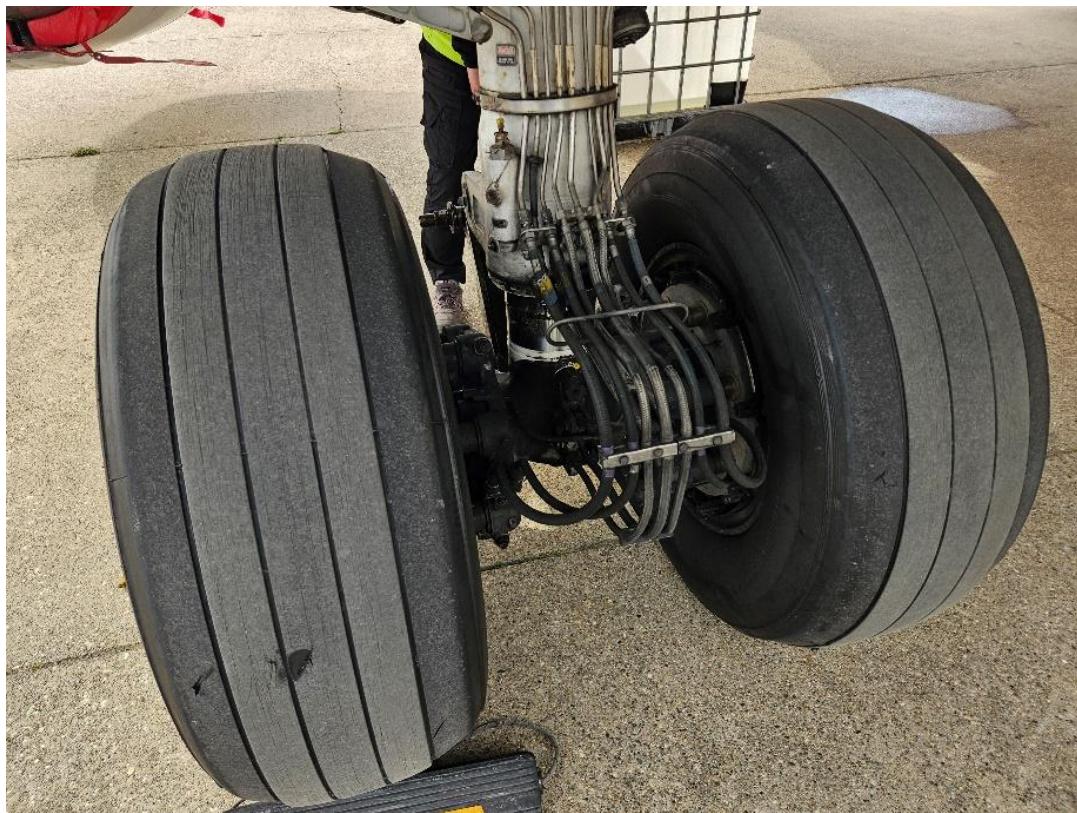
Figure 15. Left main landing gear wheels showing damage marks

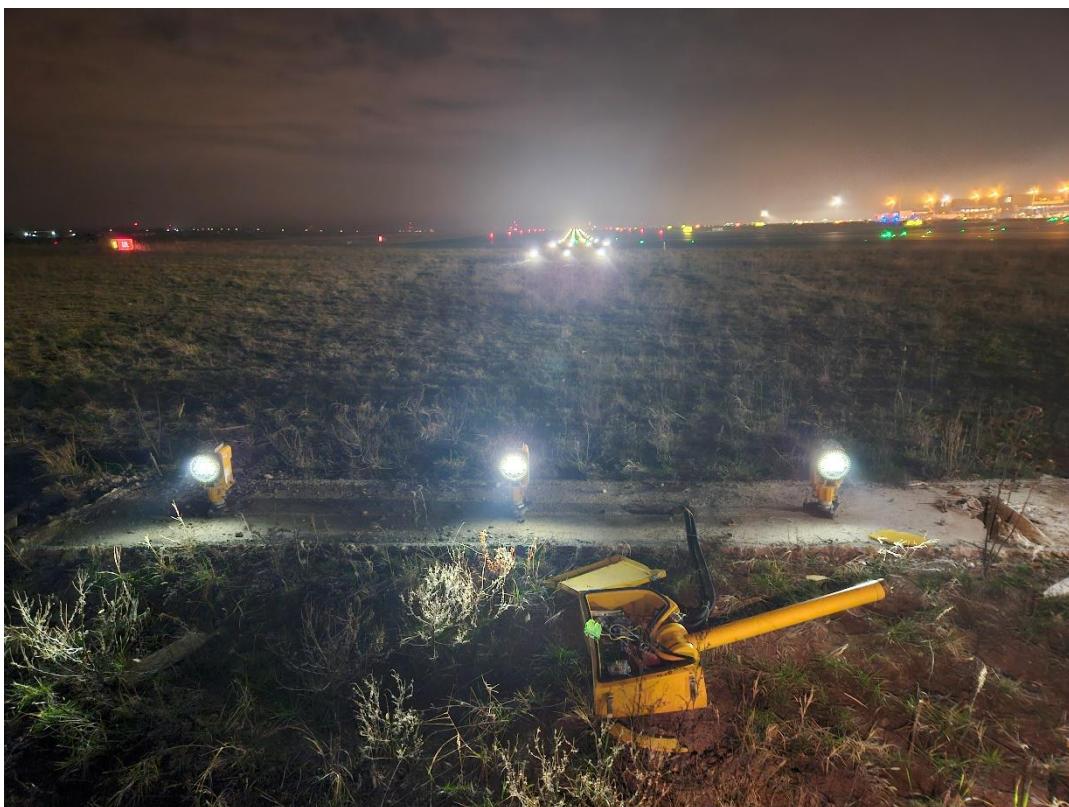
Flashing lights situated in the grassy area outside the runway strip were broken, as well as individual approach threshold lights (see Figure 16). The antenna of the Far Field Monitor for RWY 12R was also broken. The mast of the Far Field Monitor antenna was found outside the perimeter fence, at a distance of 107.9 meters from its original location.

Figure 16. Damage to the lighting system – second row of lights from the end of the runway

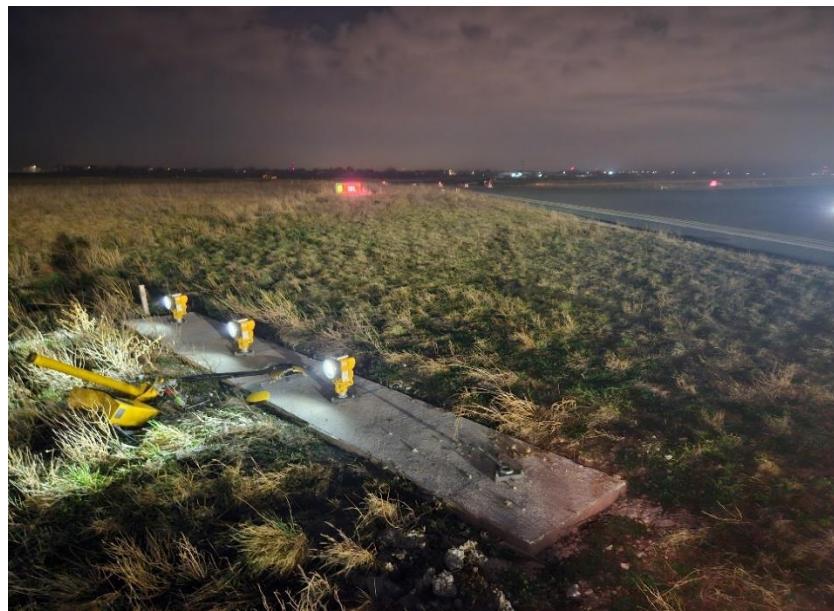
Figure 17. Damage to the lighting system - first row of lights approximately 150 meters from the runway threshold

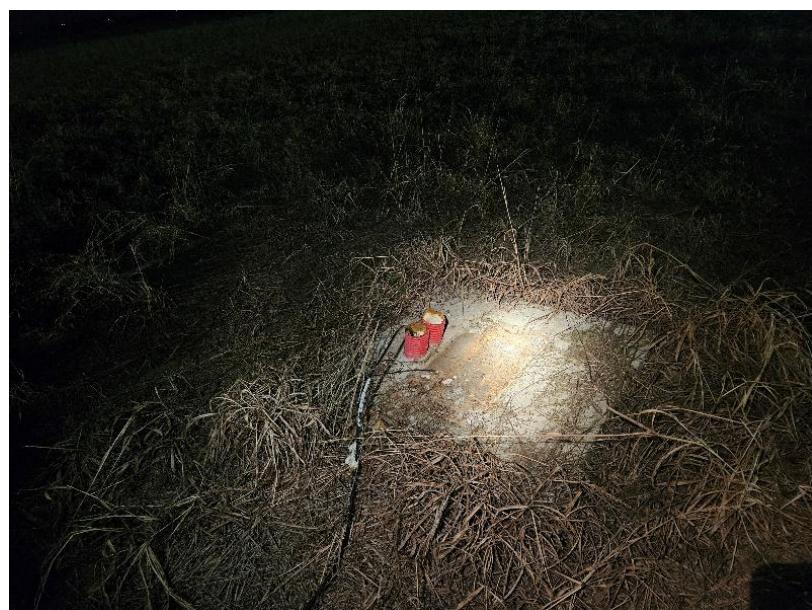
The support structure of the monitoring antenna, with its concrete foundation and severed cables remaining at the original site (Figure 18), was found at a distance of approximately 60 meters outside the airport's safety-restricted zone, on arable land. The total length of the support is 5 meters. It was located about 175 meters from the end of the asphalt surface in line with the runway extension. The support exhibited bending approximately 90 centimeters from its tip, along with traces of aircraft paint.

Figure 18. Foundation of the "Far Field Monitor" antenna support structure, located approximately 260 meters from the end of the runway threshold

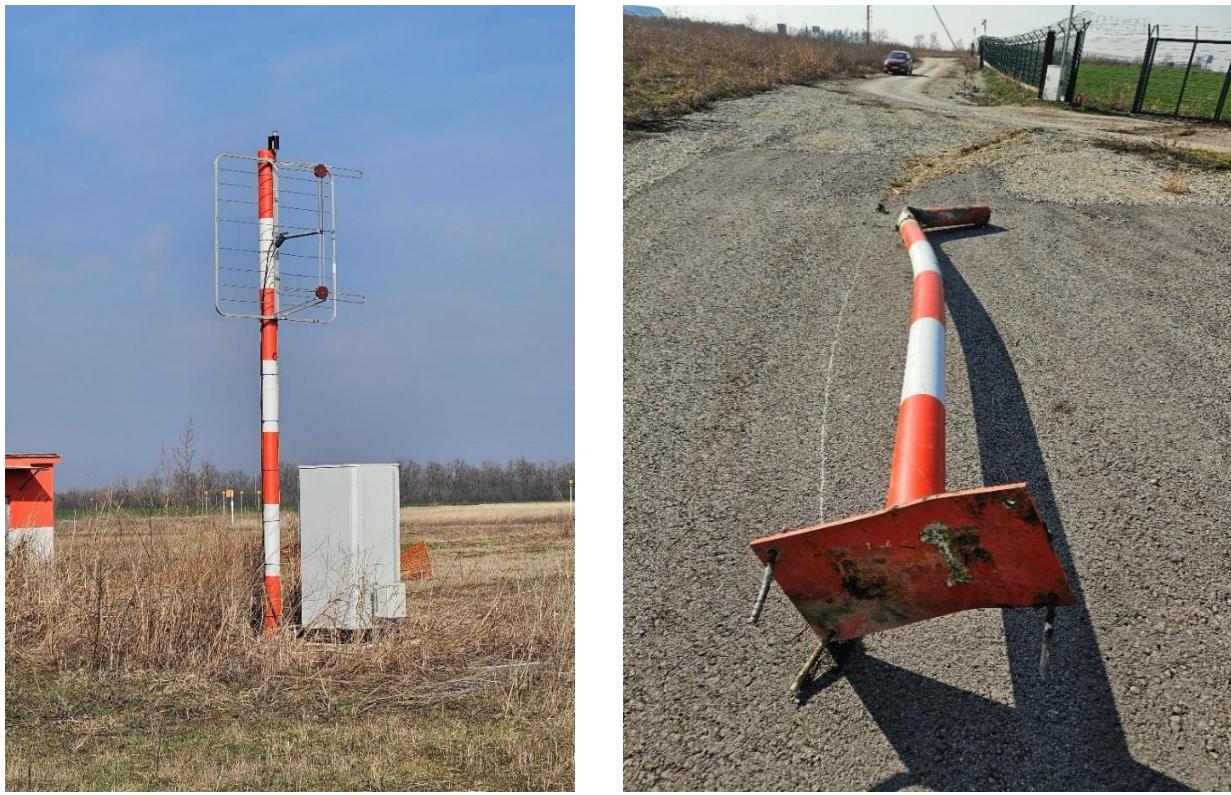
Figure 19. View of the pole with the antenna / the pole on which the “Far Field Monitor” antenna for RWY 12R was mounted, before and after the accident

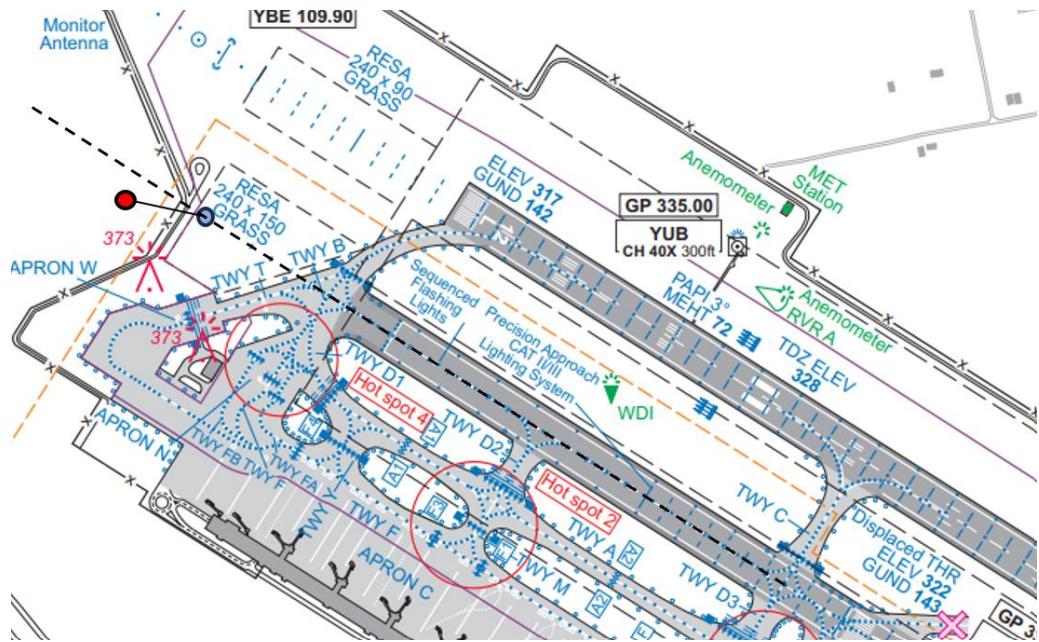
Figure 20. Location of the pole before and after the impact

The location of the pole before the impact is marked with a blue circle, and the location after the impact is marked with a red circle.

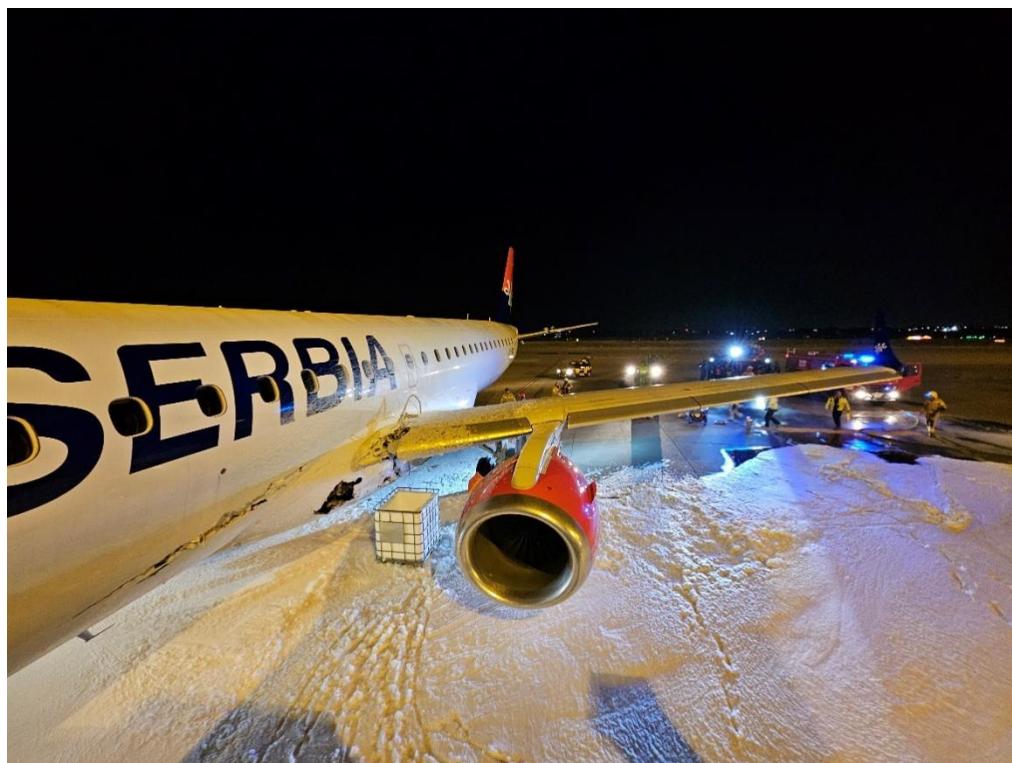
Figure 21. Condition of the aircraft at parking stand “C2”
