**REPUBLIC OF SERBIA
CENTER FOR INVESTIGATION
OF ACCIDENTS IN TRANSPORT**

FINAL REPORT ON ACCIDENT INVESTIGATION

Aircraft: Embraer E190-200LR
Registration: OY-GDC
Year of manufacture: 2008
Serial No.: MSN 190000204
Owner: Marathon Airlines S.A., Republic of Greece
User: Air Serbia
Accident location: “Nikola Tesla” Airport, Belgrade
Accident date: February 18th, 2024
Accident time: 17.39 (LT)
Flight phase: Take-off

August, 2025

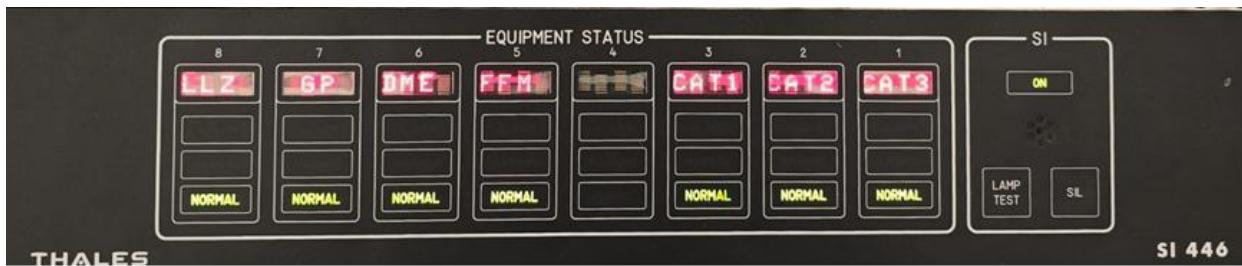
During the event on 2024, February 18th, the impact that caused the FFM antenna to collapse rendered the FFM inoperative, triggering fault indications for FFM 12R at all aforementioned workstations. As a result, the ILS 12R operational category was downgraded from ICAO CAT III to ICAO CAT I.

Display of the ILS 12R status indication as seen on air traffic controller workstations.

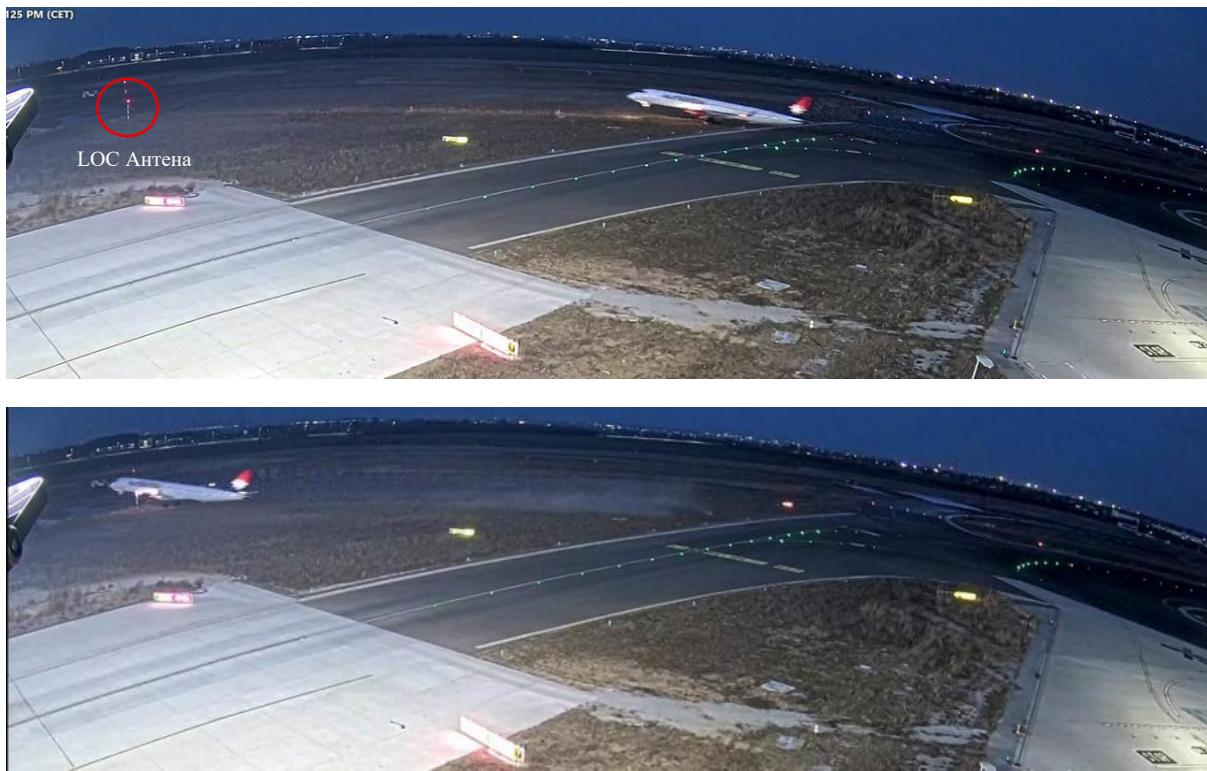
Figure 26. Moment of impact with the “Far Field Monitor” antenna

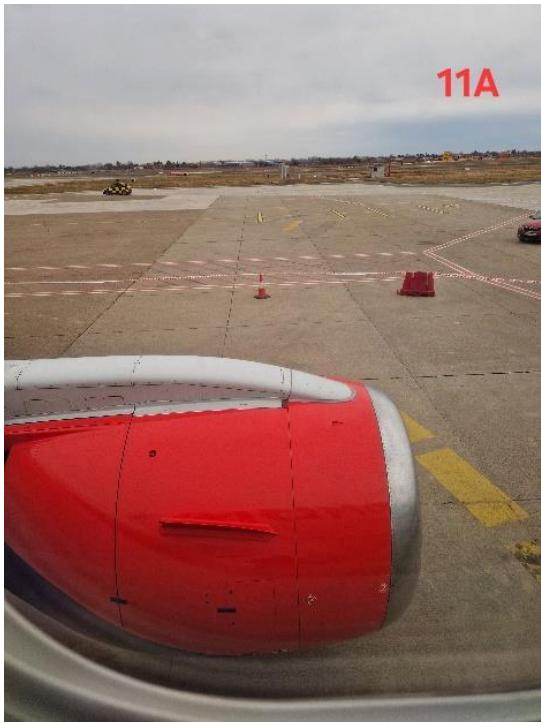
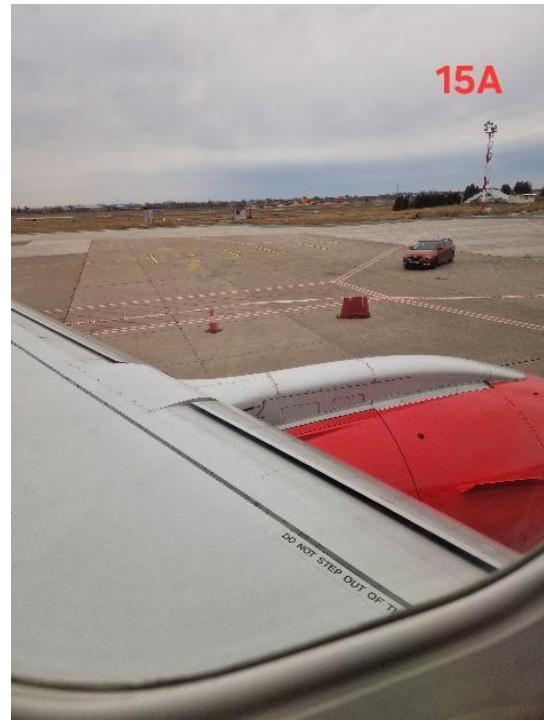
The flight crew was unable to detect the damage during taxiing after landing, as confirmed during the investigation by simulating the crew's line of sight from the aircraft toward the damaged area (Figures 30 and 31).

Figure 30. Line of sight from passenger seats 11A and 15A clearly shows that the cabin crew would not have been able to detect the extent of the damage.

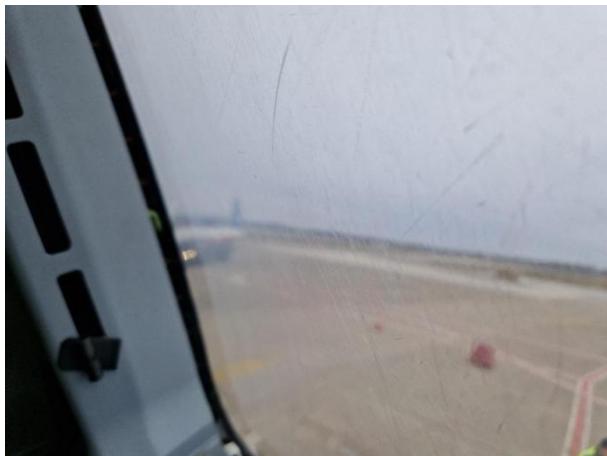
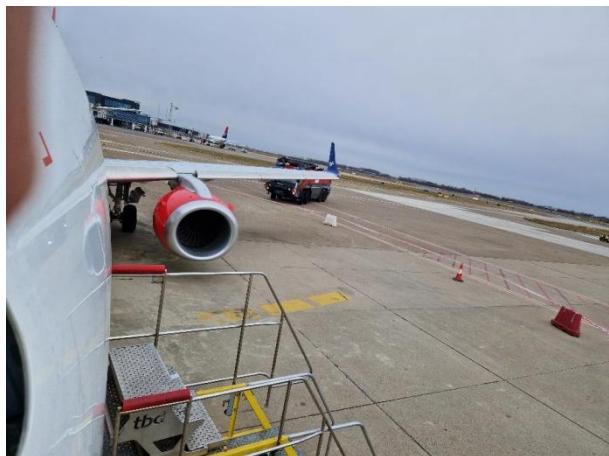
Figure 31. Captain's line of sight toward the damaged area through the closed window and through the open window.
