State Commission on Aircraft Accidents
Investigation

PRELIMINARY REPORT

SCF-PP: System Component Failure - Power Plant

Reims Aviation Cessna, Cessna F150F, D-EKIQ, Warsaw (Wawer district), 1 March 2024

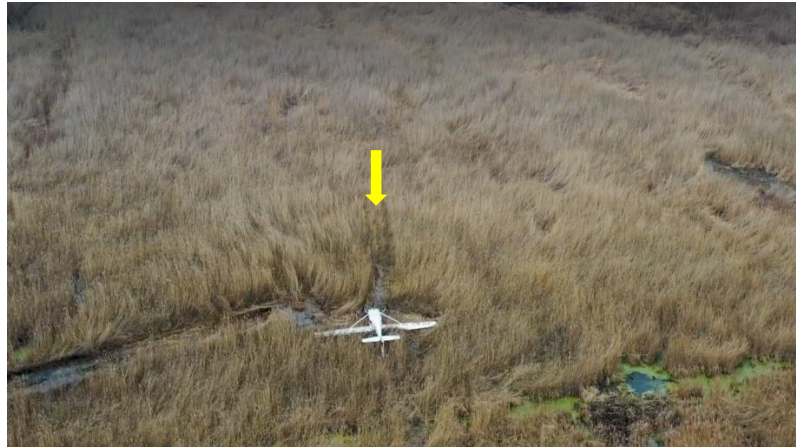
Fig. 2. The position of the aeroplane after overturn, with the touchdown point marked by a yellow arrow.

The aeroplane touched down on a waterlogged area overgrown with reeds, following which it moved on for around 15 m and its nose wheel strut broke off, causing the aeroplane to overturn.

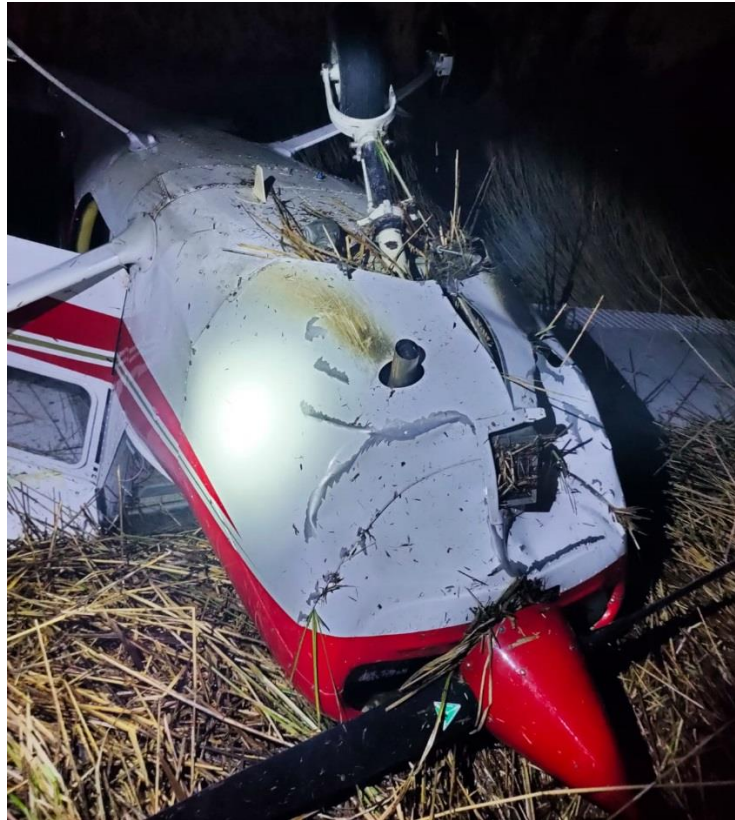
The aeroplane sustained slight damage, mainly to the nose section of the fuselage. All damage to the aeroplane was caused by the collision with the ground. No other visible damage that could have been caused earlier was found. The locations and character of the damage to the aeroplane are shown in Fig. 3.

Fig. 2. A view of the damage to the nose section of the fuselage.

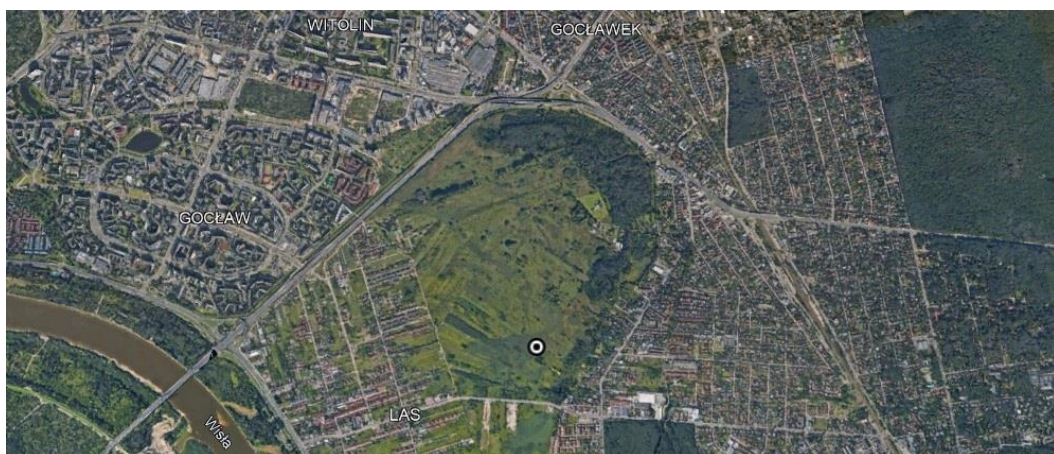
The flight was performed from the EPBC aerodrome. The pilot intended to land at the aerodrome of departure. Landing took place in the area of the Capital City of Warsaw, near Kadetów and Trakt Lubelski streets (Fig. 4).

Fig. 3. The area where the aeroplane performed an emergency landing.

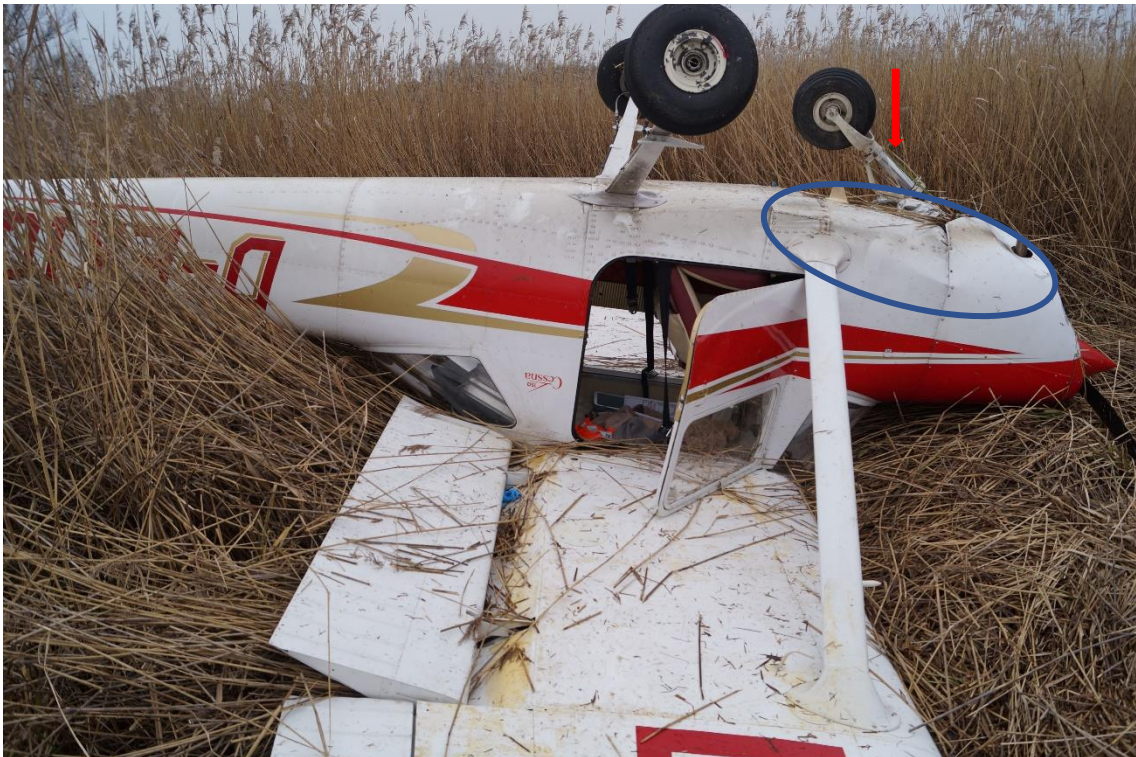
An on-site inspection of the aeroplane revealed damage to the nose wheel strut and deflections of the skin in several places in the nose section of the fuselage (Fig. 5)

Fig. 5. A view of the damage to the nose section of the fuselage.
