# FINAL REPORT

## 2024-0004

TECNAM P92 ECHO SUPER, SP-SKNN

Milewo (EPMX), 16<sup>th</sup> of February 2024

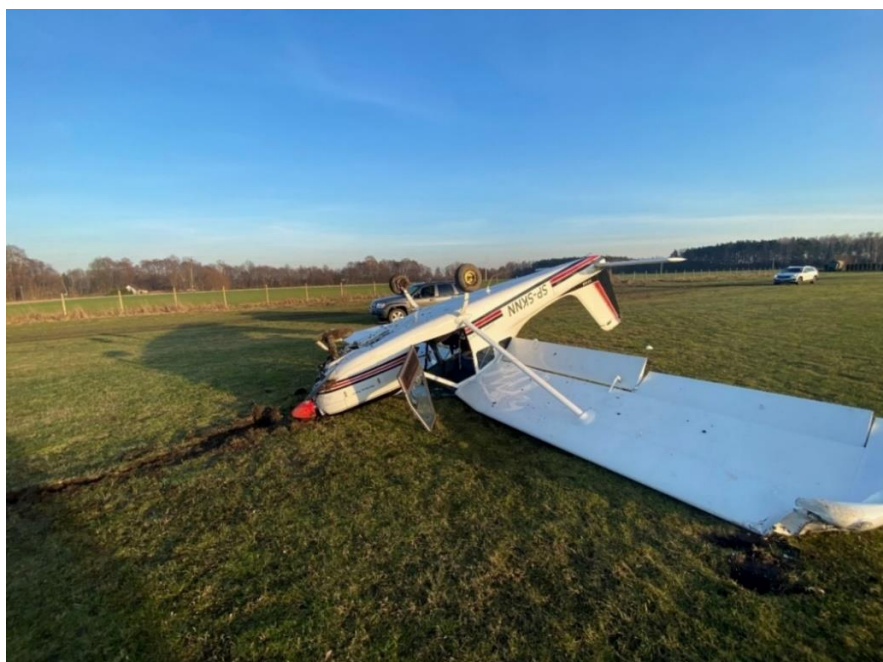
Fig. 1 Tecnam P92 Echo Super, SP-SKNN, after overturn at the aerodrome in Milewo  
[source: aircraft owner]

- 1) The pilot had the necessary qualifications to perform the flight, but his aviation experience was limited.
- 2) The airplane was fit for flight and its airworthiness and maintenance was properly documented.
- 3) The plane was insured.
- 4) As a result of stall, the pilot lost control of the lateral balance and the plane collided with the ground and turned over.
- 5) During the occurrence only the passenger suffered minor injuries.
- 6) The plane was substantially damaged.
