State Commission on Aircraft Accidents
Investigation

FINAL REPORT

2023-0008

Blue Sky Balloons, flight with passengers Cameron Balloons, Z-160, SP-BOK Bór, EPNT

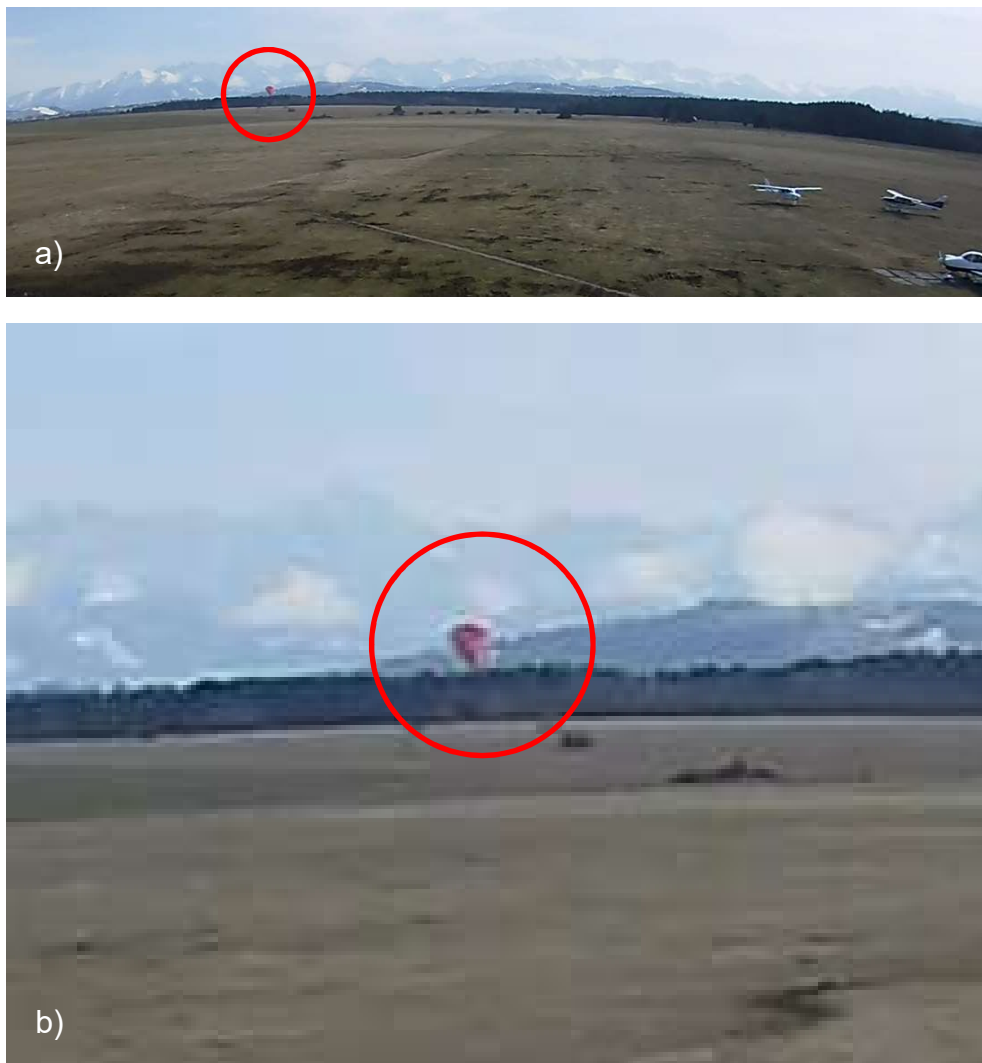
Based on that recording, it was established that the time that passed between the first landing (touchdown) and lifting of the balloon was only around 2 minutes 50 seconds. Over that time, the men got out of the basket and moved it on the meadow for several metres.

Fig. 8. Recording from a CCTV camera at the EPNT aerodrome – a view to S: (a) the balloon after being lifted into the air, just before the accident (the highest point), (b) an enlarged fragment of (a) [source: Aeroklub Nowy Targ]

The height of the balloon, from the base of the basket to the highest point on the envelope, is around 25 m. Based on the photograph (Fig. 8), it can be estimated that the aerostate ascended to the height close to its size, i.e. around 20÷25 m AGL. At the moment the balloon was lifted, the pilot activated the rapid deflation system to prevent the balloon from being lifted to a greater height.
