# FINAL REPORT

SERIOUS INCIDENT 2022/4594

State Commission on Aircraft Accidents Investigation (PKBWL)

AIRCRAFT – Boeing B-737/800-83N, SP-ENU

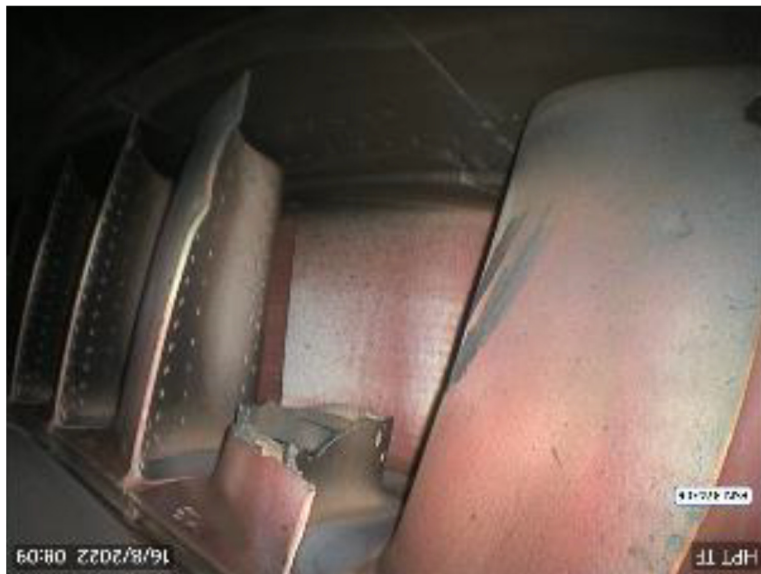
1. Engine #2 HPT Blade #80 fractured at ~15% of its span, while multiple HPT blades and downstream hardware were damaged due to impact from the liberated debris.

Fig. 2. HPT BSI results. Engine #2, HPT Blade #80 fracture at ~15% span, while multiple HPT blades and downstream hardware damaged due to impact from the liberated debris.

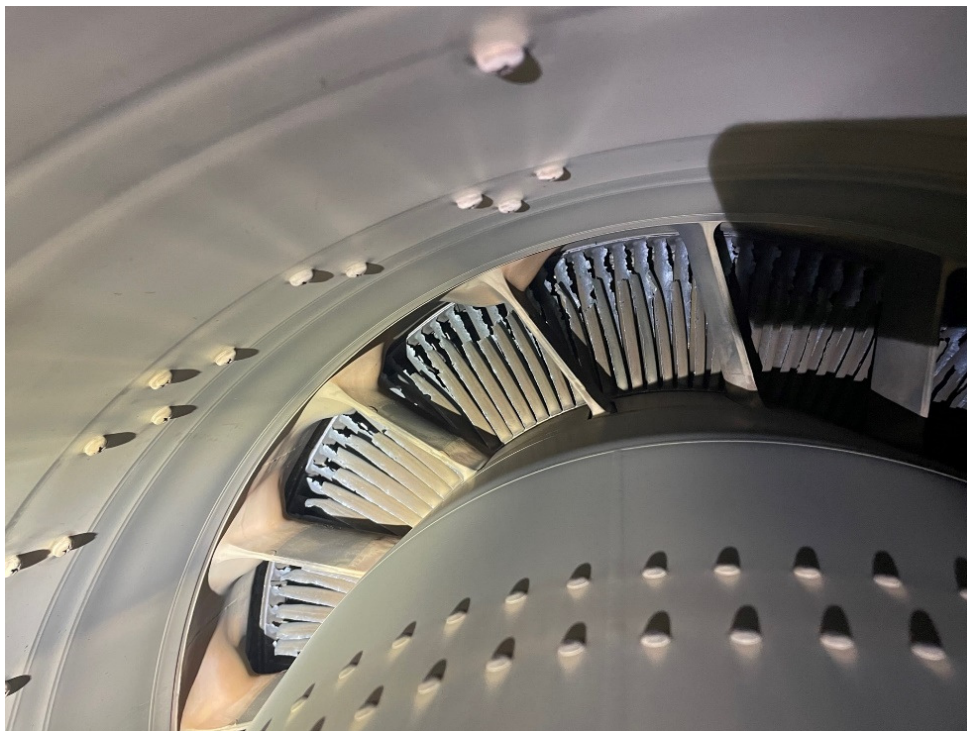
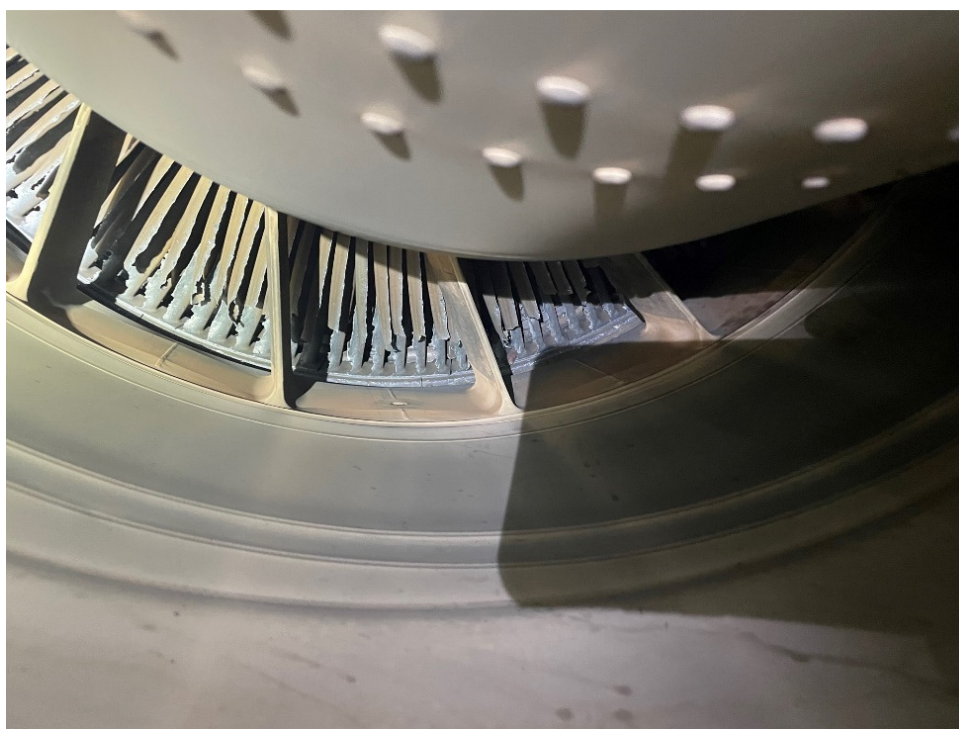
Fig. 3. Two pictures of stage 4 LPT blades of Engine #2 and downstream hardware damaged due to impact from the liberated debris.

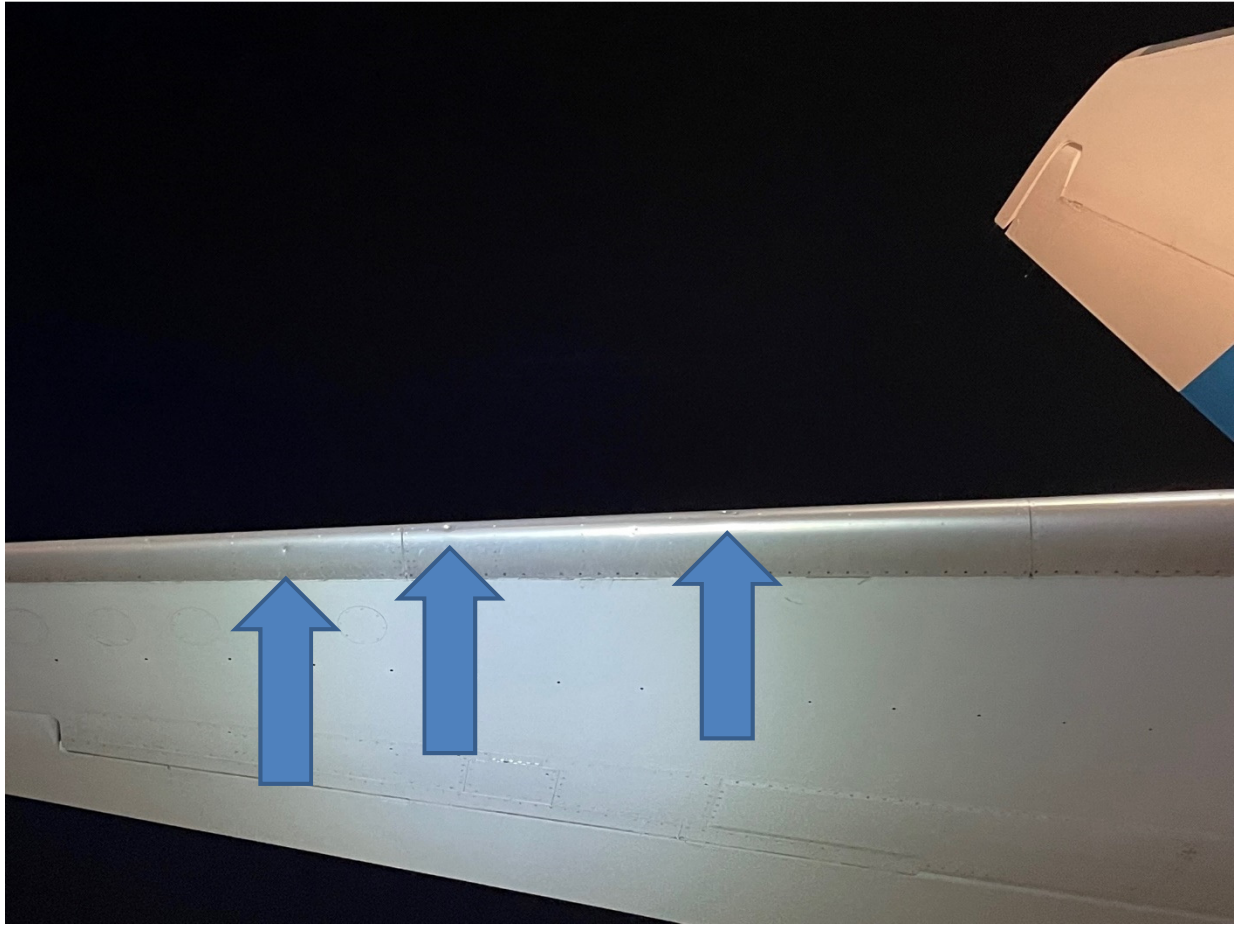
## 2. Dents on the right side of horizontal stabilizer.

Fig. 4. Multiple dents on the right side of horizontal stabilizer.

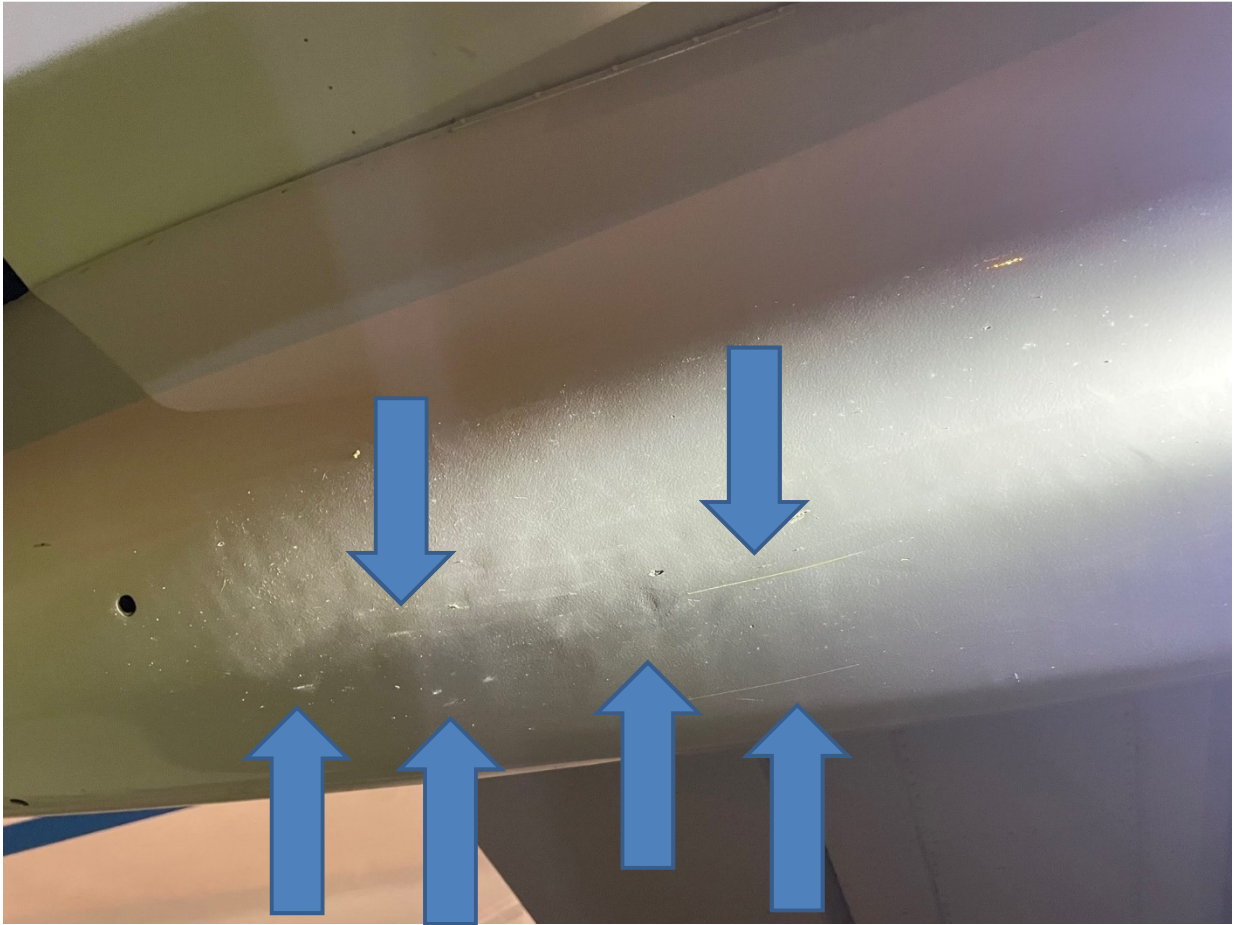
3. Scratches and dents on lower side of flap support fairing on right wing.

Fig. 5. Multiply scratches and dents on lower side of flap support fairing on right wing.

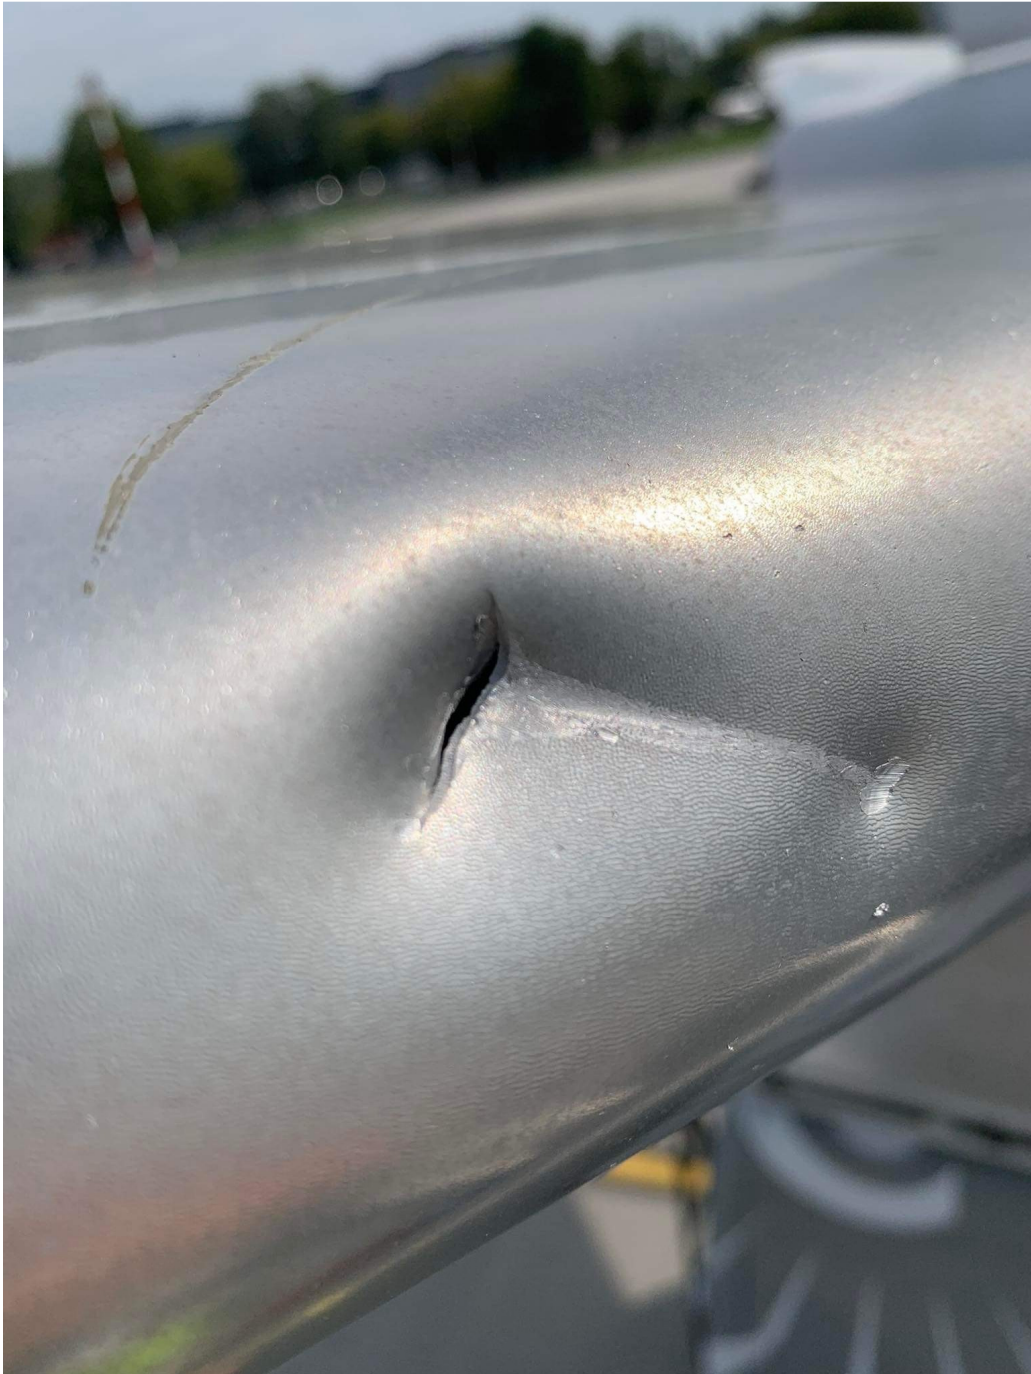
4. Dent and crack on of leading edge of the right side of horizontal stabilizer.

Fig. 6. Dent and crack on of leading edge on leading edge of the right side horizontal stabilizer.

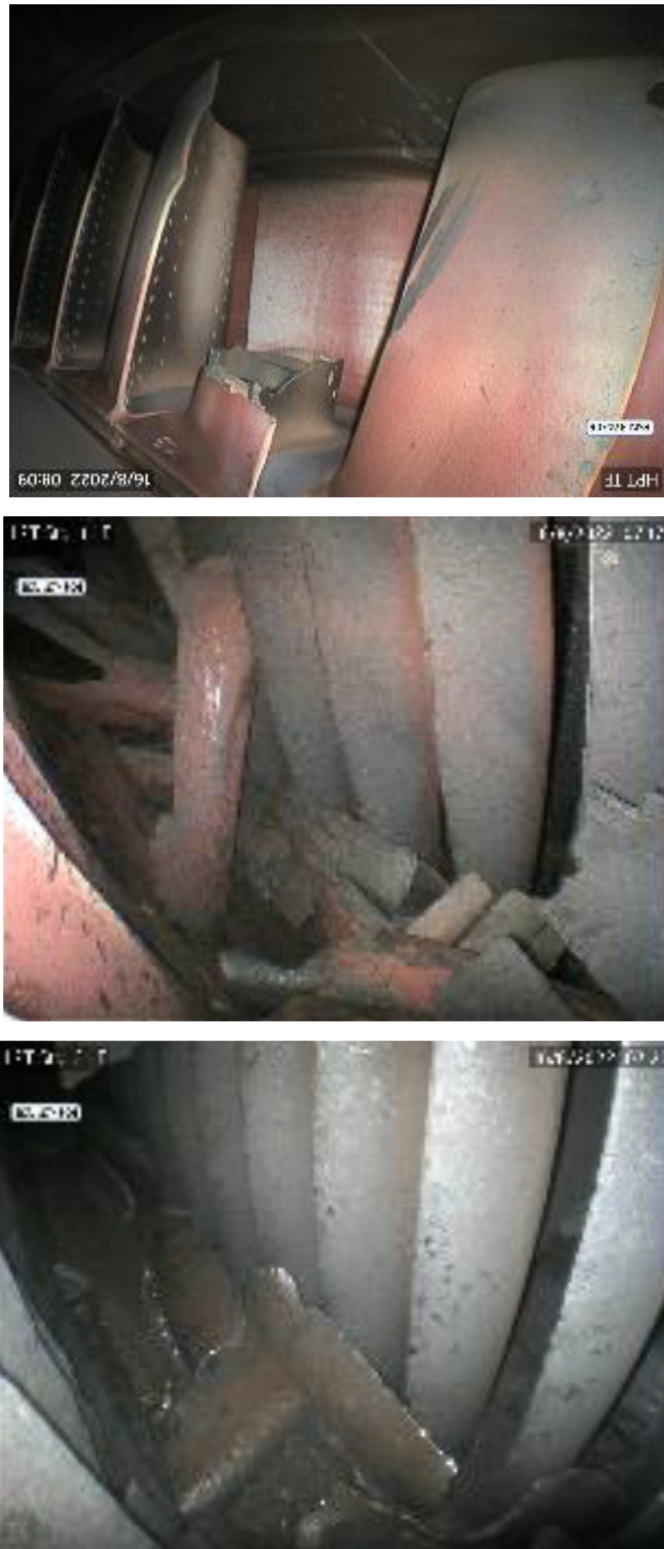
Fig. 17. Three pictures: HPT BSI results. Blade #80 fractured at ~15% span, while multiple LPT blades and downstream hardware were damaged due to impact from the liberated debris.

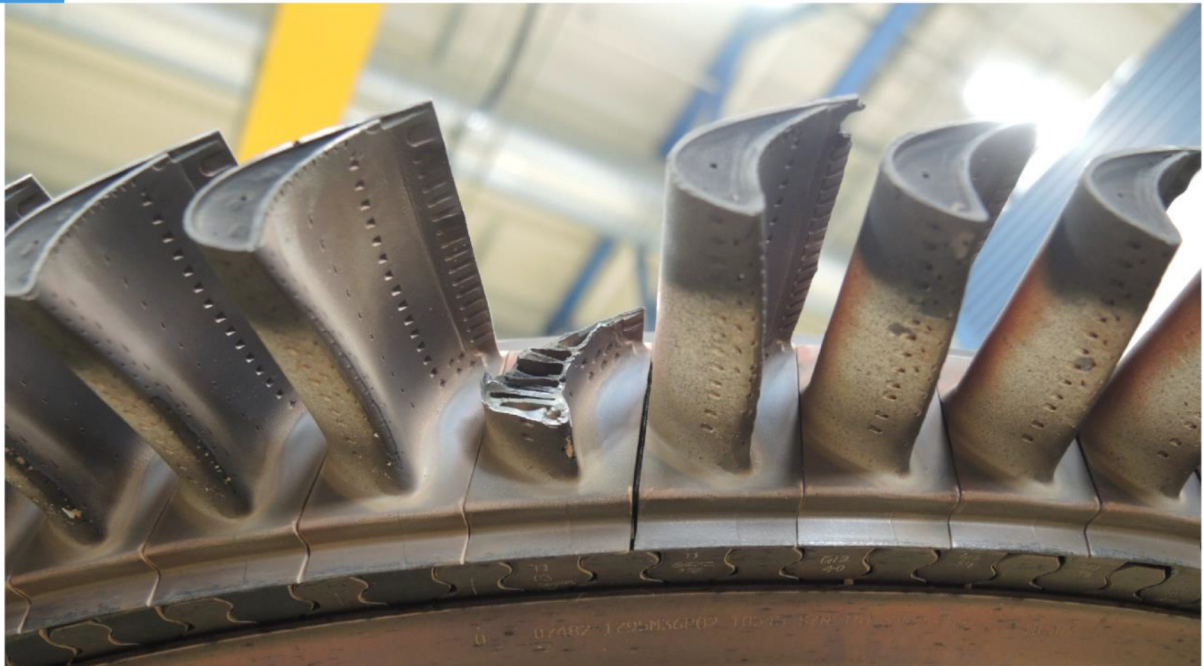
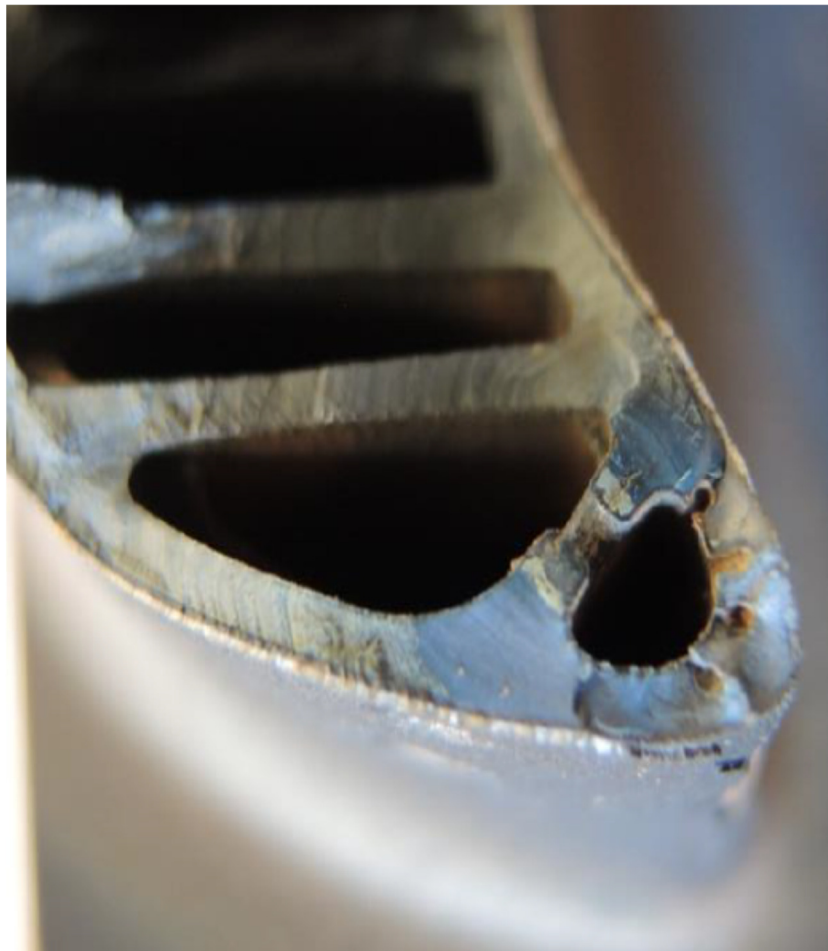
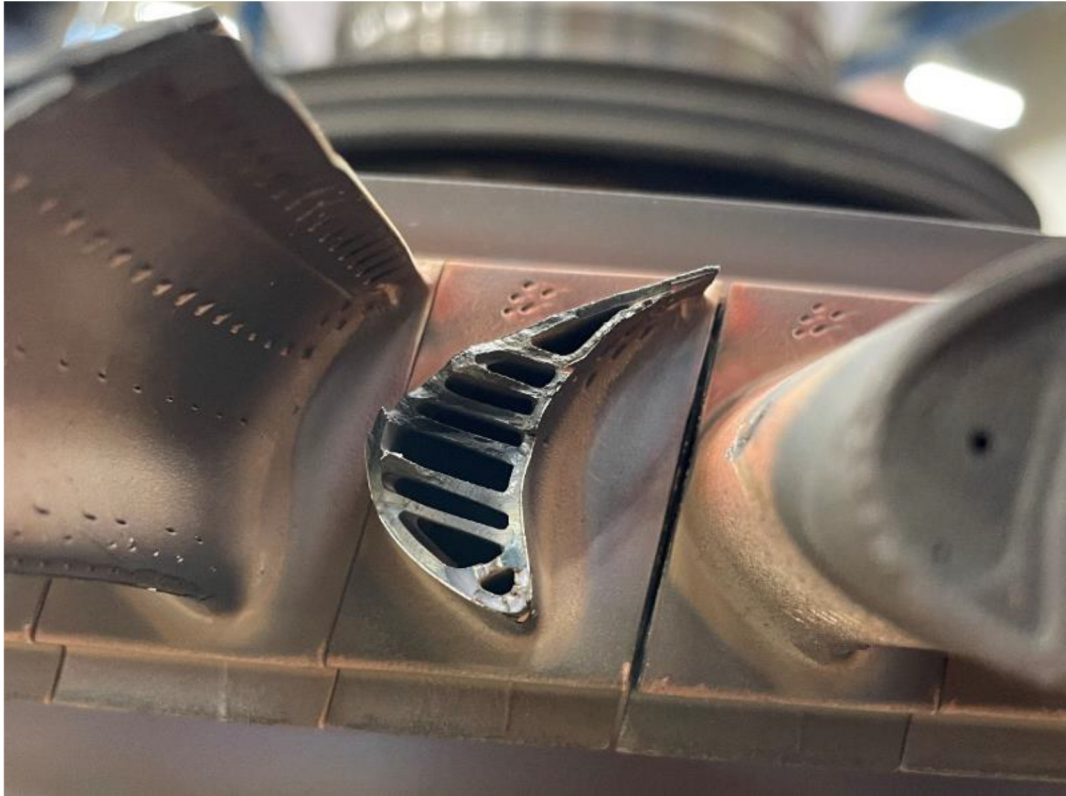
Fig. 18. Three pictures. Overview photos at HPT exposure. Blade #80. Multiple blades were damaged due to impact from the liberated airfoil debris.

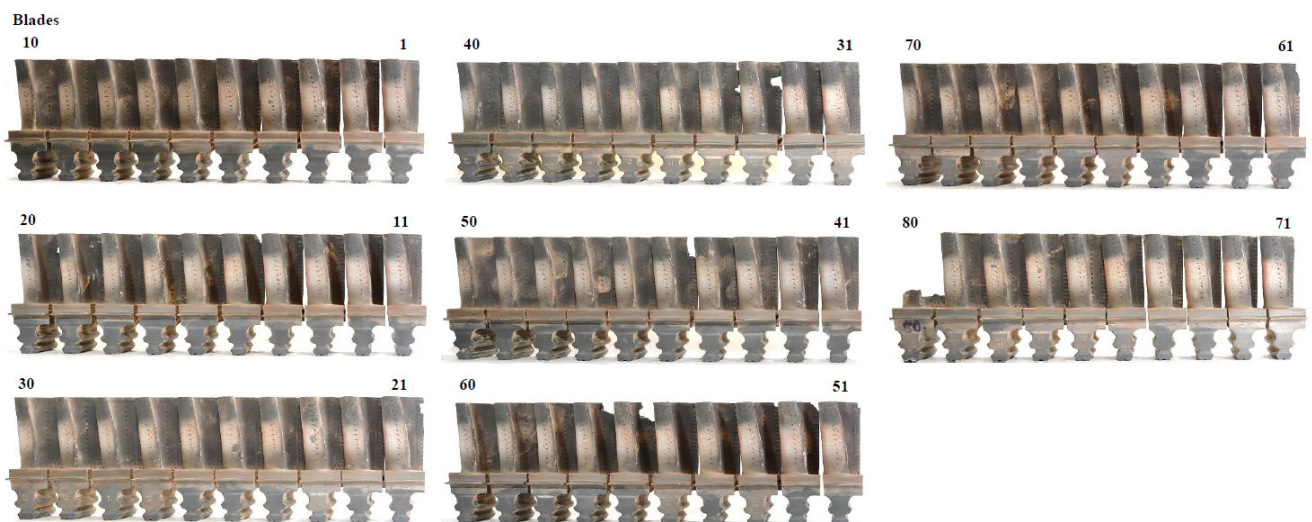
Fig. 19. Lead edge photos of complete blade set returned for evaluation in the as received condition. Blade #80 (SN BWHN9B01) shows airfoil liberation while the remaining blades show varying levels of trail edge damage.

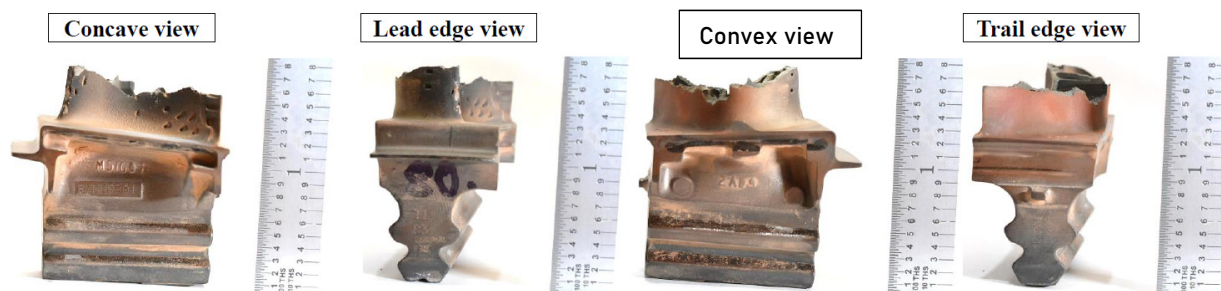
Fig. 21. Overview photos of the as-received blade #80 (S/N BWHN9B01) showing airfoil liberation.  
Source: Report: CFM56-7B Engine Serial Number: 874306 HPT blade airfoil separation event Metlab evaluation summary. P.8.

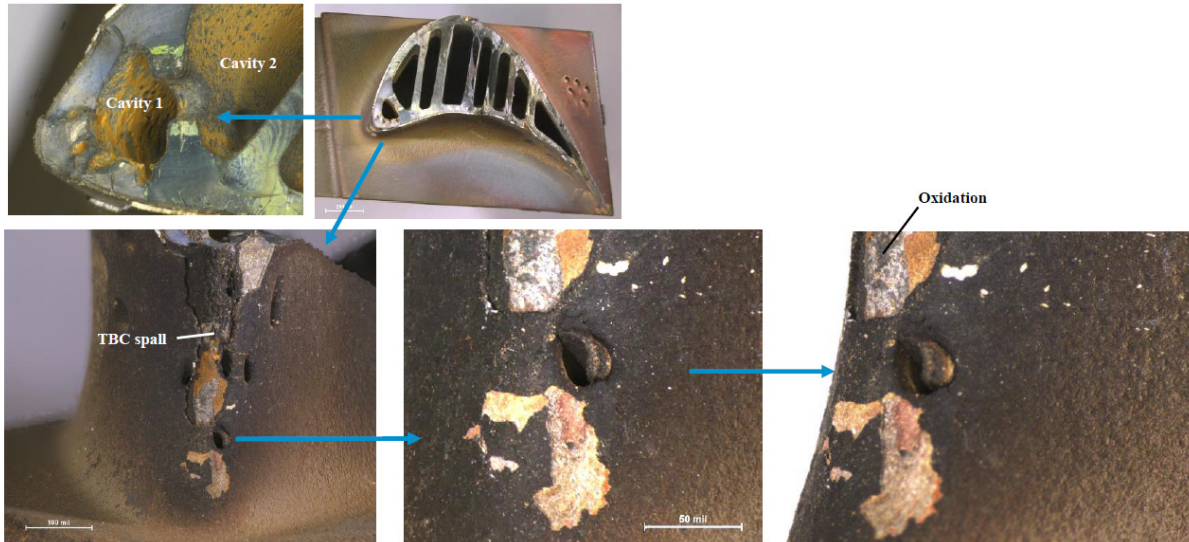
Fig. 22. Top-down & external surface photos of the as-received blade #80 (S/N BWHN9B01) liberation surface. TBC loss was identified along the lead edge below the fracture surface. The cavity 1 internal wall also showed significant dust-buildup, consistent with previous observations of HPT blades operated in a severe environment.

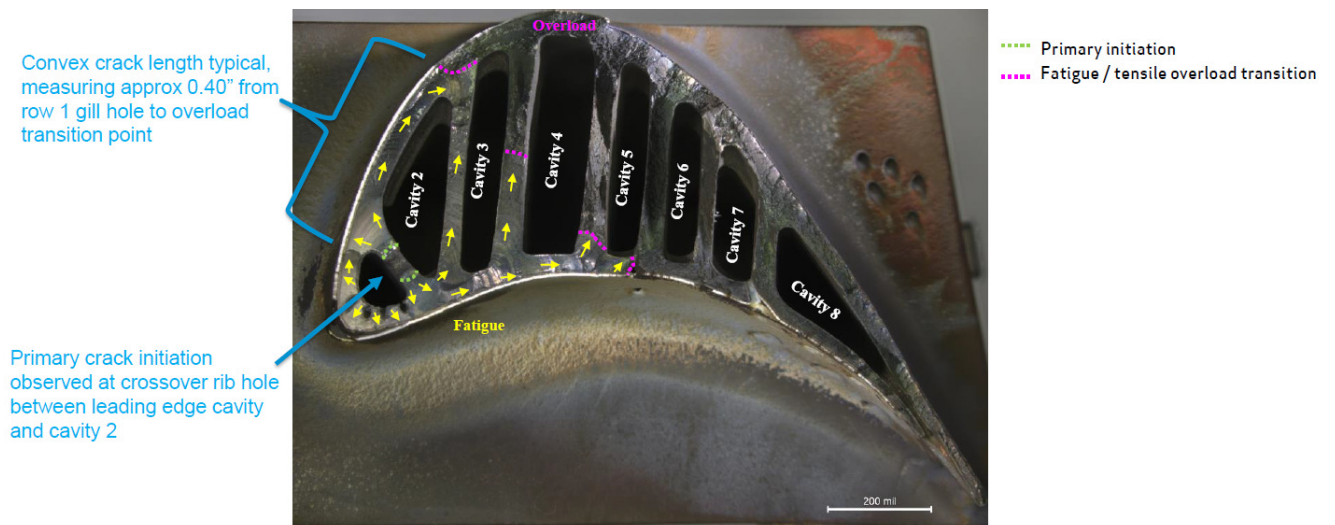
Fig. 23. Top-down photo of the cleaned blade #80 (S/N BWHN9B01) liberation surface. Primary initiation occurred at the cavity 1-2 rib cross-over hole moving toward the lead edge and aft through cavity 2-3 rib on the convex side and cavity 5 on the concave side. Progression lines and oxidation were observed all along the fracture surface consistent with low cycle fatigue.

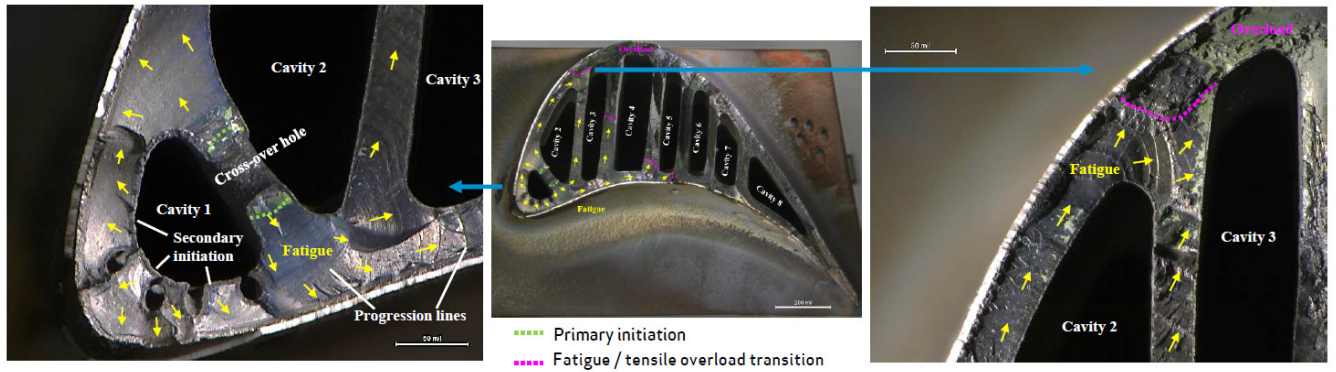
Fig. 24. Fracture surface photos of the cleaned blade #80 (S/N BWHN9B01) liberation surface showing primary initiation from the crossover hole. Progression lines and oxidation were observed along the entire crack propagation consistent with low cycle fatigue. The convex wall transition to overload is observed near cavity 3.

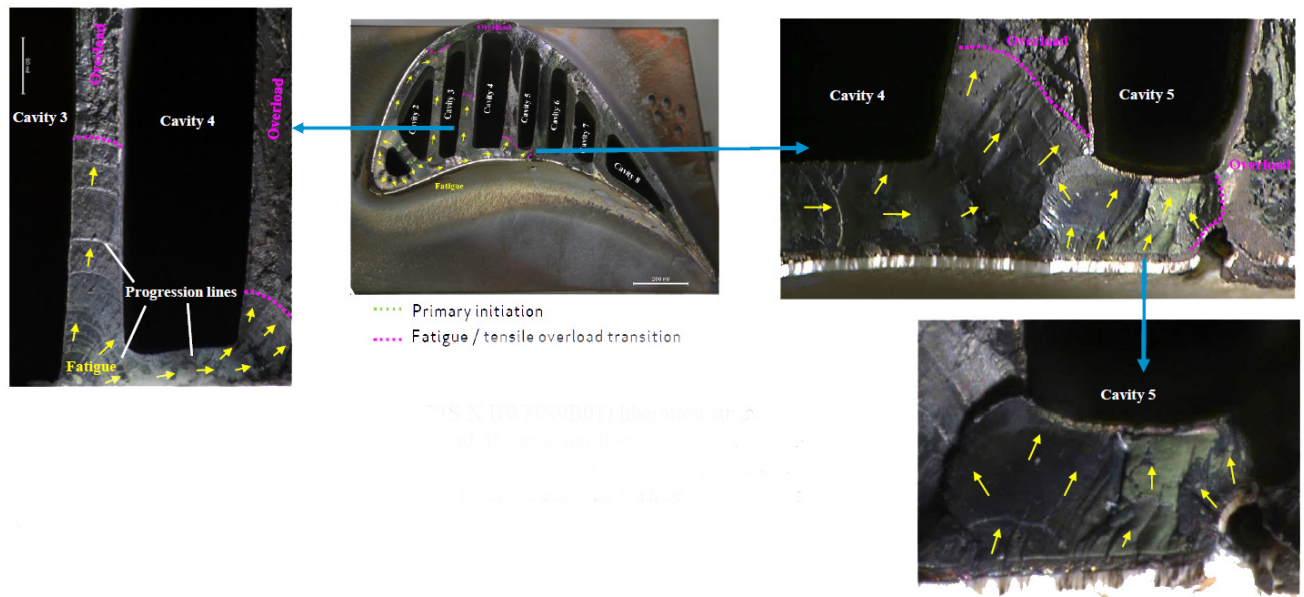
Fig. 25. Fracture surface photos of blade #80 (S/N BWHN9B01) liberation surface showing concave wall & rib transitions to overload. Progression lines and oxidation were observed along the crack propagation consistent with low cycle fatigue. Near cavity 5, additional secondary initiation sites are observed from the external surface and adjacent cooling hole.

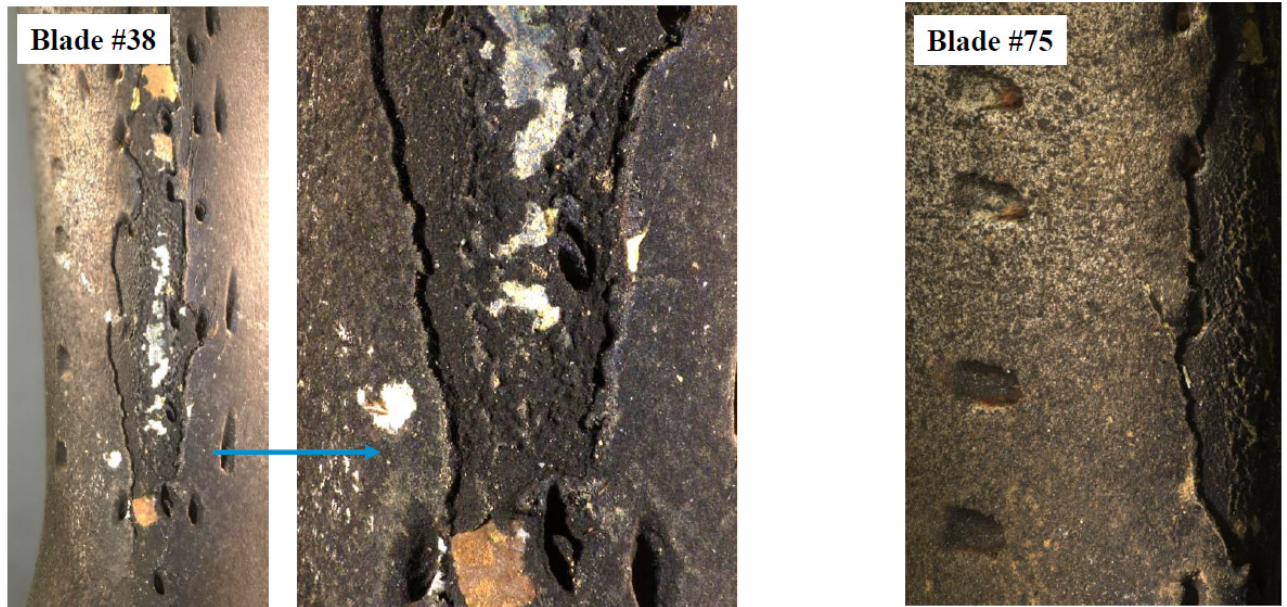
Fig. 26. Distress is also observed on other 1957M10P01 blades. Blade #75 (S/N BWHN6B89, P01) and blade #38 (S/N BWHN7C53, P01) show worst-case lead edge oxidation, which is subject to AMM limits for reduced BSI intervals.

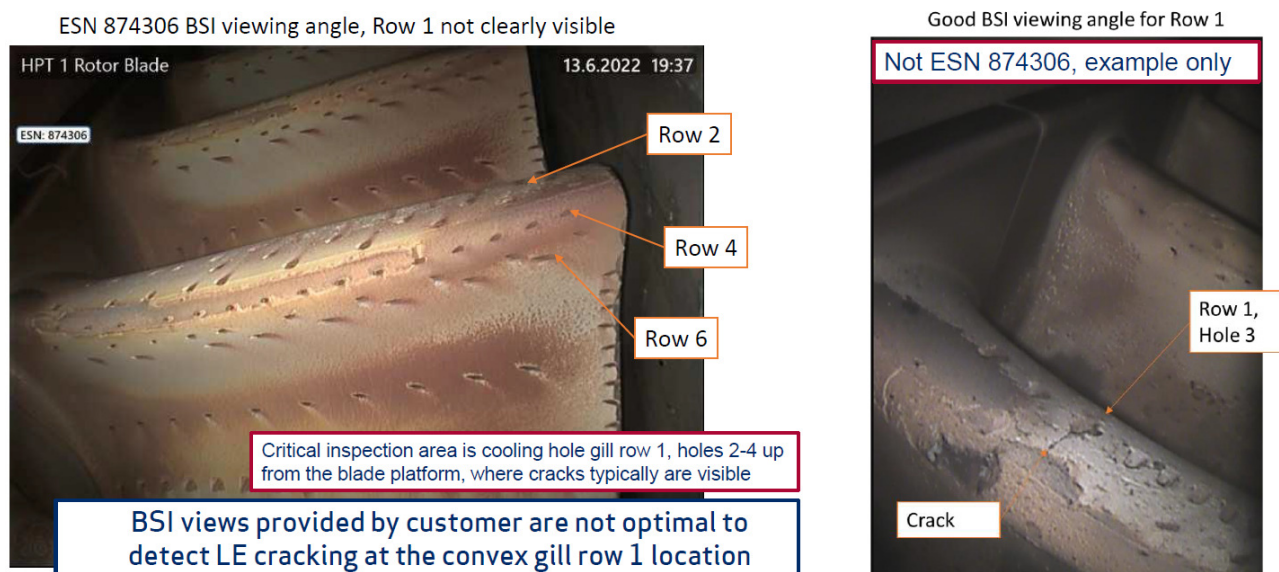
Fig. 28. BSI technique.

However, operator stated that: “crack was not detected”.

As an explanation of presented conclusion, below on the left demonstrated completed BSI on Engine 874306 and on the right-side correct angle of view during BSI. However, based on Operator`s statement: “the inspection was completed and blades have been checked from several sides and also with the straight and angular lenses, which have been in the equipment of EnterAir for 4 years”. Operator stated that photo included in figure 26 “is only an illustrative (...) to indicate that given engine sector was checked or to illustrate any damage found”.
