State Commission on Aircraft Accidents Investigation

FINAL REPORT

2023-0039

Robinson Helicopter Company R44 II, OK-LUK

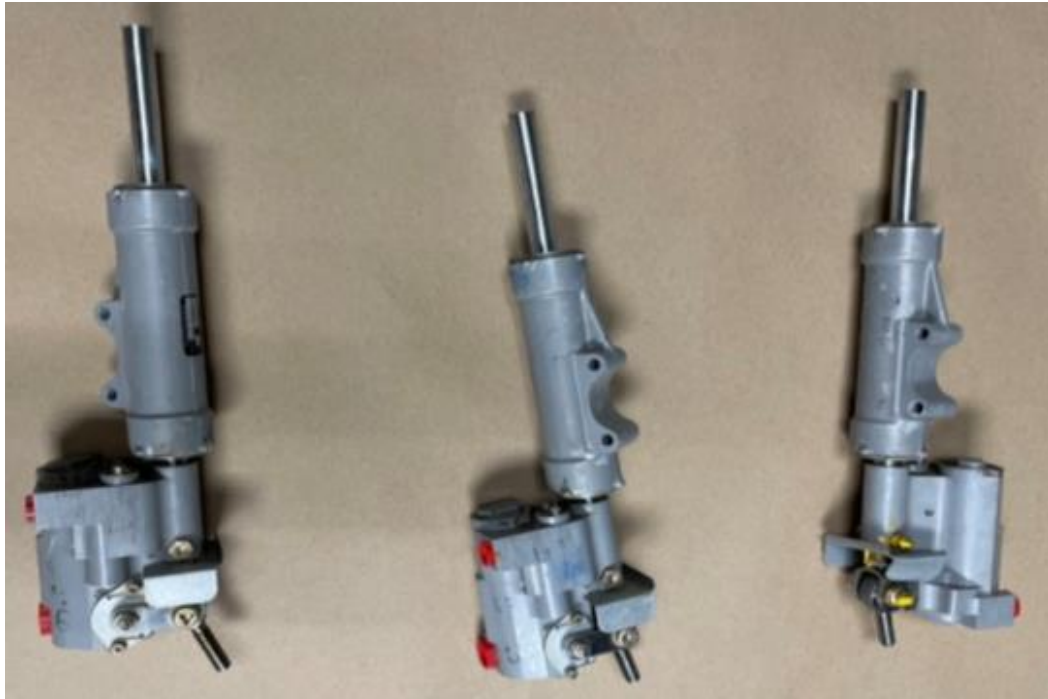
Figure 4. Hydraulic amplifiers removed from the helicopter [source: NTSB].

Steering the helicopter would be impossible in the event of a seizure or blockage of the hydraulic amplifier (subsection m). Tests of the amplifiers carried out by NTSB showed that no such failure had occurred.

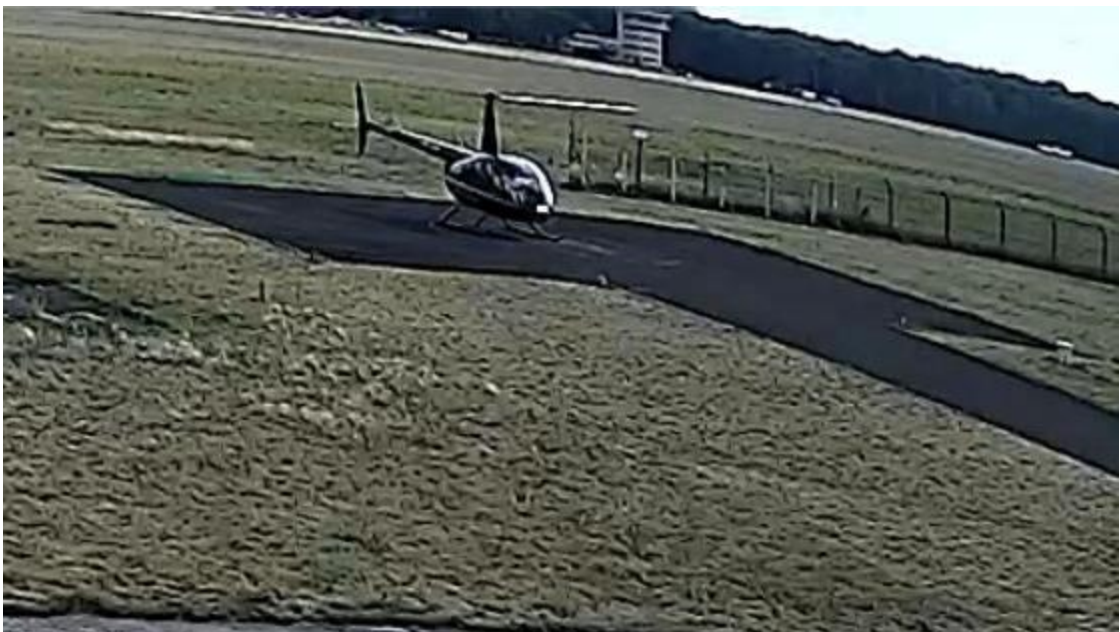
Figure 6. The initial attempt to take off, linear movement of approximately 1 m to the right with a simultaneous rotation of approximately 30° to the left with a forward tilt [source: CCTV footage].

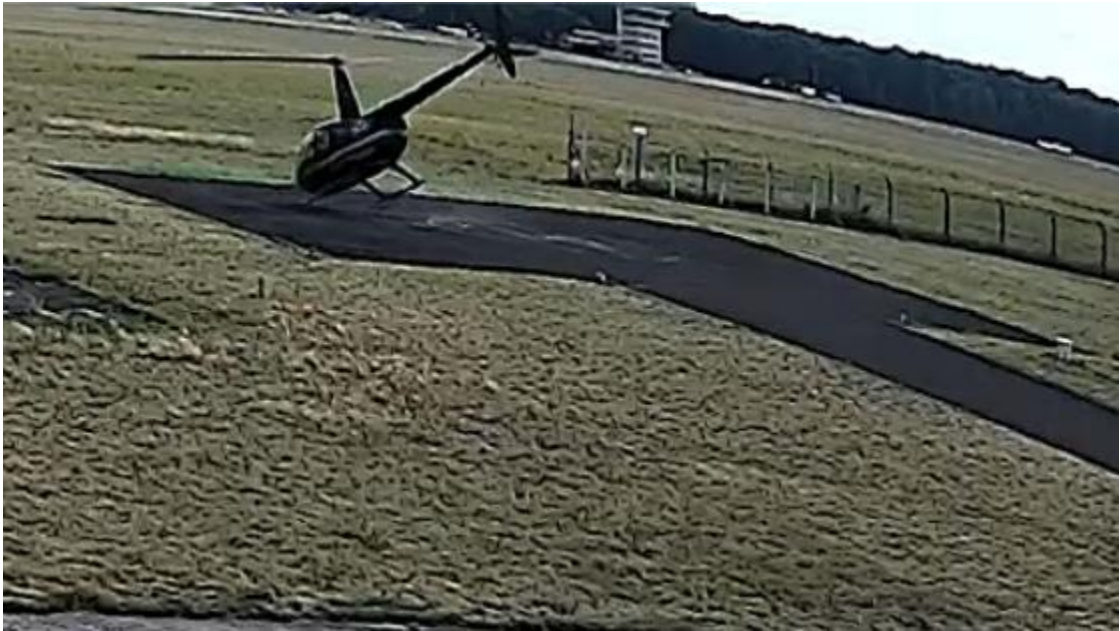
Figure 7. Leftward rotation of approximately 180° with simultaneous forward tilt [source: CCTV recording].

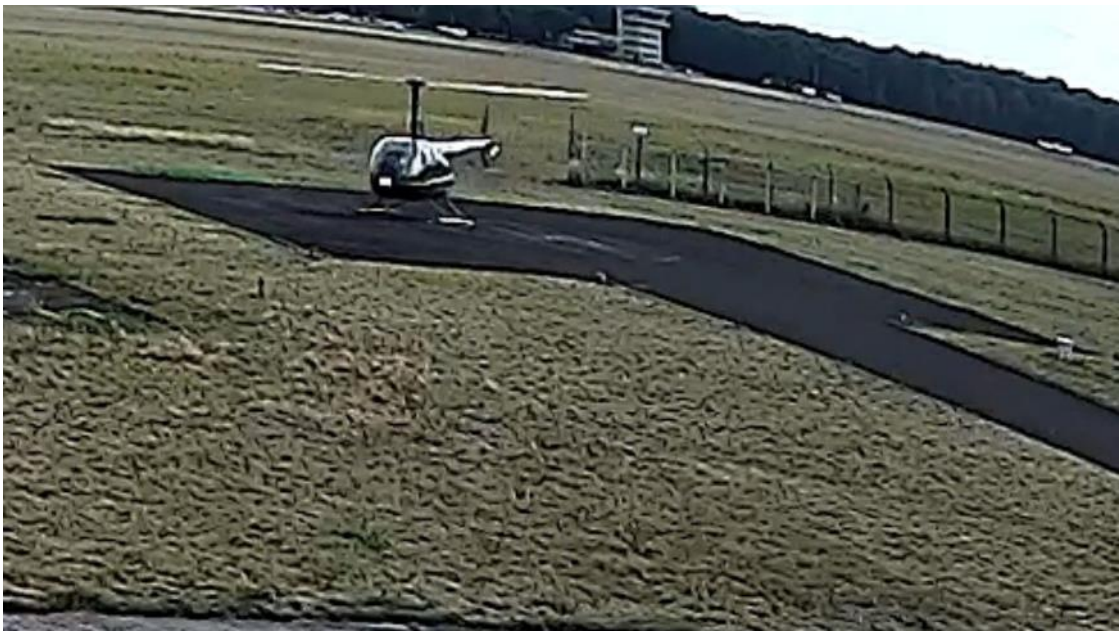
Figure 8. Leftward rotation of approximately 315° with simultaneous backward tilt [source: CCTV footage].

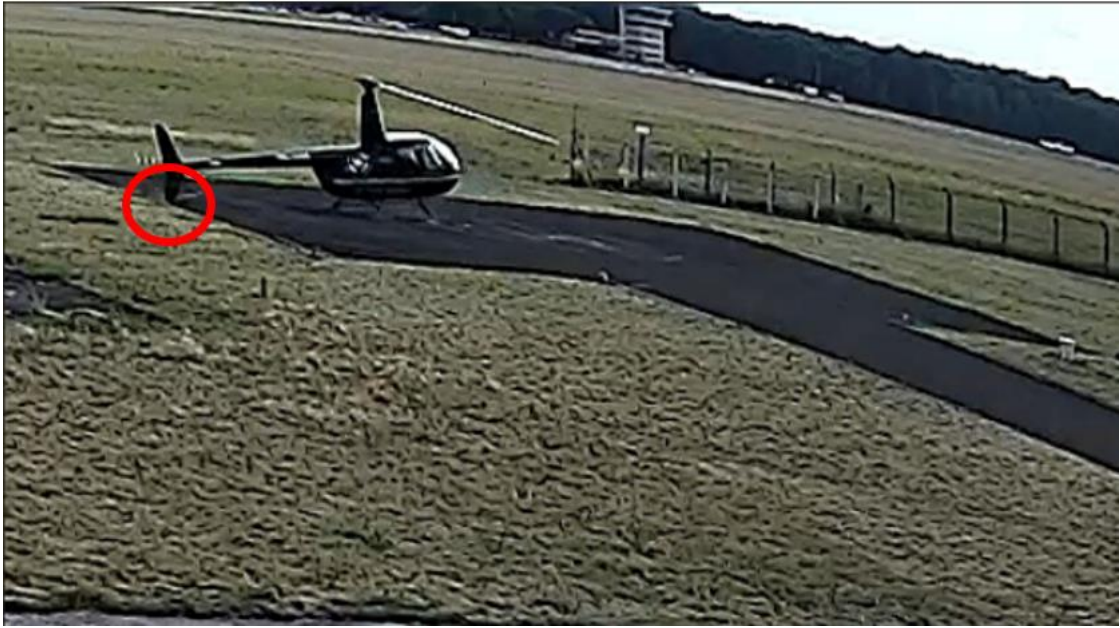
Figure 9. After another rotation of approximately 90° with the tail skid hitting the helipad for the first time (marked with a red circle) [source: CCTV footage].

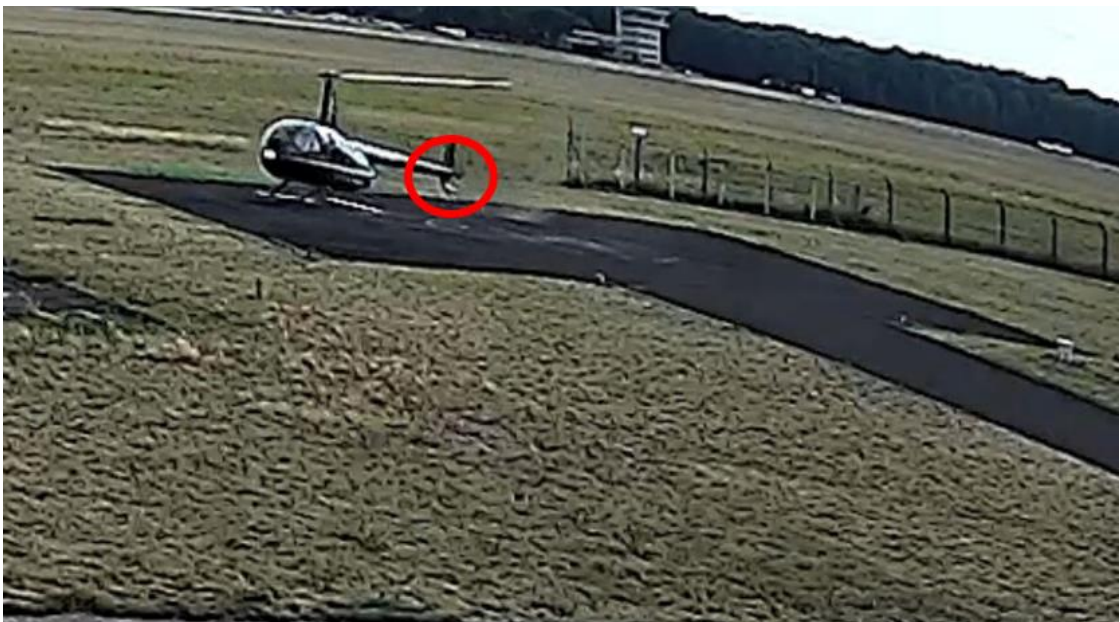
Figure 10. After another rotation of approximately 270° with the tail skid hitting the helipad for the second time (marked with a red circle) [source: CCTV footage].

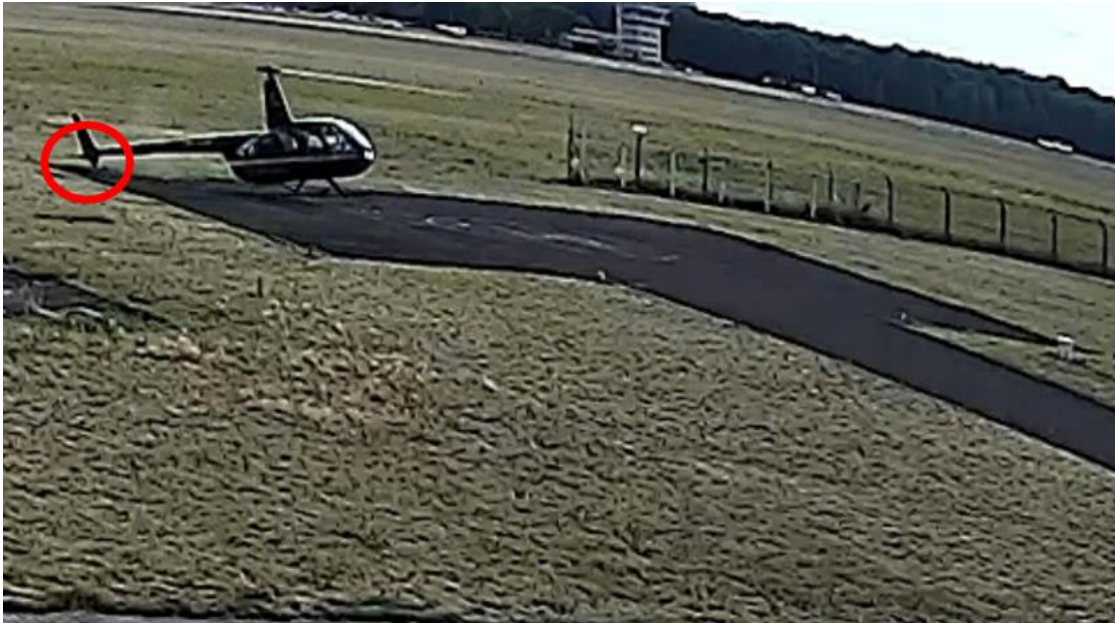
Figure 11. Just before the leftward rotation stops, hitting the helipad for the third time, destroying the tail rotor (marked with a red circle) [source: CCTV footage].

During the take-off attempt, the helicopter made a rapid 360° left turn at a speed of approximately 75°/s, in approximately 4.5 s.

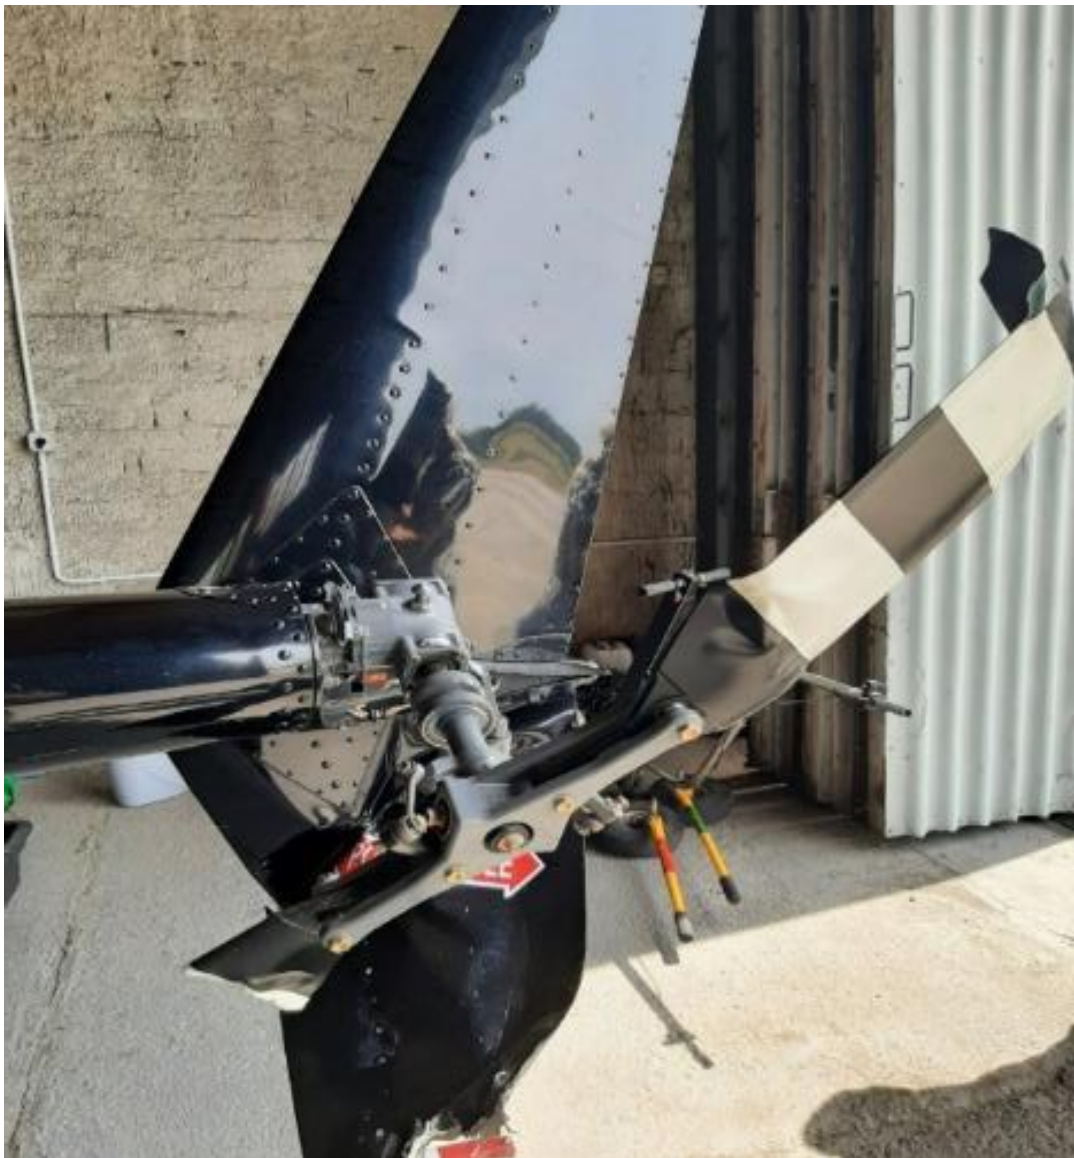
Figure 12. Destroyed tail rotor, damaged angle gearbox attachment to the tail boom.

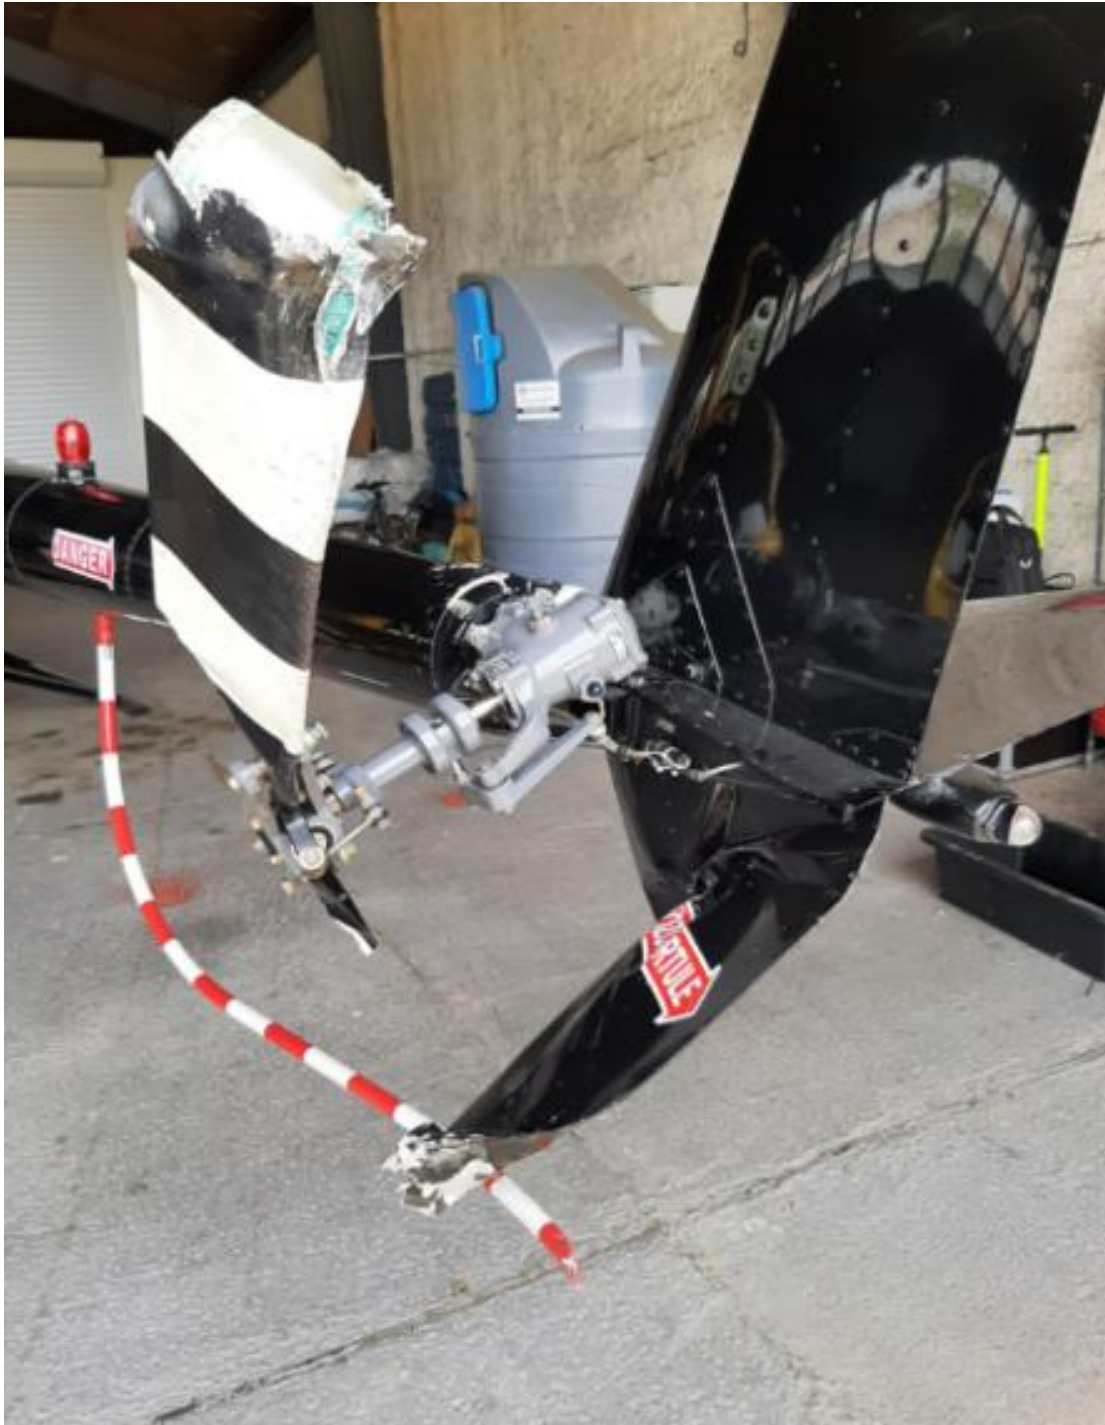
Figure 13. Broken tail skid, damaged lower vertical stabiliser and broken tail rotor bracket.

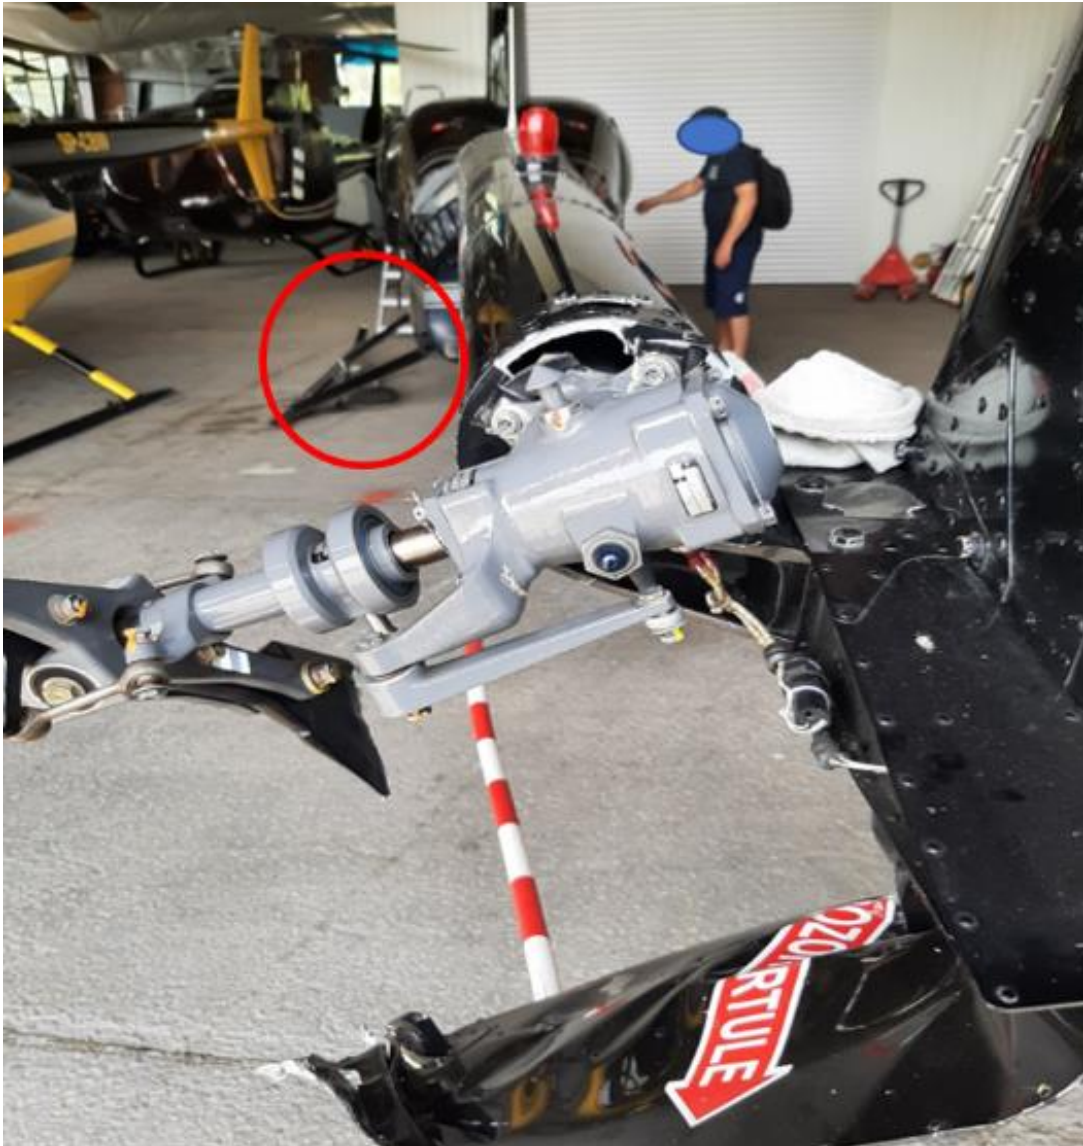
Figure 14. Broken angle gearbox including attachment to the tail boom assembly, damaged skid landing gear (red circle, left skid).
