# FINAL REPORT

**of the State Commission on Aircraft Accidents  
Investigation**

## 2024-0055

Socata TB-9 Tampico airplane, SP-TAI

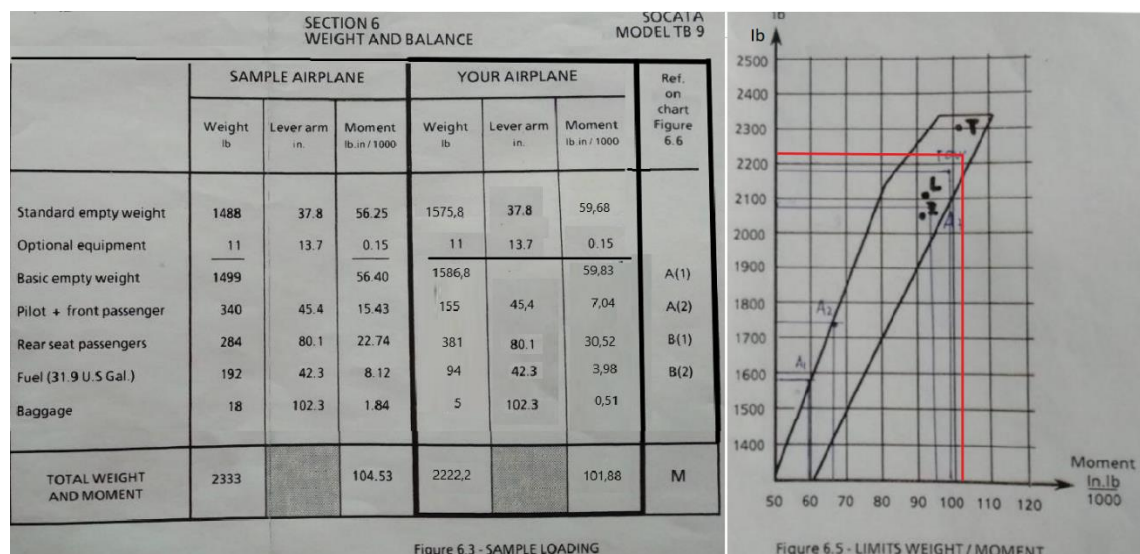
The airplane was balanced towards the back, but it was within the acceptable range (Fig. 1).

Fig. 1. Balancing table and chart.

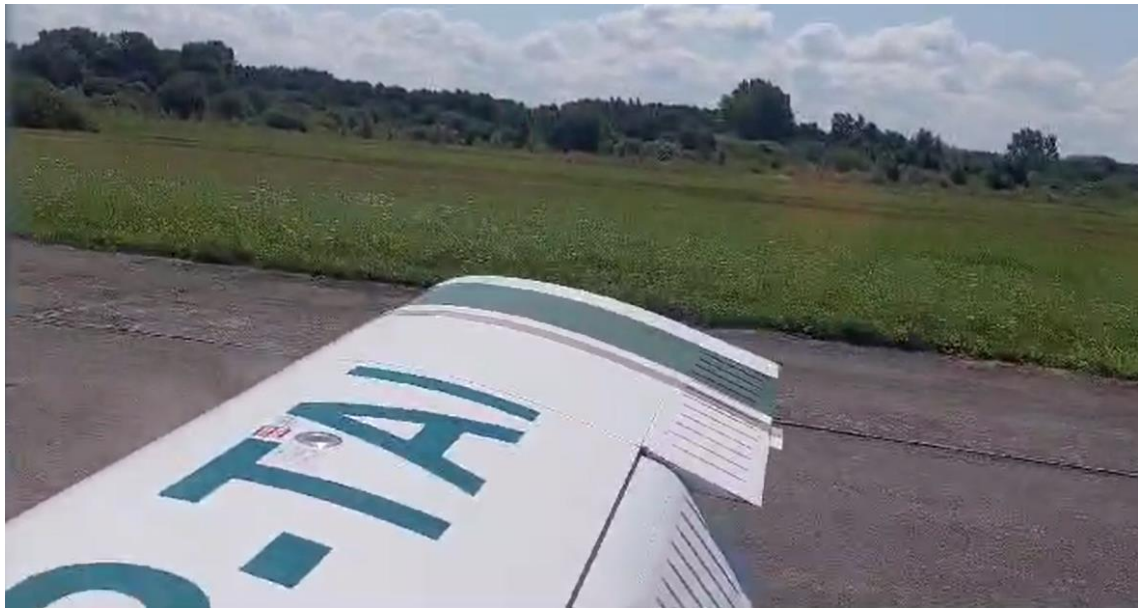
Upon asking the pilot if he should sit in the front of the airplane, the passenger was told that he can sit in the back. The passengers occupied their seats at the back of the cabin. Around 11:55 hrs<sup>3</sup> the pilot started taxiing for the second flight that was supposed to last 15 minutes. During taxiing the flaps were in landing position – large flaps (Fig. 2).

Fig. 2. Visible flaps deflected into the landing position [source: passenger]

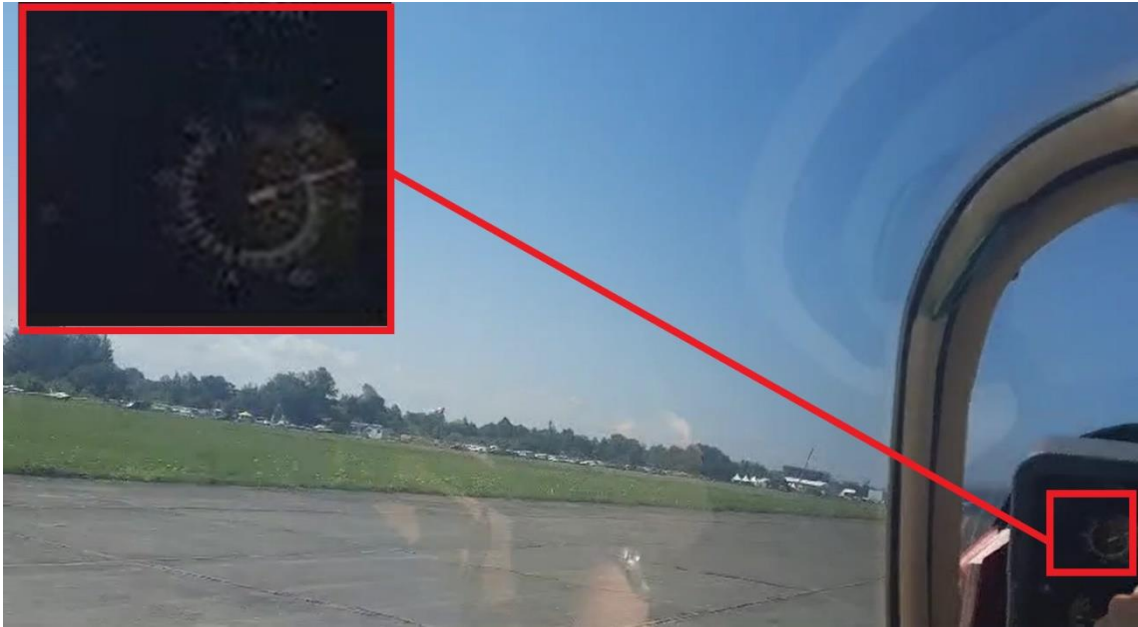
After backtracking to 170 m away from the airstrip 25 threshold, the pilot turned 180° and the plane commence take off which initially went correctly. After travelling 220 m with the speed of approximately 50 kt, the airplane's nose lifted up more than the recommended value and simultaneously the back side of the airplane touched the airstrip and the stalling signal was emitted (Fig. 3).

Fig. 3. View of the lifted up hood and airspeed indicator [source: female passenger]

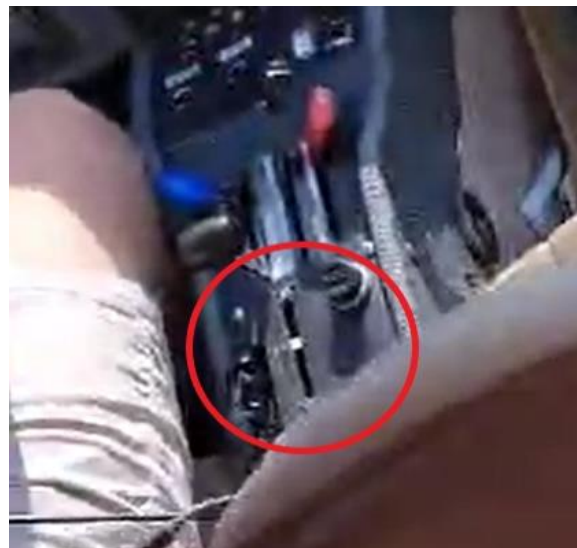
The pilot tried to correct the pitch angle, but as he stated the airplane did not react to releasing the control wheel. During the analysis of recordings made by the passengers it was determined that the airplane take-off was probably conducted with the flaps in landing position, however during the conversation, the pilot claimed that the flaps had been set to the takeoff position before takeoff. The PKBWL was unable to determine the position of the flaps during takeoff. The airplane being balanced towards the back in combination with the flaps being set in the landing position and the trim tab in neutral position (Fig. 4) might resulted in high moment lifting the nose of the airplane up.

Fig. 4. The figure shows the trimming tab position [source: male passenger]

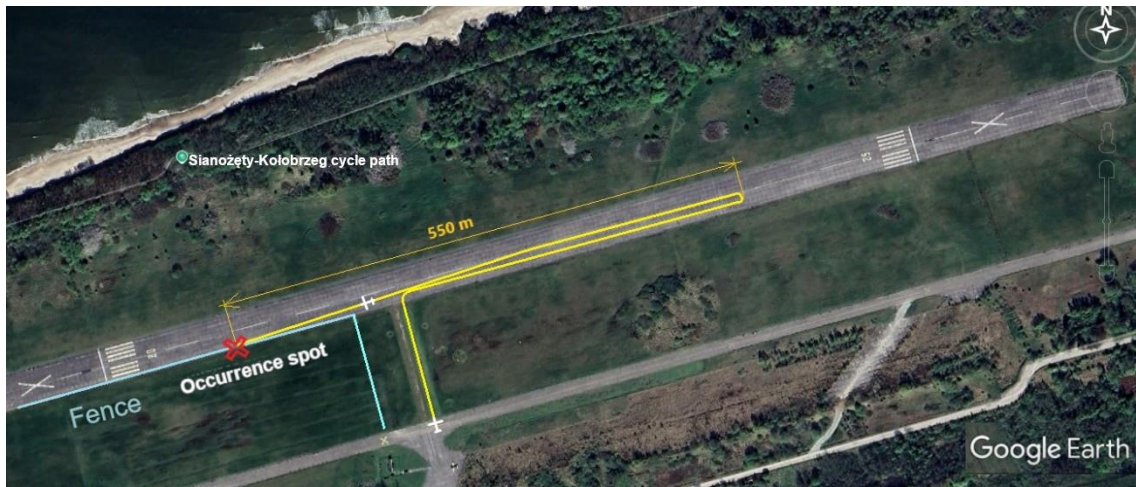
After the 550 m of take-off roll the airplane collided with the fence placed at the southern airstrip edge. The occurrence sketch is presented in Fig. 5. During the inspection of the aircraft after the occurrence, damage to the left-side elevator attachment tab was found, among other things, but the PKBWL was unable to determine whether the damage occurred before the aircraft collision with the barriers at the edge of the runway.

Fig. 5. Sketch of the occurrence.

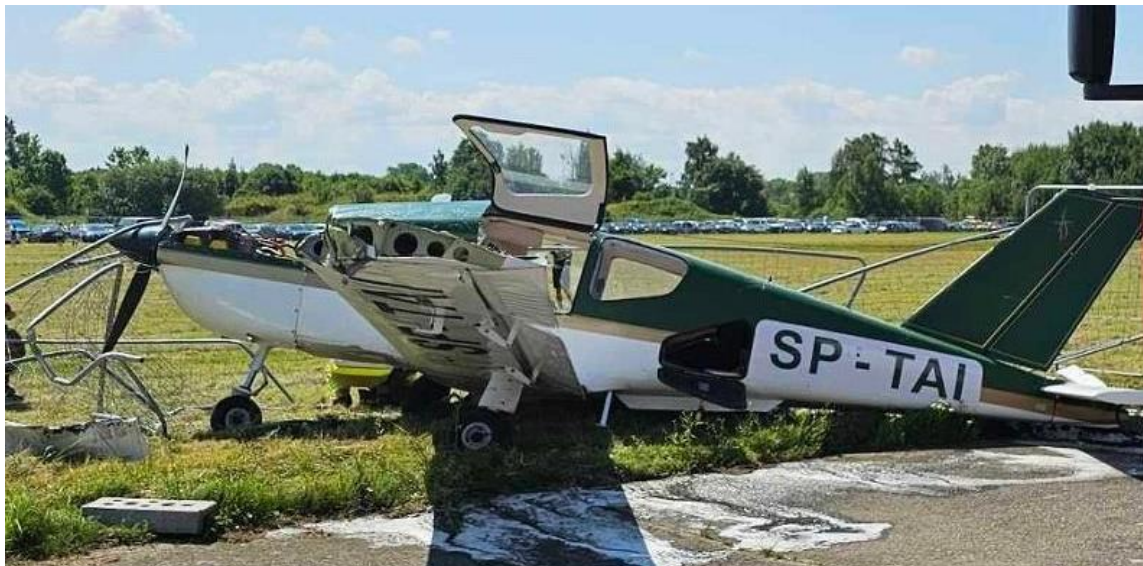
During the occurrence the pilot and passengers did not suffer any injuries, the fence got damaged and the airplane got seriously damaged (Fig. 6).

Fig. 6. The airplane after the occurrence [source: Internet]
