PRELIMINARY REPORT

State Commission on Aircraft Accidents Investigation

2024-0057

Robinson R44 Cadet, SP-NHM

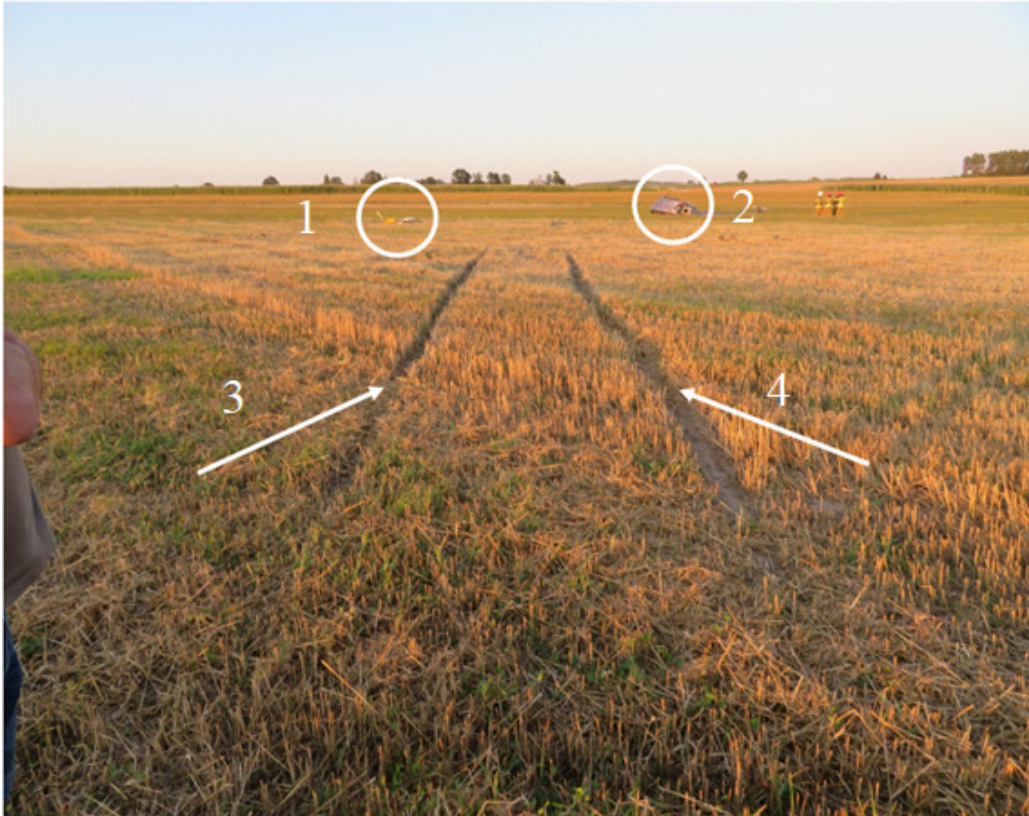
Due to that situation, the pilot decided to make a precautionary landing. He initiated an autorotation towards the selected landing site. Before touchdown, the pilot performed "FLARE" manoeuvre, then touched down and made a landing roll of approximately 10 meters (Fig. 1).

Fig. 1. Emergency landing area: 1 – part of the tail boom with the final drive and tail rotor blades, 2 – helicopter wreckage, 3 and 4 – skid landing gear marks

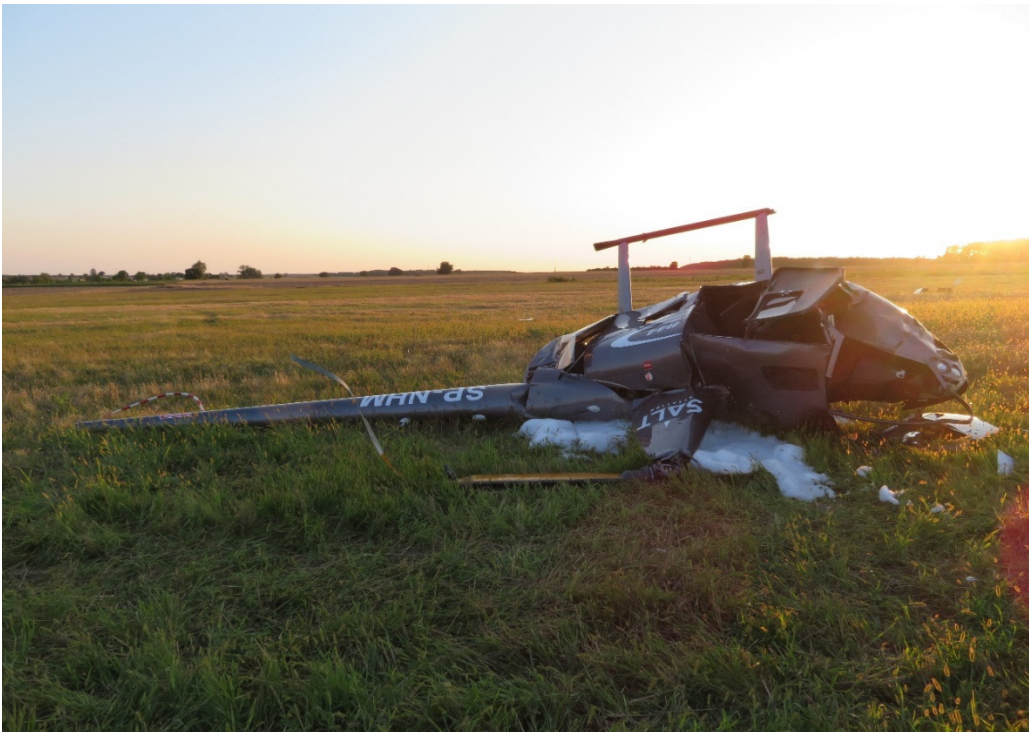
In the final stage of the landing roll, the helicopter overturned, hitting the ground with the left side of the cabin, and then the helicopter fall over on its right side. By that time the engine was no longer running.

Fig. 2. Helicopter wreckage

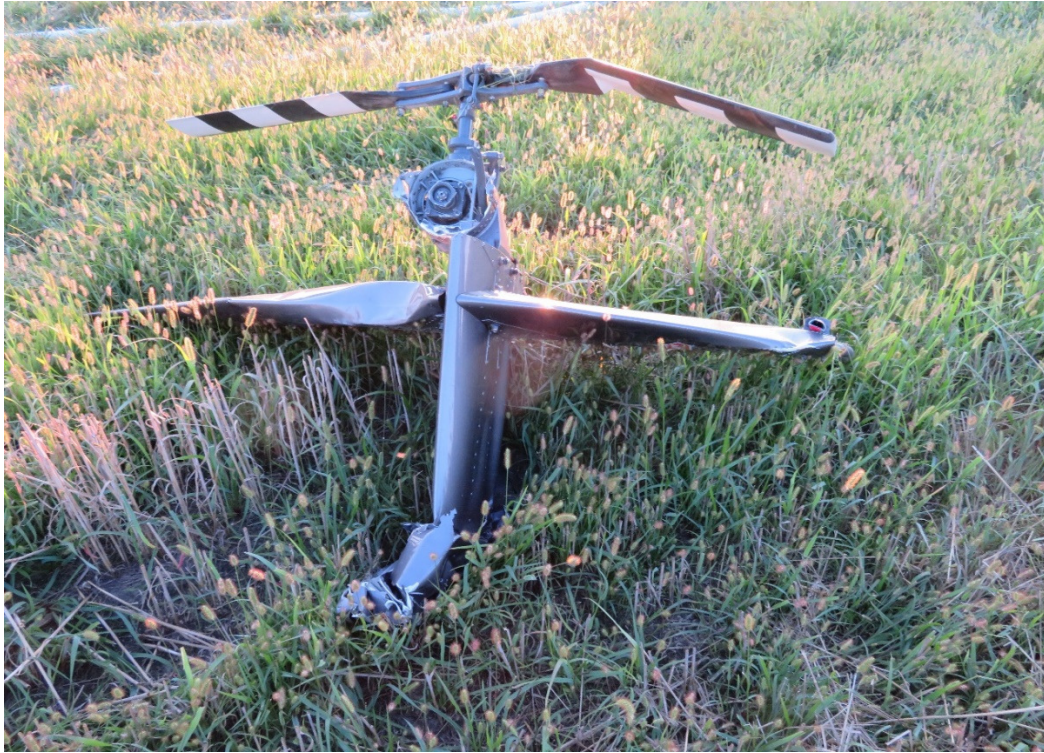
Fig. 3. Part of the tail boom with final drive and tail rotor

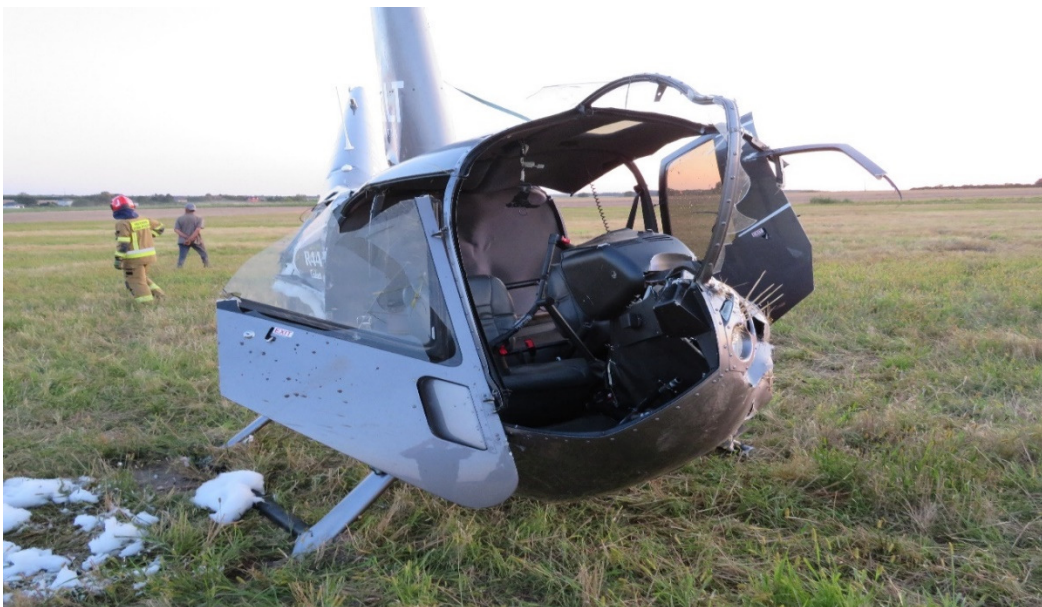
The helicopter was destroyed. All helicopter damage was caused by its collision with the terrain. There was no other visible damage (including visible engine and drive train damage), which could have occurred earlier. The damage is shown in figures 4, 5 and 6.

Fig. 5. Deformed right side of the helicopter cabin

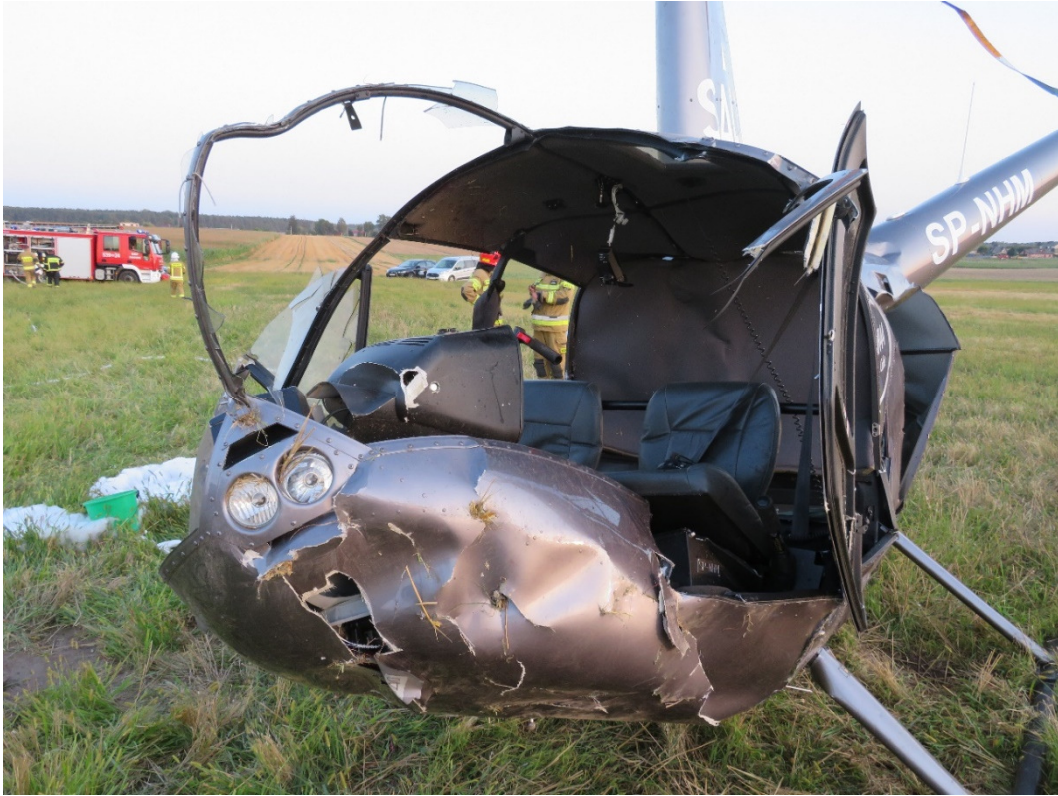
Fig. 6. Deformed left side of the helicopter cabin
