# FINAL REPORT

## 2024-0070

AK1-3 helicopter, SP-HLLI

25 August 2024, Łosiewice, near Łochów

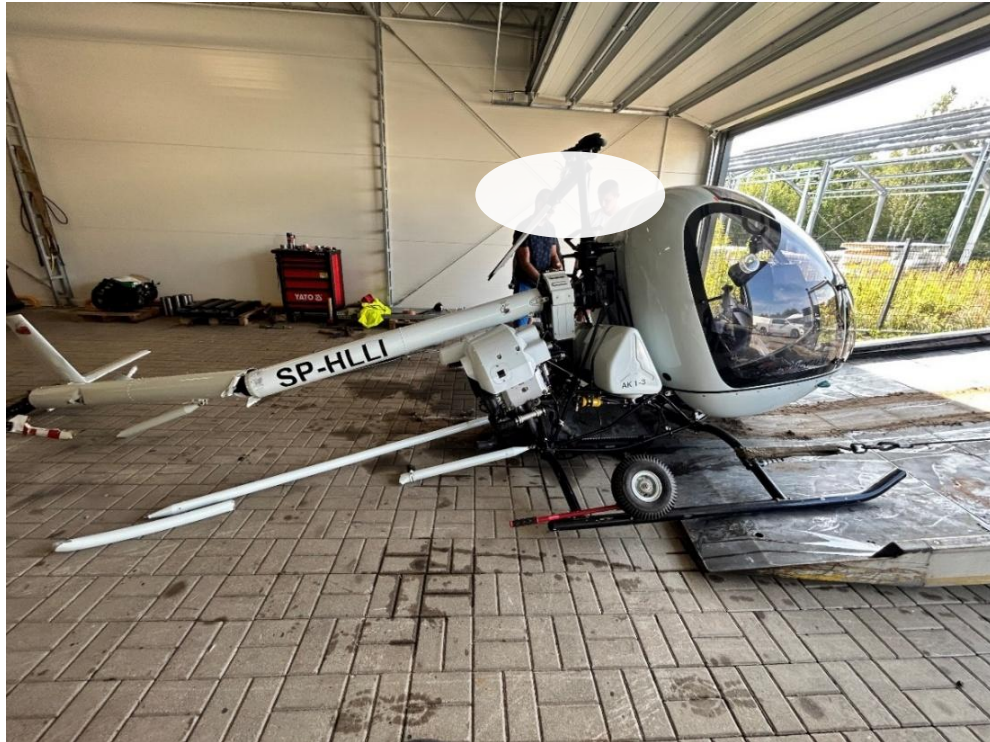
- broken tail boom;
- broken main rotor blades;
- damaged tail rotor;
- broken cockpit glazing;
- damaged landing gear.

Fig. 2. Damaged helicopter [source: helicopter owner]

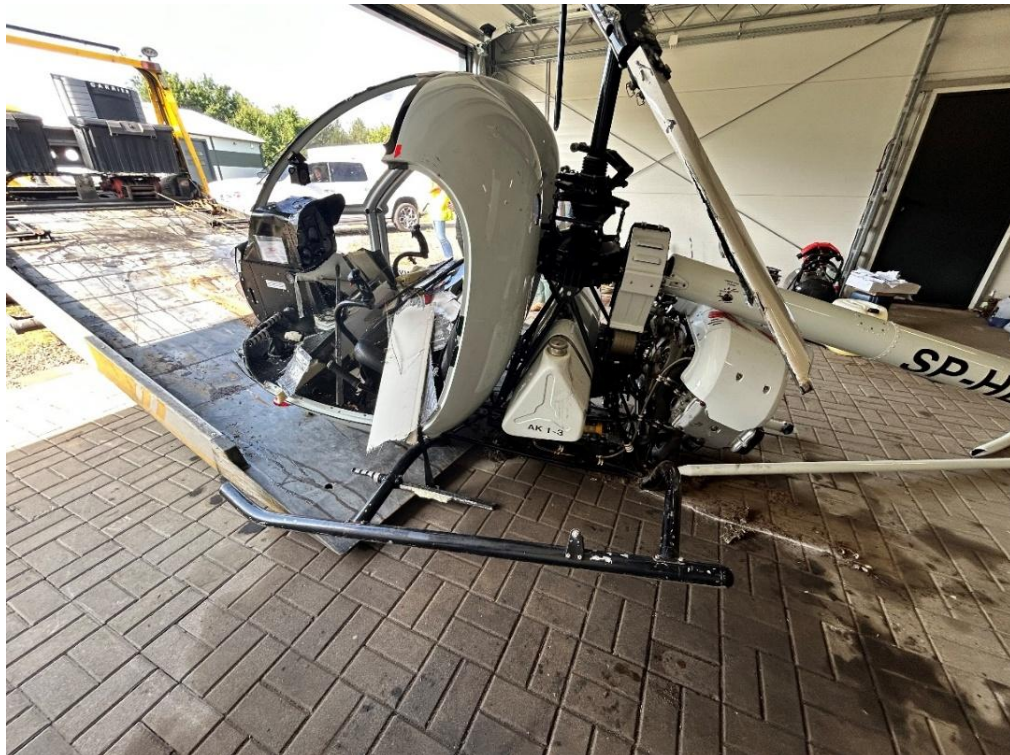
Fig. 3. Damaged helicopter [source: helicopter owner]

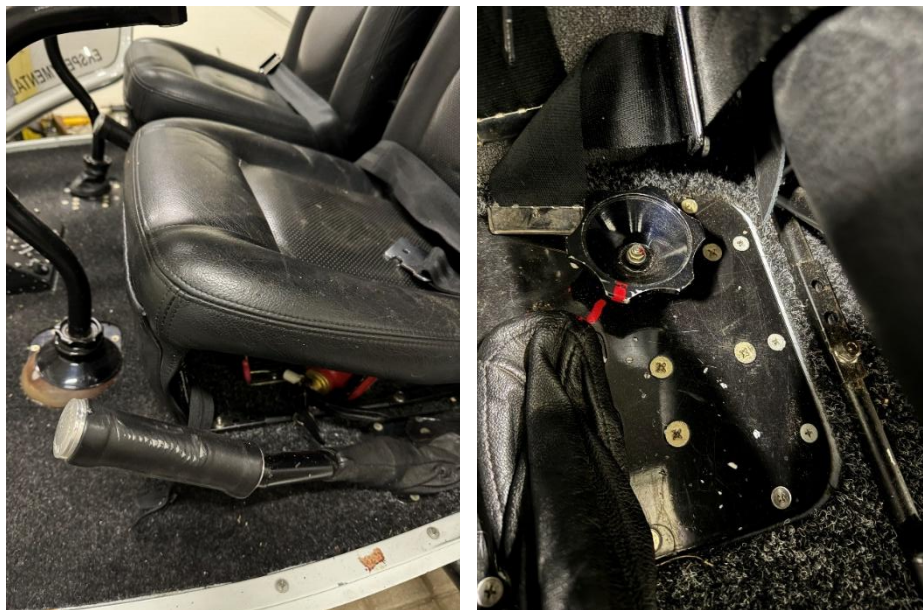
The series of events leading up to the accident began with the pilot releasing the lock on the collective control. At the base of the lever is an adjustable knob that tightens the friction lock (Fig. 4). When adjusted correctly, it prevents the collective pitch angle from changing inadvertently during the flight, whilst still allowing the pitch to be adjusted during manoeuvres. From practice, the control cannot be locked too tightly, as it would make it difficult, among others, for autorotation to occur in the event of an engine failure. In accordance with the pilot's operating handbook, the lever lock must be checked and adjusted before take-off. Any unlocking should be smooth and in small movements to prevent the collective from moving uncontrollably. It is worth noting here that the lock knob is at the base of the control, so the lever has to be released when adjusting the knob. In the case at hand, when the lock was released, the collective control dropped inadvertently, causing an unplanned reduction in the collective pitch to the minimum. As a result, the thrust of the main rotor decreased suddenly and triggered an accelerated descent. The reduction in collective pitch also brought about a reduction in the main rotor drag torque and a resulting increase in the rotor's rotational speed.

Fig. 4. The collective (on the left) and the lock knob (on the right)

- (1) The friction lock on the collective was incorrectly adjusted.
- (2) The excessive loosening of the friction lock on the collective brought about an uncontrolled collective pitch reduction.
