PRELIMINARY REPORT

State Commission on Aircraft Accidents Investigation

2024-0073

EC 120B helicopter, SP-PBW

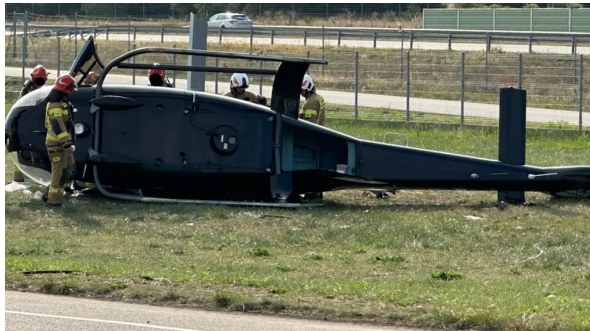
Fig. 2. EC 120B wreckage (source: private person)

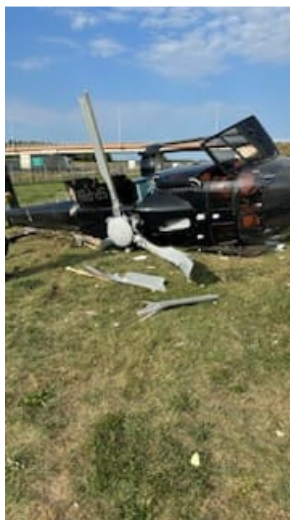
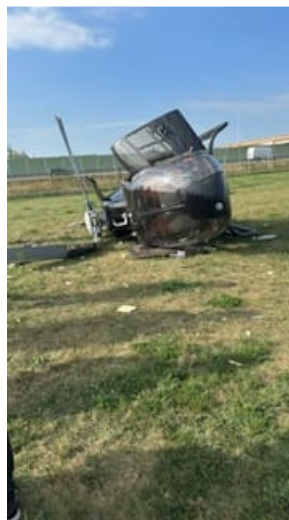
Fig. 3 and 4. EC 120B wreckage (source: private person)

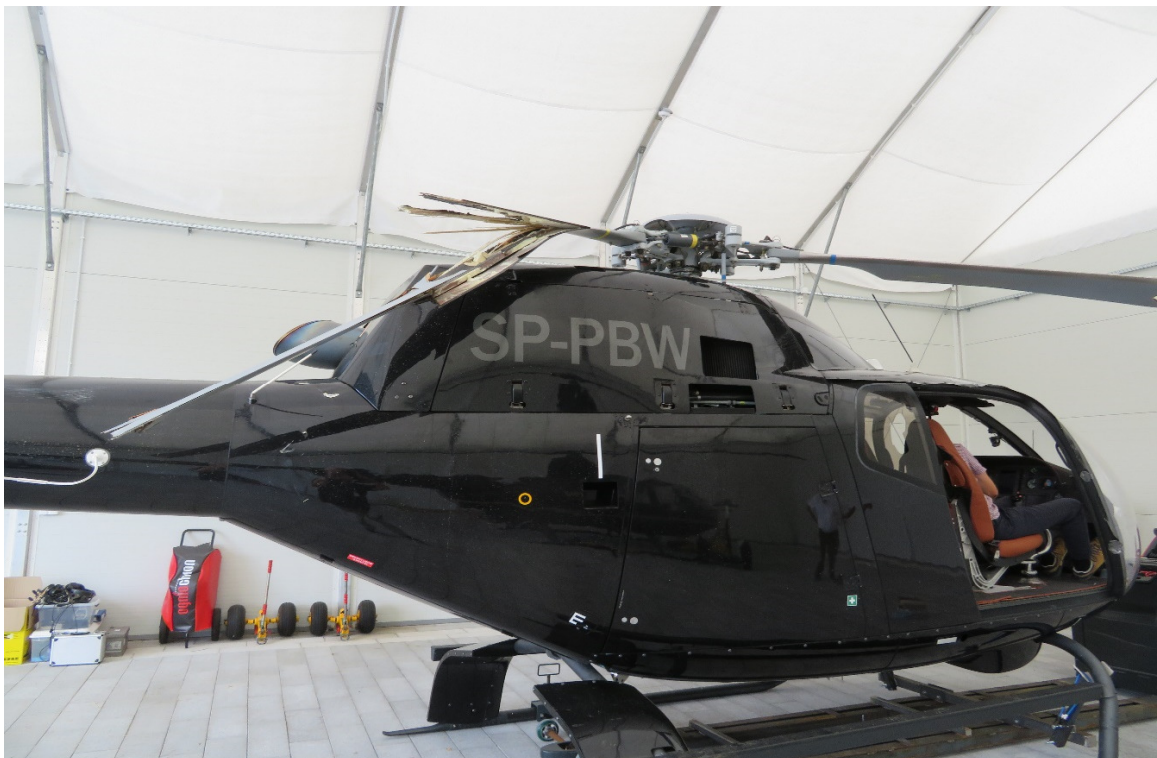
The helicopter was destroyed. All damage to the helicopter was a result of its fall over to the right side and collision with the ground. There was no other visible damage, including engine and drive train damage, that could have occurred before the accident. The main damage of the helicopter was shown in Figures 5 and 6.

Fig. 5. Damage to the main rotor hub, main rotor blades and fuselage.

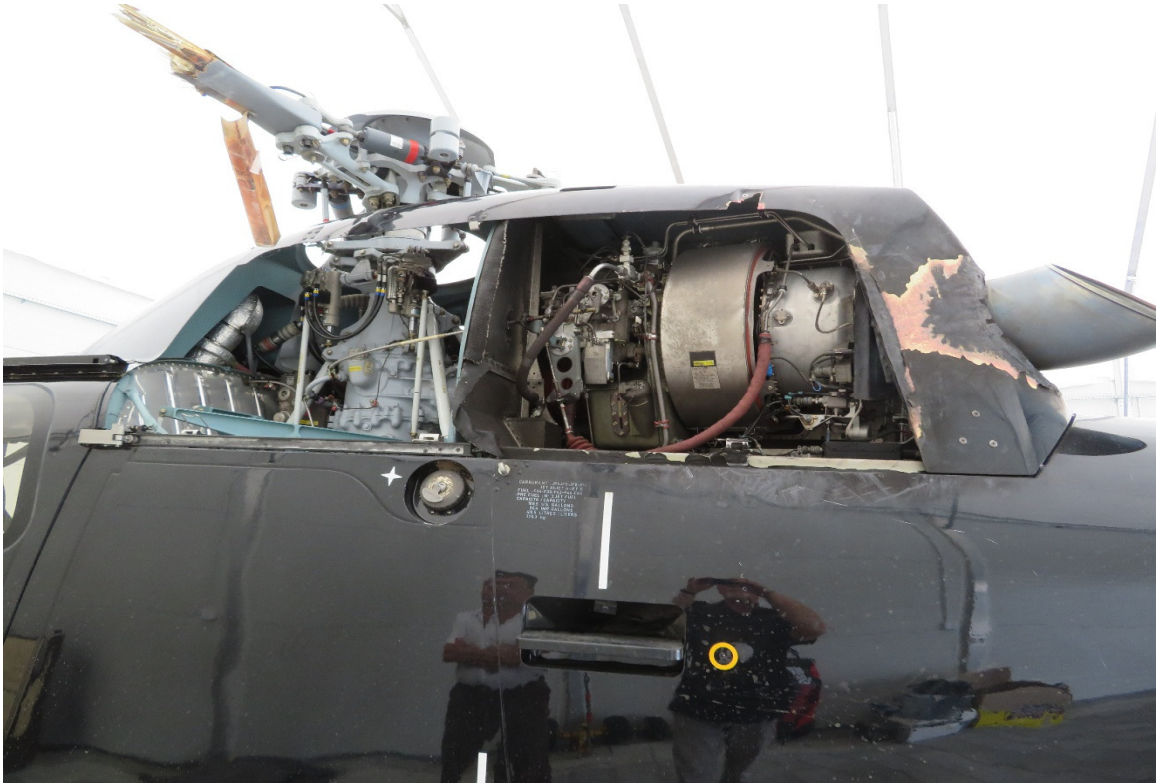
The pilot stated that he set the GRIP to the marker and applied idle and began to start the engine. According to the pilot's statement, at the moment of start-up, "flames erupted" and then there was a rapid increase of temperature to about 1100 degrees. A moment later, the pilot felt a large vibration of the helicopter and after 2-3 seconds the helicopter fell over to the right side. The pilot could not remember that phase of the occurrence. He only remembered the high temperature and quite intense vibrations of the helicopter.

Fig. 6. Visible thermal changes on the fuselage after the hot engine start.
