PRELIMINARY REPORT

State Commission on Aircraft Accidents Investigation

2024-0074

Cessna Aircraft Company

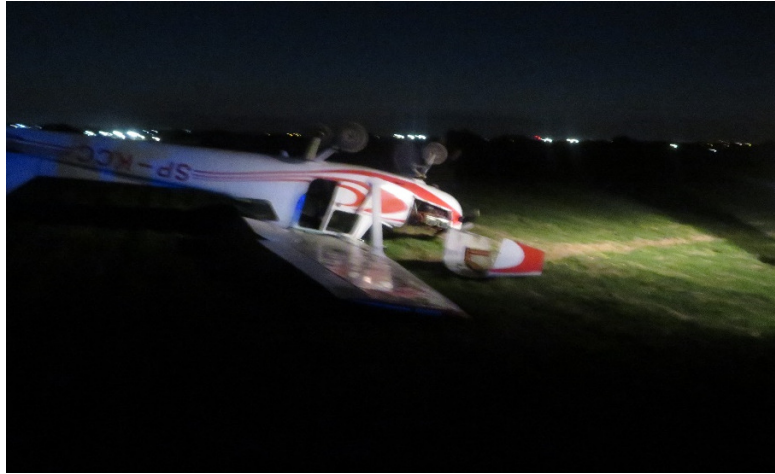
As a landing area, the student chose a field covered with short grass and plants. Wanting to avoid a small elevation, he landed the aircraft abeam to the left, while at the same time he turned left and applied brakes with maximum force. After contact with the ground, the aircraft covered a distance of about 80 m and overturned (Fig. 1).

Fig. 1. The aircraft after overturn [source: SCAA]

The wings (deformation of: front and rear spars, ribs, leading edge nose covering), propeller and vertical stabilizer and rudder were damaged.

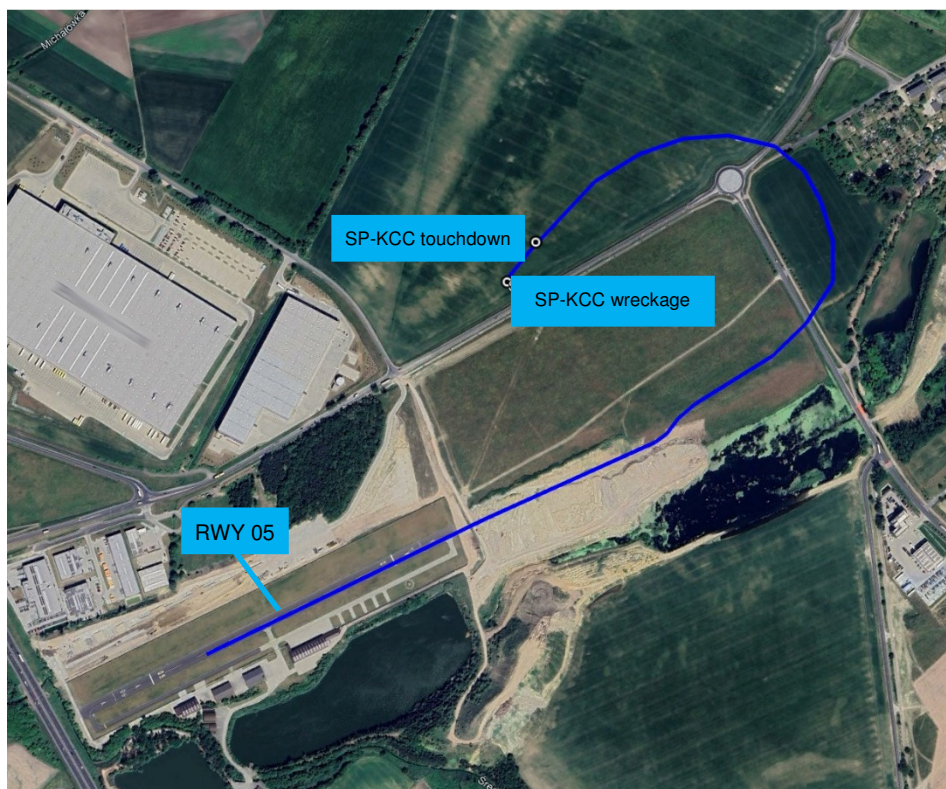
Fig. 2. The flight path of the aircraft from take-off to the point of collision with the ground [source: SCAA]
