FINAL REPORT

State Commission on Aircraft Accidents Investigation (PKBWL)

OCCURRENCE NO – 2021/0289

AIRCRAFT – TECNAM P2008-JC, SP-LFD, BOEING 737-800, SP-RKG

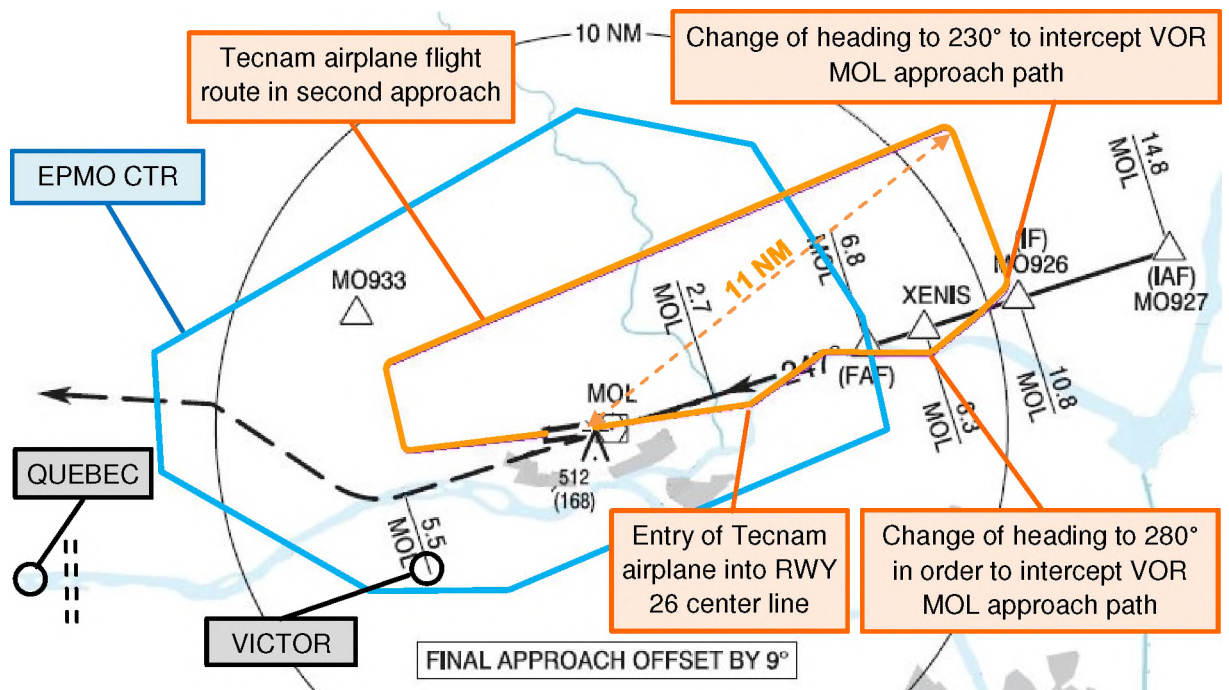
Fig. 1. Sketch of the flight route of SP LFD aircraft during the second landing approach on the EPMO aerodrome [source: PANSa, PKBWL]

instructed the student to descend to 3000 ft AMSL. When the Tecnam was at bearing of 51° at a distance of 11 NM from the RWY 26 threshold, APP ATC instructed the student to turn to the heading of 160°. The student was flying with the ordered heading at 2800 ft AMSL instead on of the ordered 3000 ft AMSL.

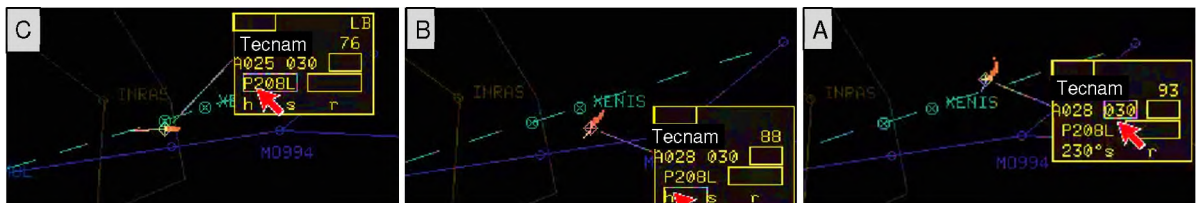
When the Tecnam was at bearing of 66° at a distance of 11 NM from the RWY 26 threshold, APP ATC instructed the student to make a turn to a heading of 230° for an approach according to VOR to RWY 26 (Figure 2 A). While monitoring the flight of the Tecnam, APP ATC determined that it crossed the approach path and continued the flight with the heading of 230°. When asked by APP ATC, the student replied that he had not intercepted the approach path yet. APP ATC said that according to the radar, the Tecnam was located south of the final approach path and instructed the student to make a turn to a heading of 280° (Figure 2 B), which once again allowed the student to intercept the approach path according to the VOR. At that time, the Tecnam was approximately 8 NM from RWY 26. Approximately 7 NM from RWY 26, the student began a descent. The APP ATC asked the student whether he was stabilized on the approach path. Upon confirmation, the APP ATC instructed the student to establish communication with the EPMO TWR (Figure 2 C).

Fig. 2. Screenshots of PEGASUS_21 system at the APP ATC workplace at the time of:
A - change the heading to 230°,
B - instruction to change heading to 280°,
C - confirmation of stabilisation according to VOR,
[source: PANSAs]

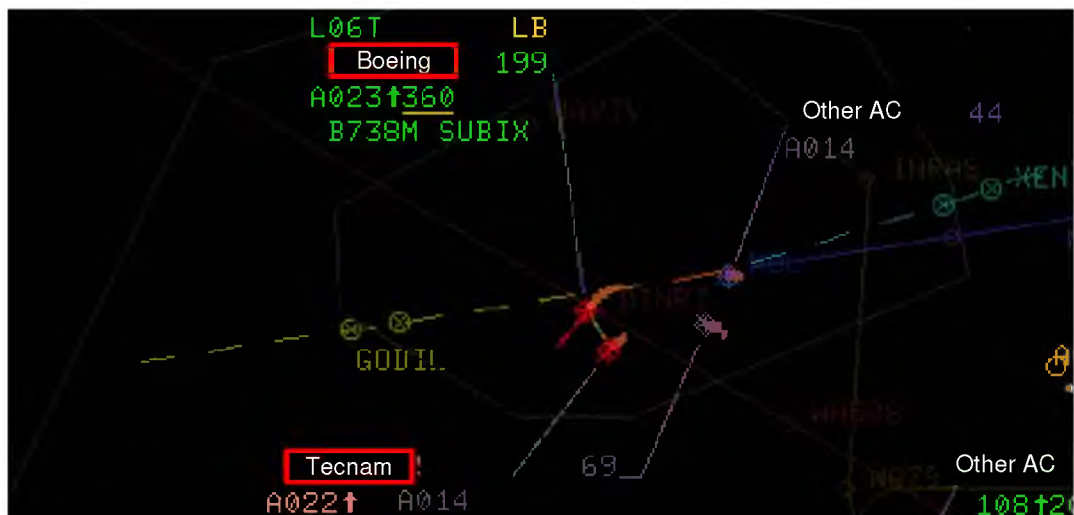
Fig. 3. Screenshots of PEGASUS_21 system at the APP ATC workplace during the proximity of Tecnam and Boeing aircraft (aircraft descriptions changed) [source: PANSA]

The APP ATC cleared the Boeing crew to fly direct to the SUBIX waypoint. At the time of giving this clearance, at 12:17:04 hrs, a warning about proximity of the two aircraft appeared on the PEGASUS_21 APP ATC screen.

The minimum recorded horizontal distance between the aircraft was 1.29 NM when the aircraft were at an altitude of about 2300 ft AMSL in the Warsaw TMA. Required separations (in Class C airspace) were at least 5 NM horizontally and 1000 ft vertically. The proximity occurred below the designated MVA in Sector 03 of TMA Warsaw, which is 2600 ft AMSL.

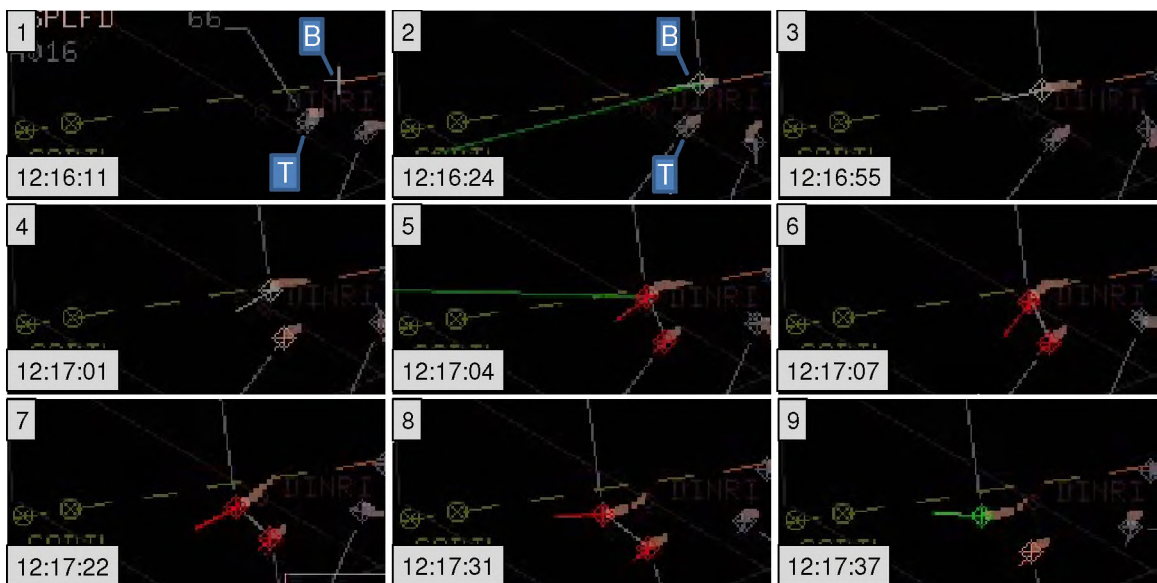
Fig. 6. Course of aircraft proximity, T - Tecnam, B - Boeing [source: PANSA, PKBWL]

At 12:16:54 hrs, the Boeing aircrew established communications with APP ATC. At that time, the Tecnam was on a climb at an altitude of 2,000 ft AMSL and was entering Warsaw TMA without clearance. When APP ATC finished communicating the updated clearance to the Boeing aircrew, they were already executing a left turn in accordance with SID LOLSI-2J. At 12:17:04 hrs, a warning about the dangerous proximity of the two aircraft appeared on the screen. When the Boeing made a right turn and the Tecnam began its descent, the conflict situation ended. The APP ATC did not inform the Boeing crew about the proximity.
