PRELIMINARY REPORT

from the investigation of a serious incident

2024-0096

Robinson R44 II helicopter, SP-CBW

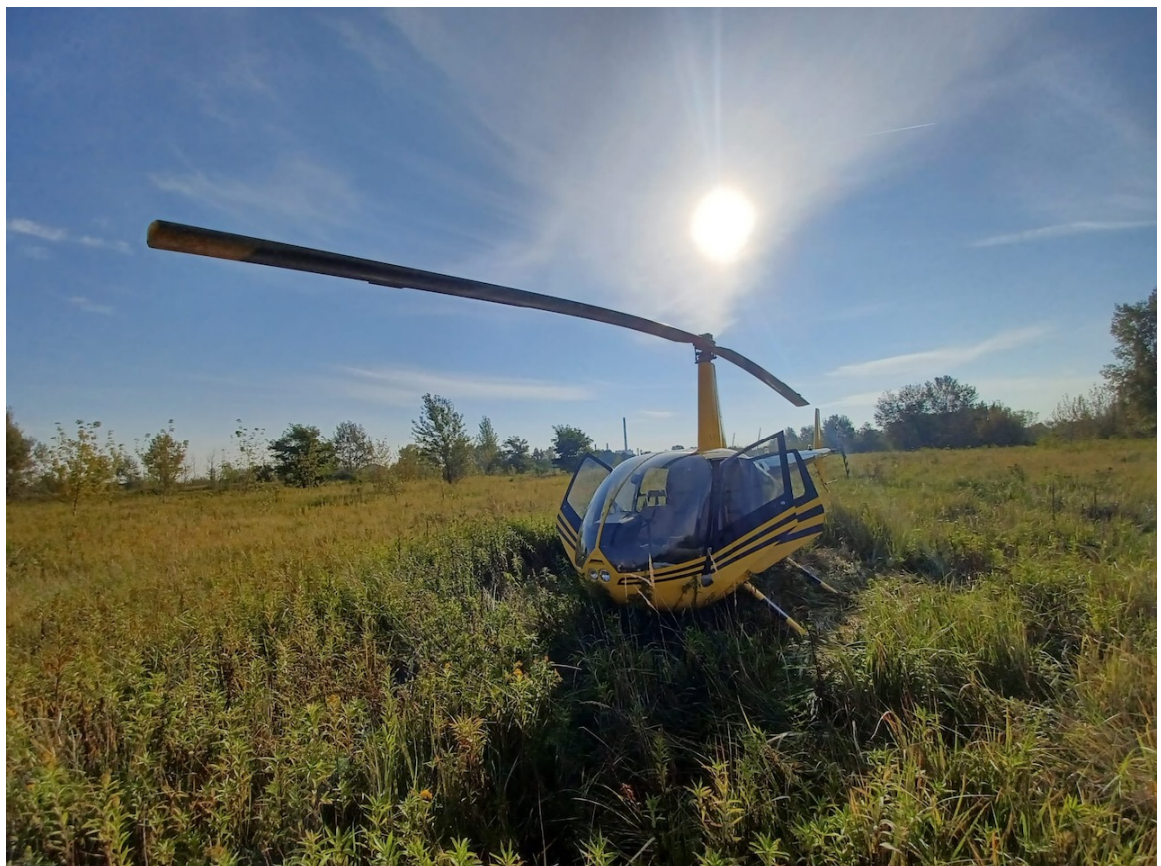
Fig. 2. Emergency landing site of the R44 II helicopter, SP-CBW. (source: photo of the pilot).

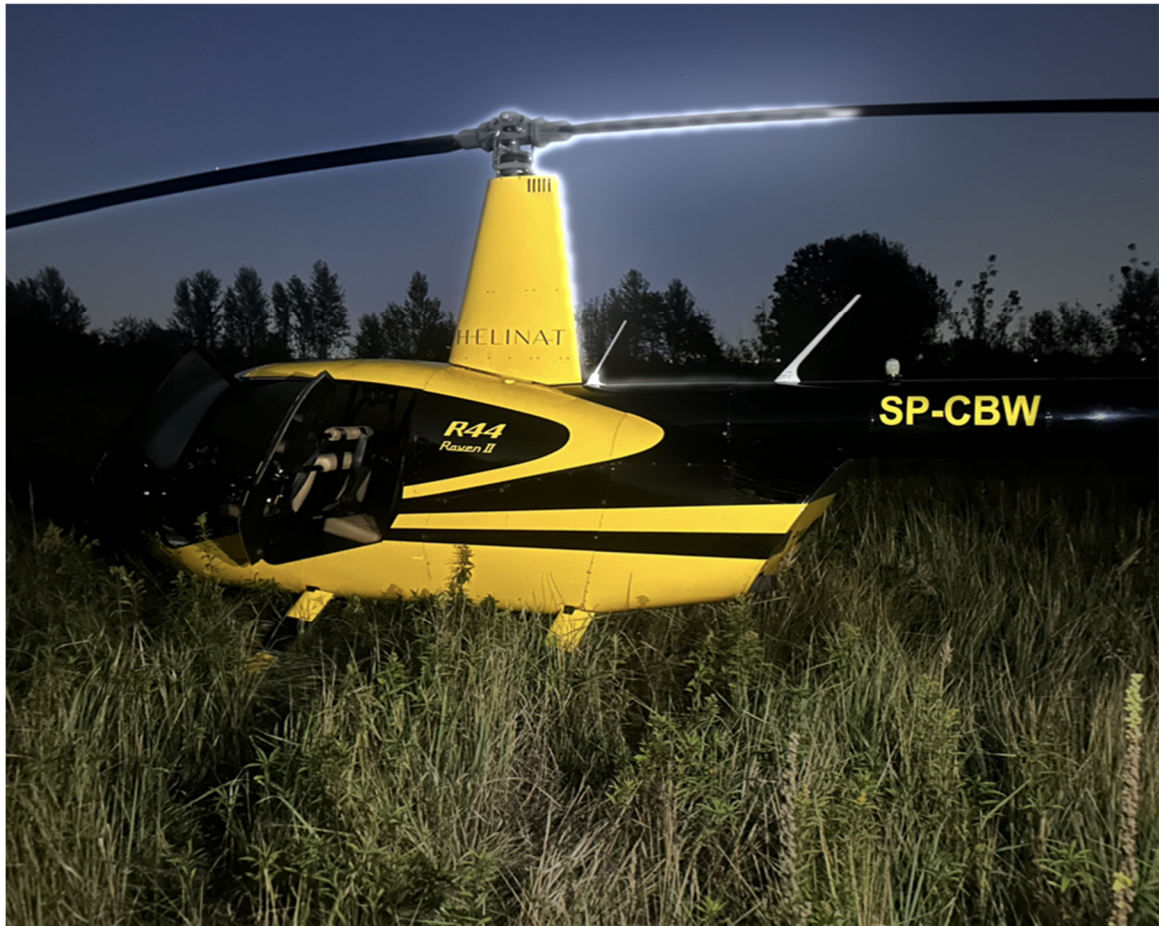
Fig. 3. Emergency landing site of the R44 II helicopter, SP-CBW. (source: photo of the pilot).
