PRELIMINARY REPORT

State Commission on Aircraft Accidents Investigation

2024-0138

Reims Aviation S.A., Cessna FA150L, SP-KIK

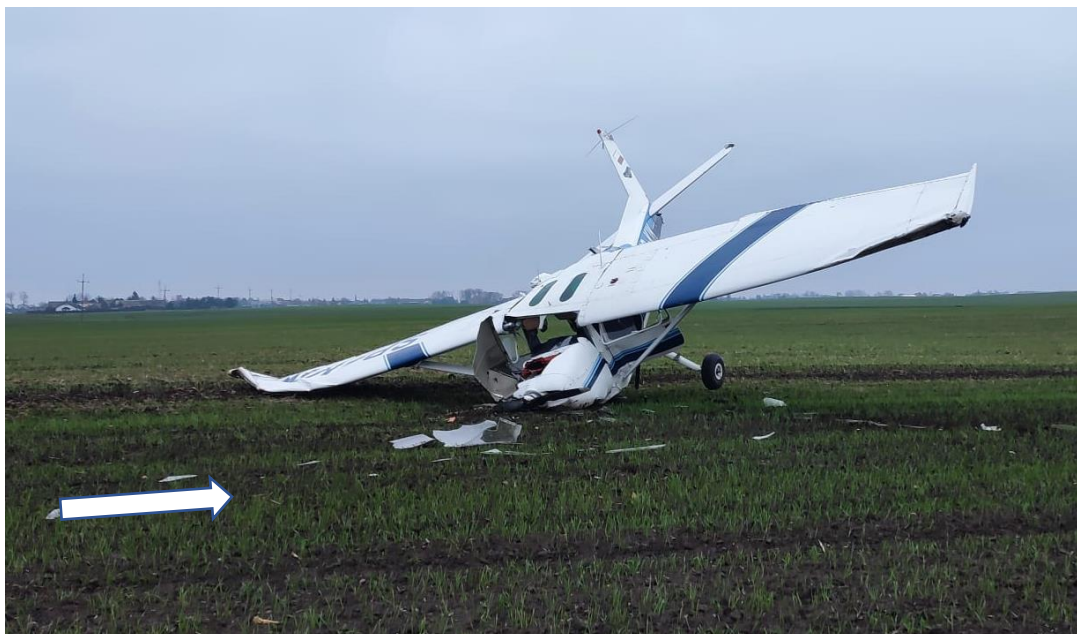
The aircraft stopped in the distance of 26 m behind power line, rotated about 140° - 160° versus take-off direction, with the pitch angle of about 35° nose down. The crew left the aircraft unaided

Fig. 1. Cessna-150 SP-KIK at the site of accident. The white arrow indicates take-off direction

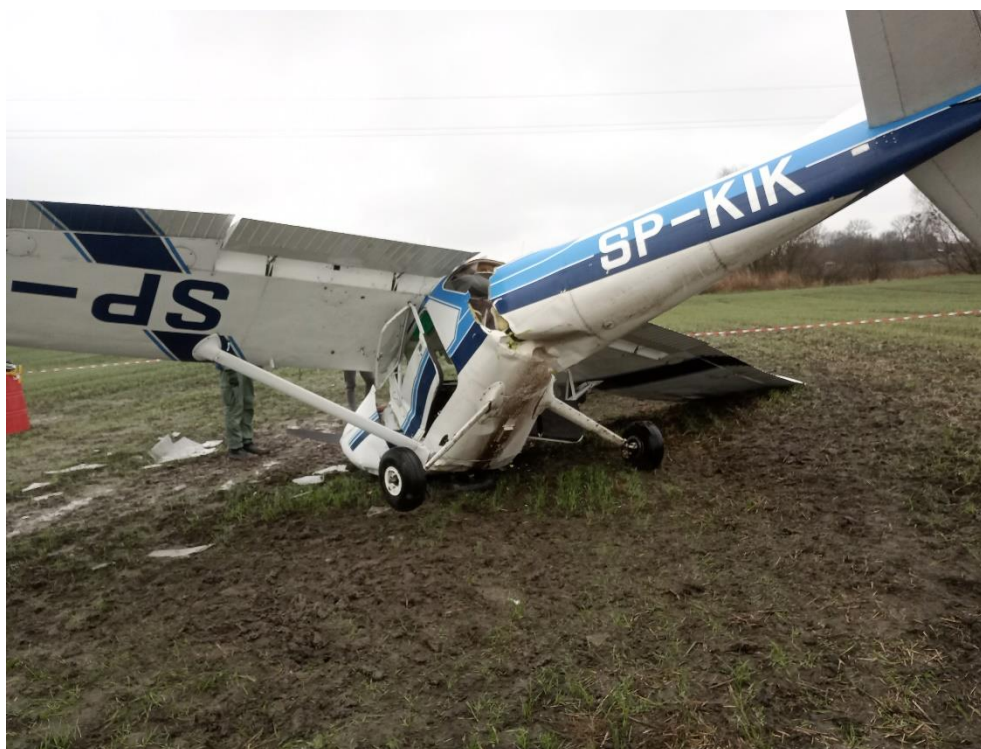
Rys. 1. Breaking of the fuselage behind the cockpit

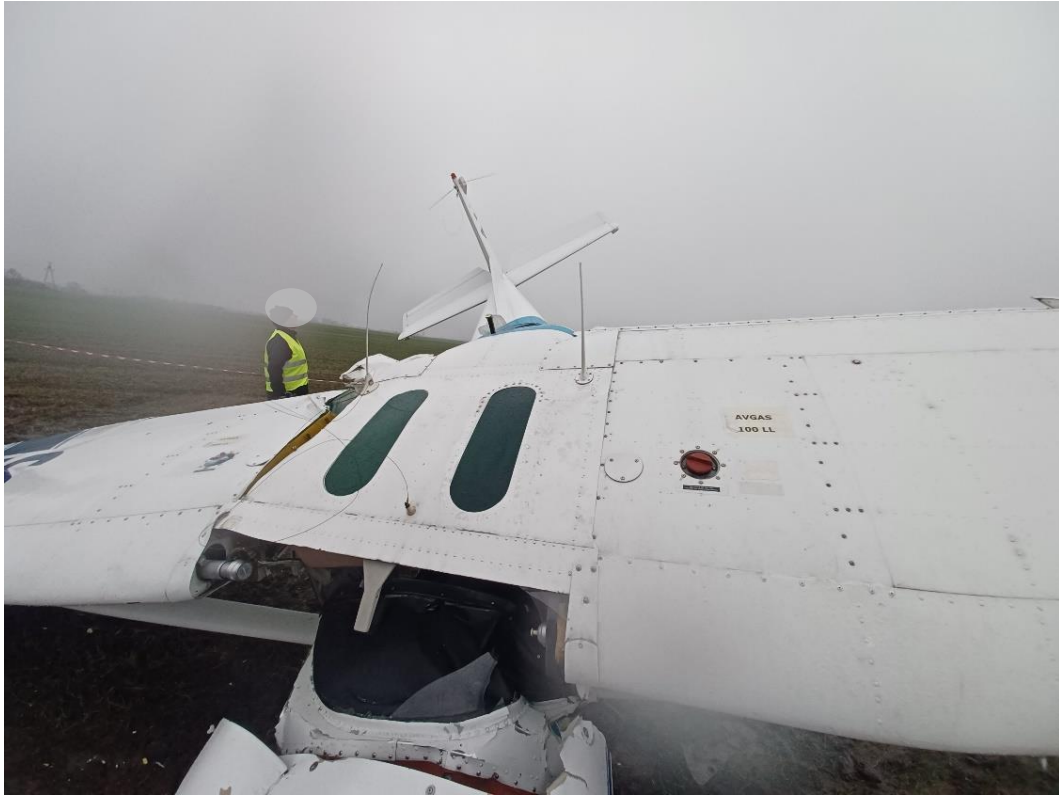
Rys. 2. Damage of the starboard wing fittings

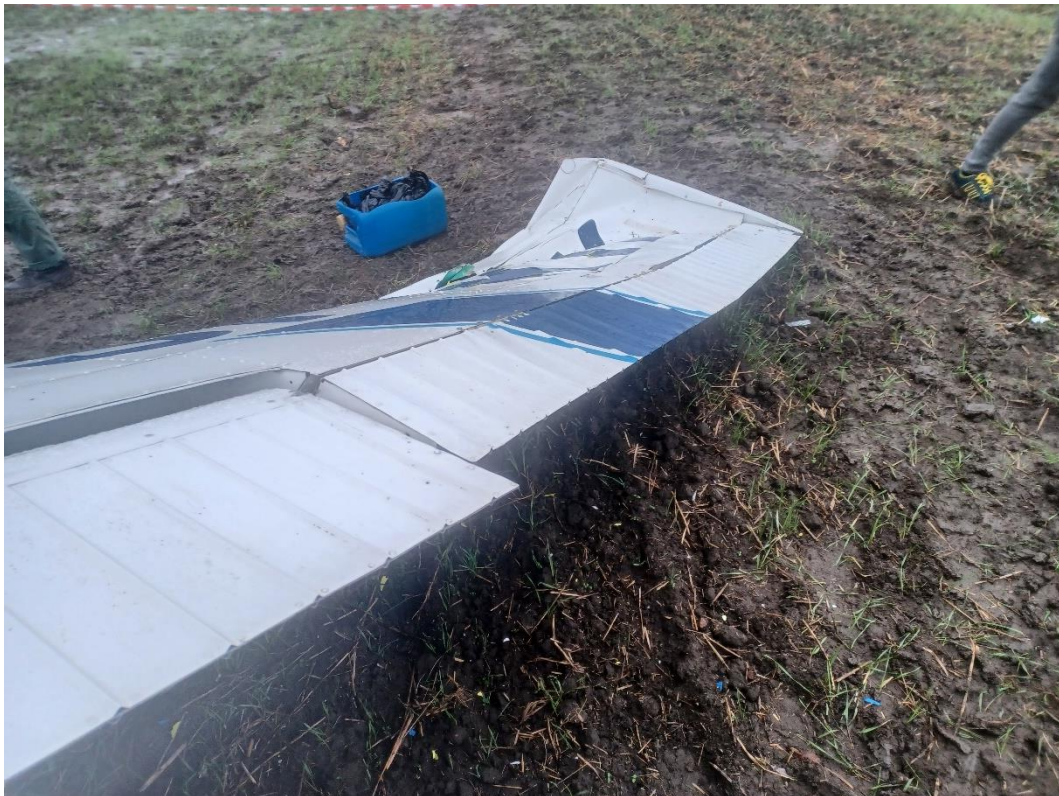
Rys. 3. Bending the outer part of the starboard wing (about $\frac{1}{2}$ of the aileron span), from the leading edge

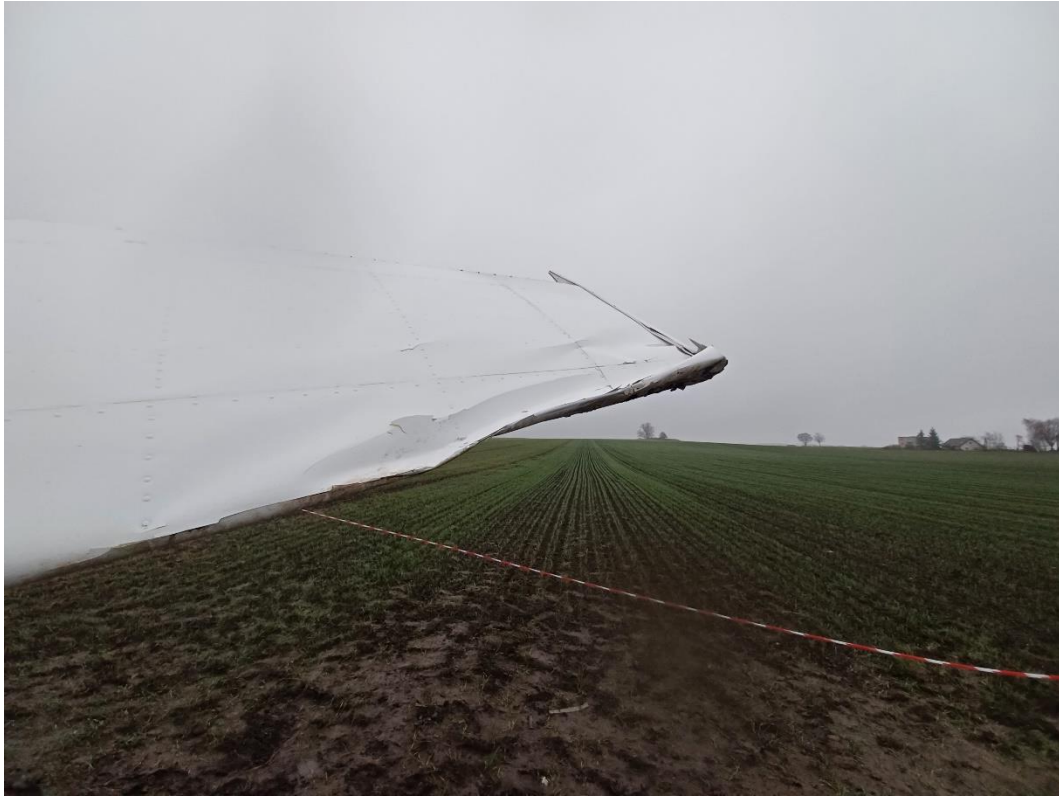
Rys. 4. Crumple of the port wing leading edge

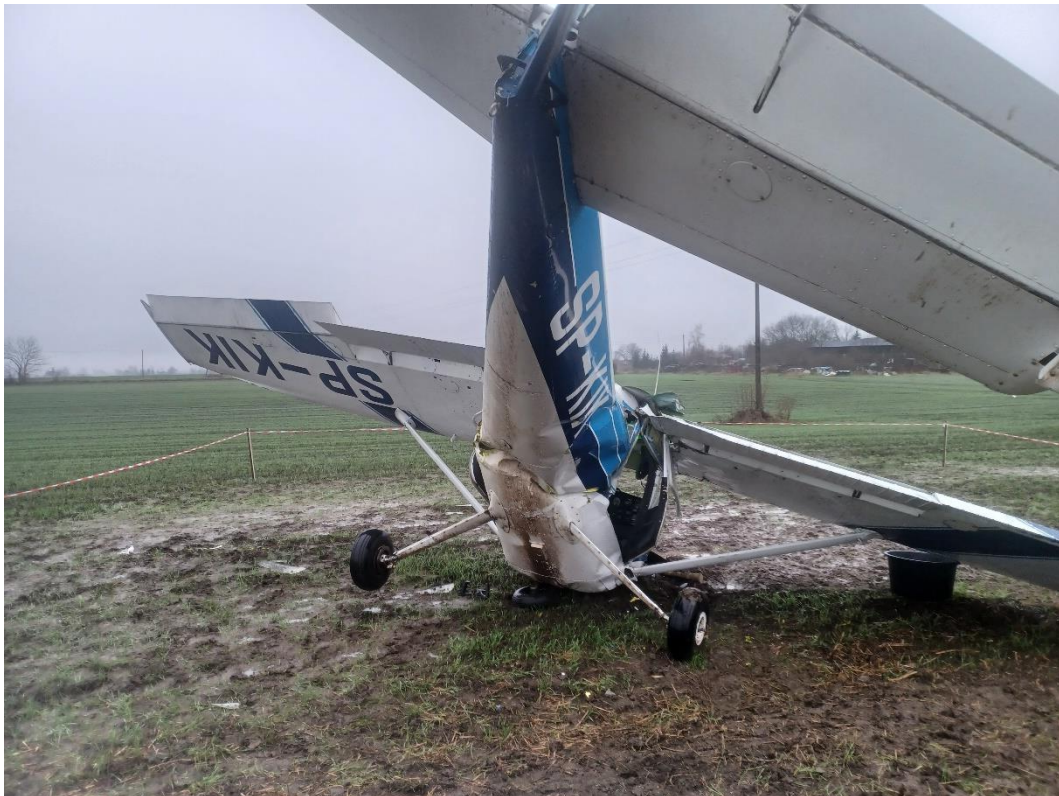
Rys. 5. Bending of the fuselage seeing from the compressed (crumpled) side. Notice the broken down leg of front landing gear below the fuselage and damaged mounting of the starboard wing.

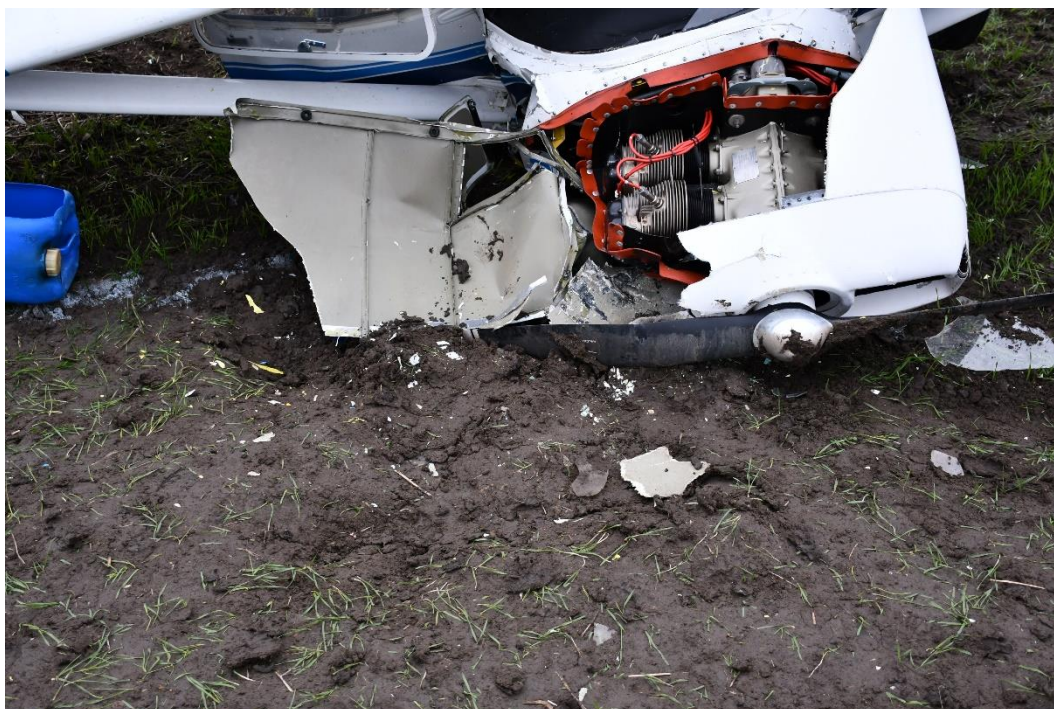
Rys. 6. The propeller bent along the shaft axis. Engine cowlings were destroyed during rescue operation (to disconnect electric installation)
