# RESOLUTION

regarding the aviation incident

## 2025-0001

Tecnam P2006T, SP-SUT  
17.02.2025, Gliwice

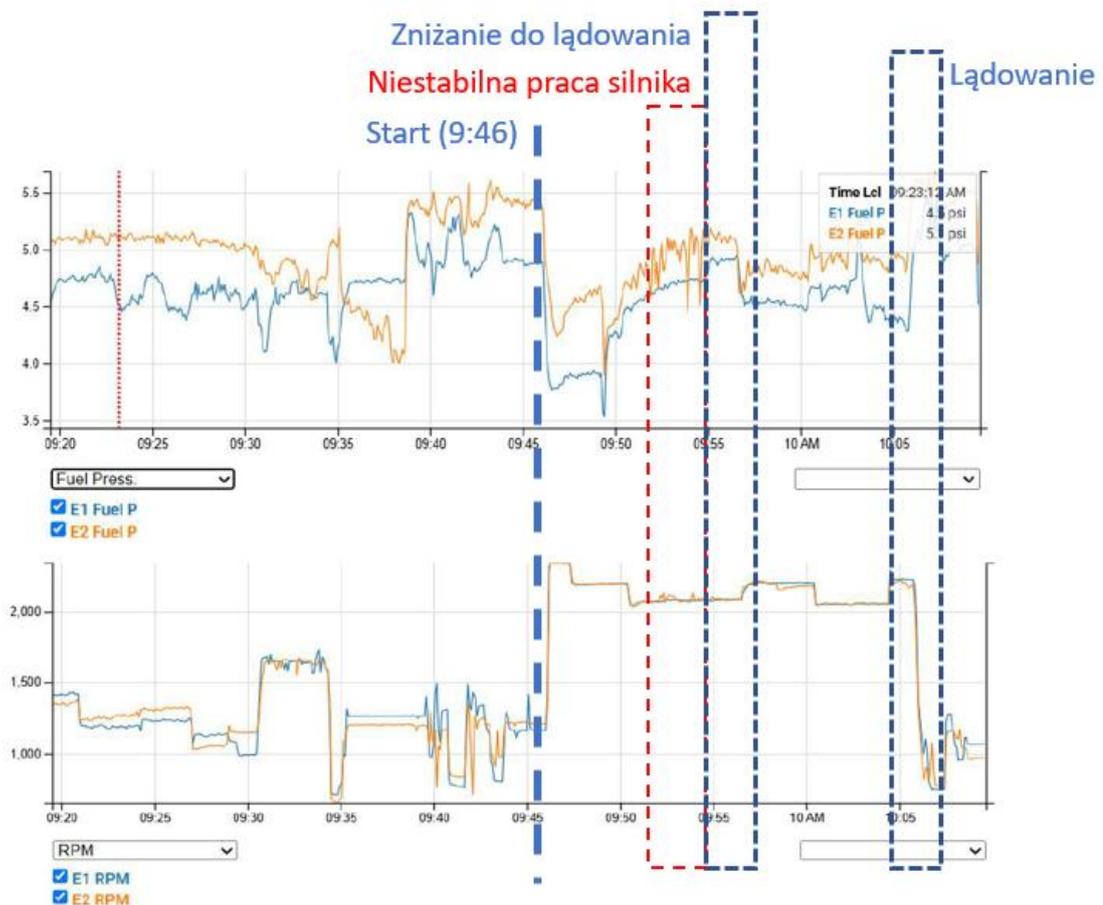
At around 9.52 a.m.,<sup>1</sup> while flying over Gliwice, the right engine started to malfunction. The crew observed unstable readings on the right engine tachometer, which was showing alternating dips and rises. In this situation, the instructor decided to turn back towards the EPGL airport and prepare for landing. During the approach, after the flight has been stabilised, the instrument readings returned to normal. In this situation, the instructor changed the decision. The crew aborted the approach, intending to continue with the originally planned task (flight in the vicinity of the airport to familiarise with the aircraft). However, already during the climb, at around 9.57 a.m., unstable right engine RPM readings occurred again. In addition, the crew noticed that the fuel gauge of the right tank was showing zero. In this situation, the instructor again decided to abort the task and return to the EPGL airport.

Figure 1. Engine performance parameters: fuel pressure (top graph) and RPM (bottom graph), recorded by the Garmin G1000 system [source: user]

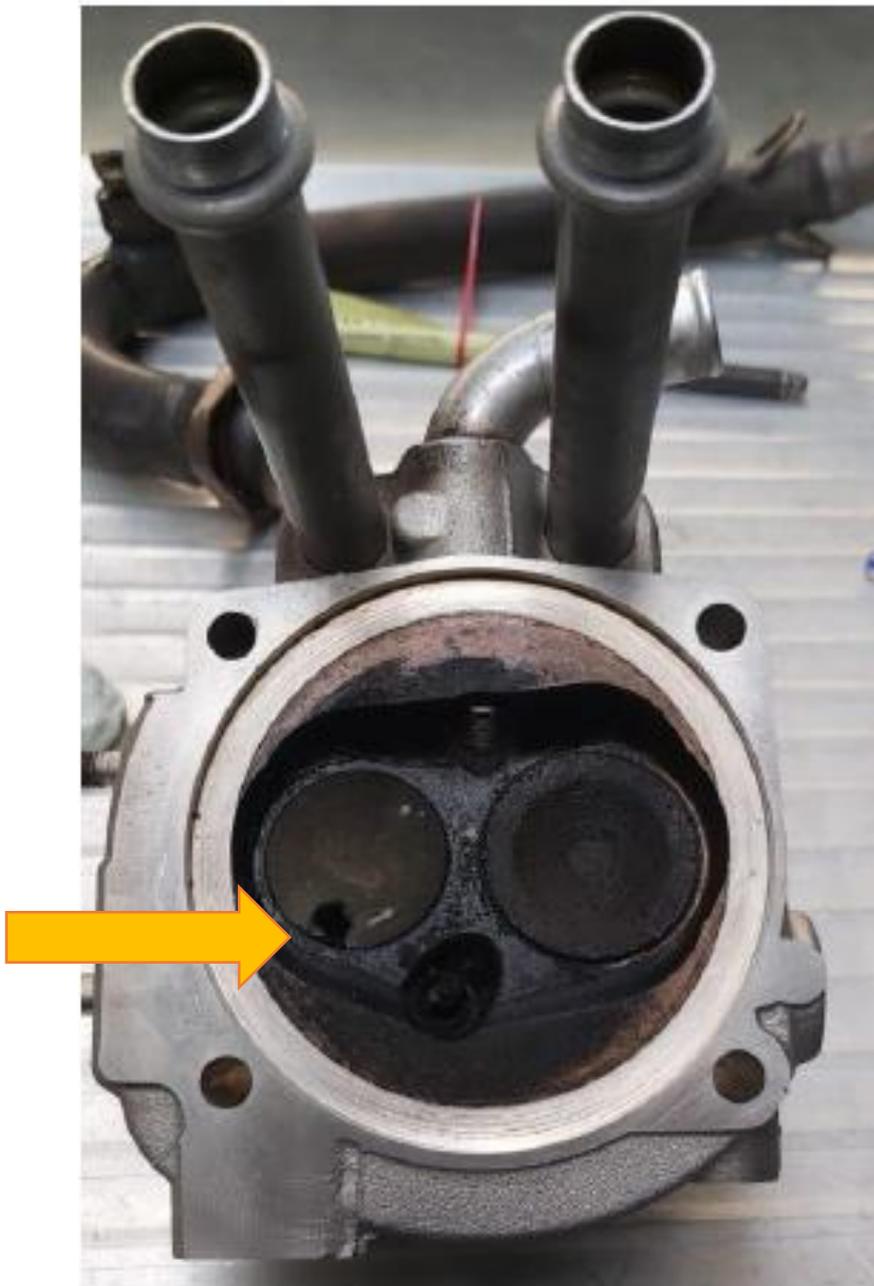
After the occurrence, the visual inspection of the aircraft was performed, revealing a burned-out exhaust valve of the right-engine cylinder no. 2. In addition, the fuel level sensor of the right tank was found to be malfunctioning. This fault caused erroneous readings of the fuel gauge. This was not linked to the engine malfunction – the tank was filled with fuel during the flight.

Fig. 1. Head of the right-engine cylinder no. 2. Visible burnout of the exhaust valve.

The unstable operation of the engine was caused by pressure fluctuations in cylinder no. 2, which occurred after the exhaust valve had burned out. Presumably, this fault was due to the exhaust gas temperature (EGT) being too high during engine operation. The operation of the valves under such conditions led to excessive oxidation of the valve material and, ultimately, to valve burnout.

As there was no EGT monitoring sensor, the crews operating the aircraft were unable to control the performance of the power unit in an optimal manner.

- the exhaust and intake valves in the head of the right-engine cylinder no. 2 were replaced;
- the fuel level sensor for the fuel gauge on the right tank was replaced;
- the maintenance organization was instructed to carefully monitor the level of carbon deposits in the cylinders, including to inspect valve condition during scheduled maintenance;
- the condition of the valves on the left engine (not damaged) was verified.
