FINAL REPORT

2025-0015

Reims Aviation S.A., F150M, SP-PIA

Gliwice, 16 April 2025

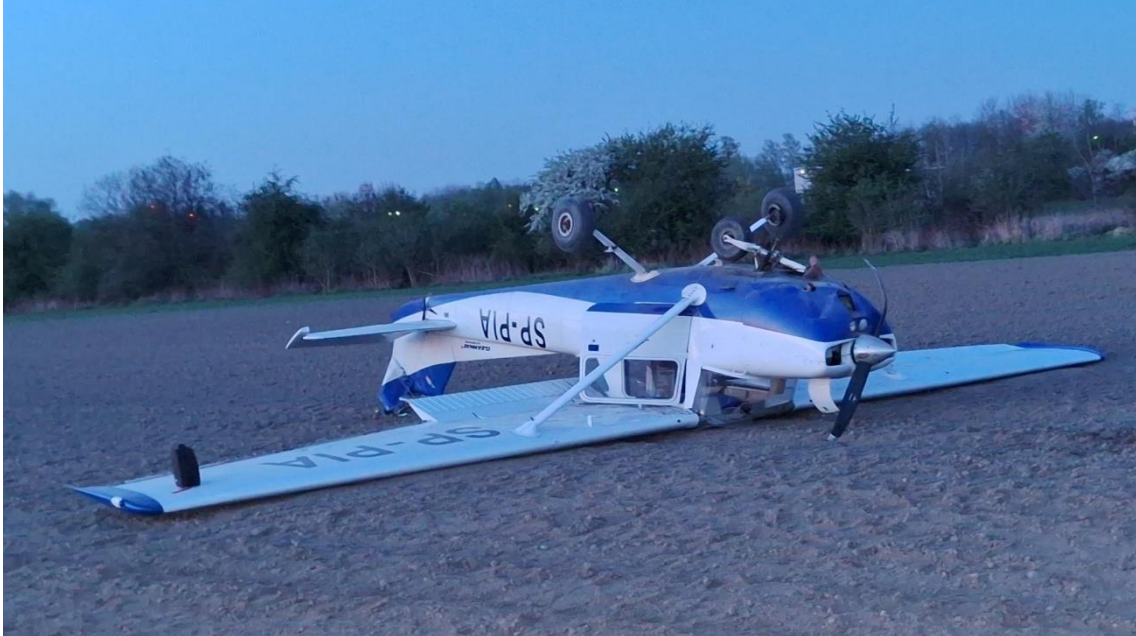
Fig. 1. Cessna F150M SP-PIA aircraft after the nose-over

The aircraft sustained significant damage. At the accident site, a broken nose landing gear leg, destruction of the vertical stabilizer along with the rudder, deformation (twisting) of the propeller blades, damage to the engine mount, dents and cracks in the engine cowling, and a shattered front cockpit windshield were observed.

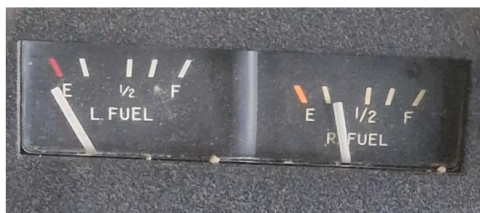
After draining all remaining fuel and switching the electrical power on, the right fuel gauge indicated a level above $\frac{1}{4}$ (Fig. 2).

Fig. 2 Fuel gauge indications of the aircraft on 17 April 2025 (with electrical power on), after fuel tanks were emptied. [source: FDA]

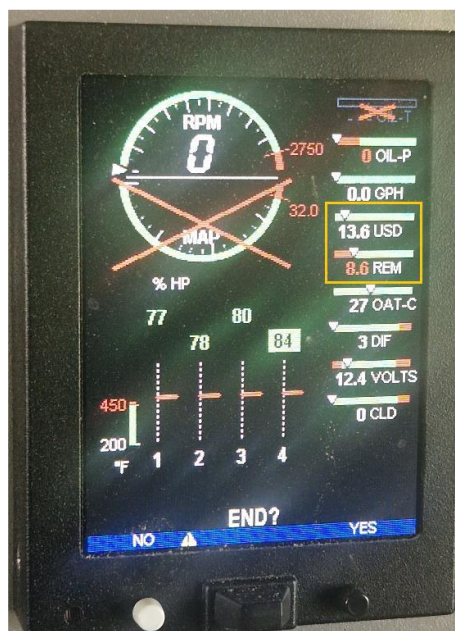
During the inspection, the EDM indicated 13.6 gal (approx. 51 L) of fuel used (Fig. 3 – USD) since the last refuelling, and 8.6 gal (approx. 32 L) of remaining fuel (Fig. 3 – REM). The possibility of incorrect updating of the fuel quantity in the EDM after the last refuelling was excluded (13.6 + 8.6 = 22.2 gal). It was confirmed based on the refuelling document that the amount of fuel added on 14 April 2025 was 58 L.

Fig. 3 EDM display indications (the remaining 8.6 gal of fuel is highlighted in orange) [source: FDA]
