PRELIMINARY REPORT

2025-0015

Reims Aviation S.A., Cessna F150M, SP-PIA

Gliwice-Trynek Airport (EPGL)
coordinates: 50° 16' 11.8" N, 18° 40' 20.6" E
16 April 2025

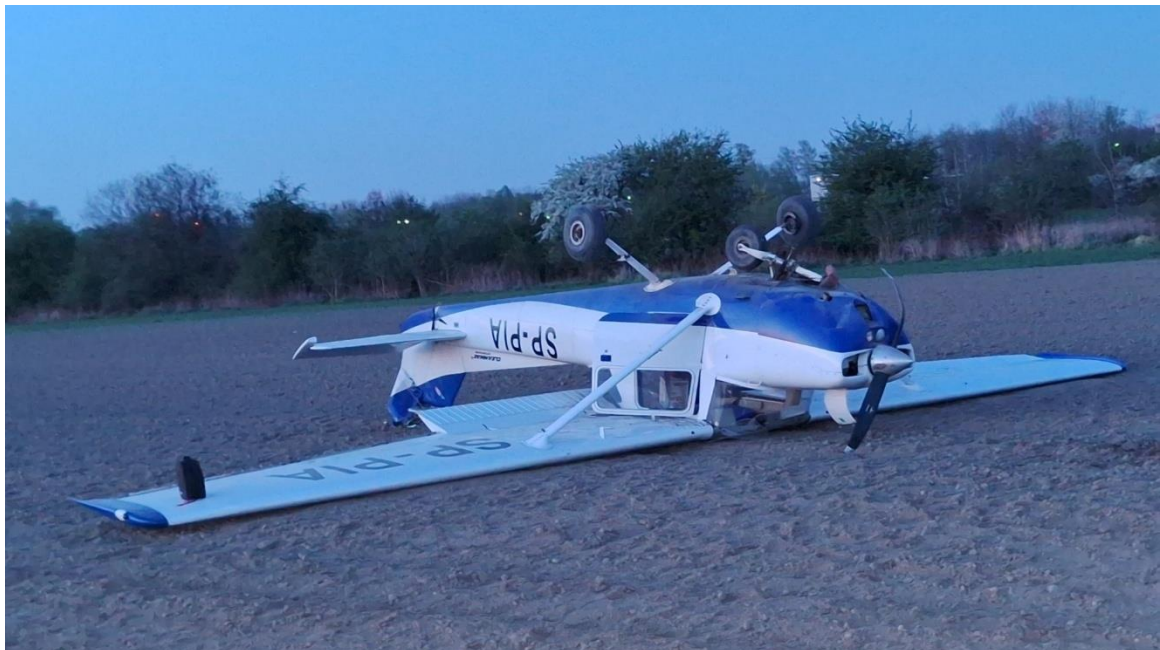
Fig. 1. SP-PIA aeroplane after landing in a field behind Gliwice-Trynek Airport
[source: PKBWL]

The aeroplane sustained significant damage. The following damage was found: broken landing gear strut, damaged vertical stabiliser and rudder, deformed propeller, damaged engine mount and bent engine cowling.
