PRELIMINARY REPORT

of the State Commission on Aircraft Accidents
Investigation

2025-0023

Konner s.r.l., Konner K1-S19 ultralight helicopter,
SP-HTMS

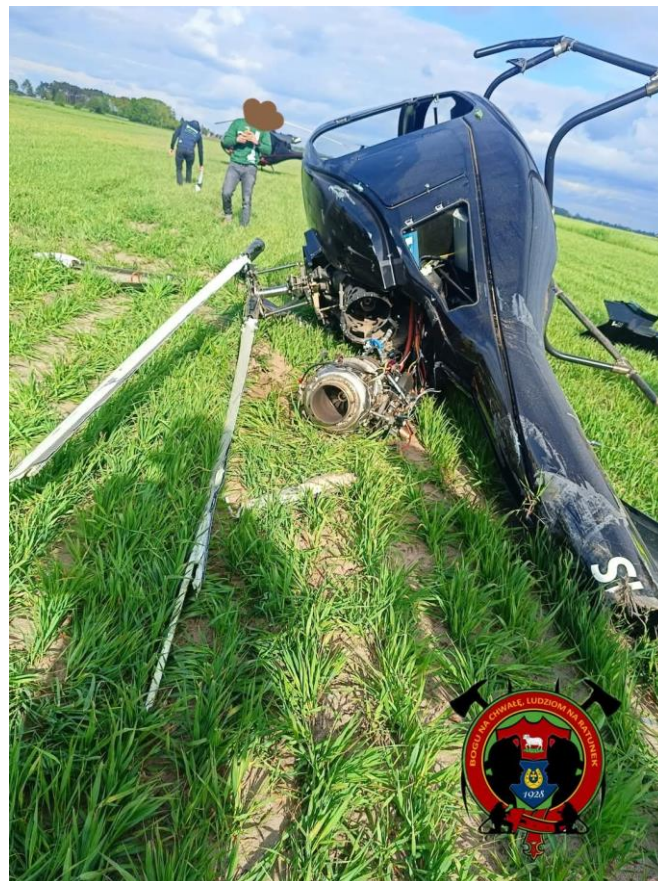
Fig. 1. SP-HTMS helicopter after landing in a field in Stopin near Sierpc [source: State Fire Service (PSP)]

The helicopter sustained significant damage due to the capotage. The tail boom was fractured, both the tail rotor and main rotor were destroyed, and the engine was torn from its mount. Additionally, the right-side cabin door, the left-side boot door, and the right-side technical hatch door were all ripped off. The glazing on the left side of the cabin sustained damage.
