PRELIMINARY REPORT

2025-0050

Helicopter R44, SP-SIM

29 June 2025

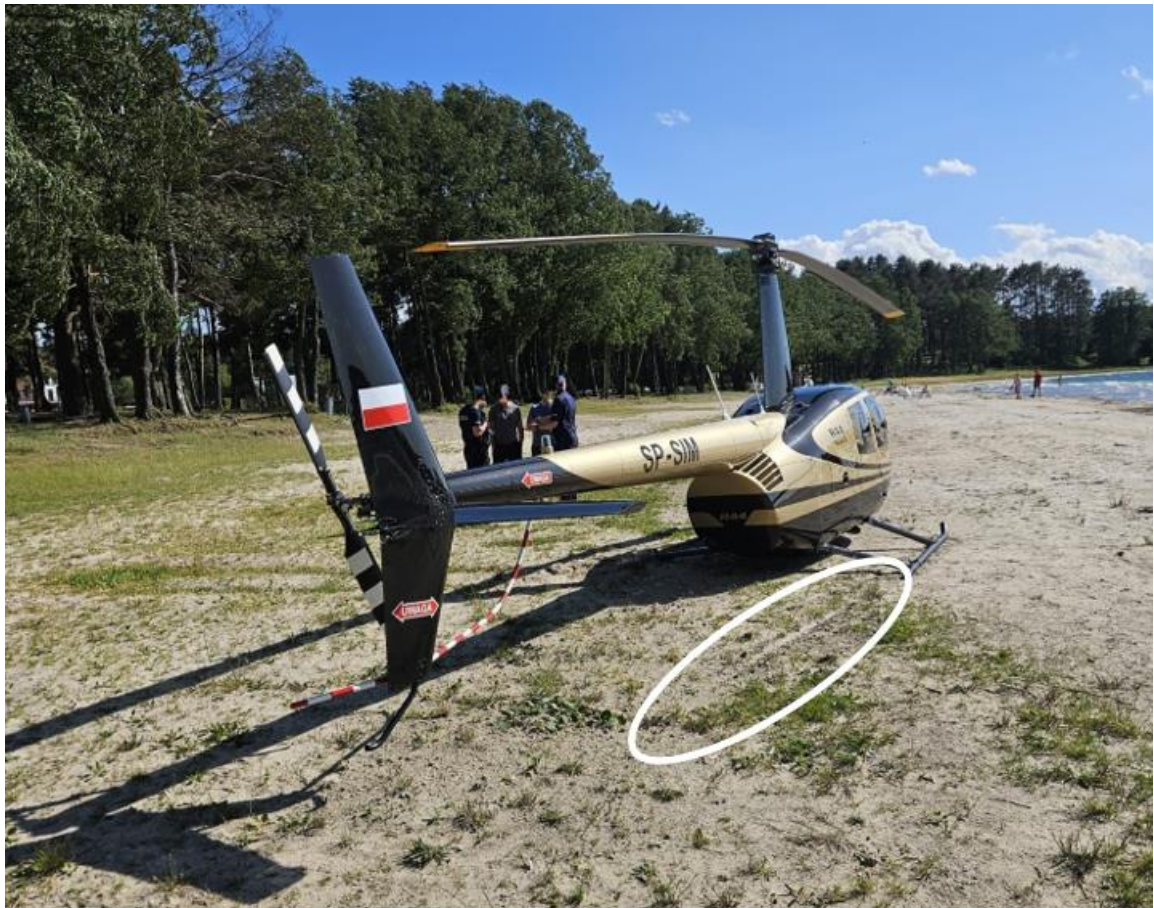
The pilot decreased the helicopter's speed to around 50 kt and at the same time turned right to a downwind position; at that time, the helicopter started losing altitude and changing its flight direction. Trying to adjust the direction and drift-down, the pilot energetically moved the collective pitch control to the highest position possible. A moment after that, the warning system showed that the engine was being used at maximum power. A few (three to five) seconds later, the pilot heard an aural signal and saw a warning that the main rotor was slowing down. The pilot decided not to inspect the helideck and decided to conduct a precautionary landing near the shoreline of Lake Świętajno. There was a hard landing, with the skid landing gear touching down and the aircraft having a short ground run (Fig. 2).

The helicopter was damaged. All the damage to the helicopter resulted from the hard landing. No visible damage which could have occurred beforehand, including to the engine or transmission, was found. Main damage to the helicopter includes:

Fig. 2. The helicopter on the precautionary landing site – near hotel Warchoły, Świętajno Lake, touchdown coordinates 53°32'28" N, 20°48'08" E – the oval highlights the marks from the hard landing [source: owner of the helicopter]

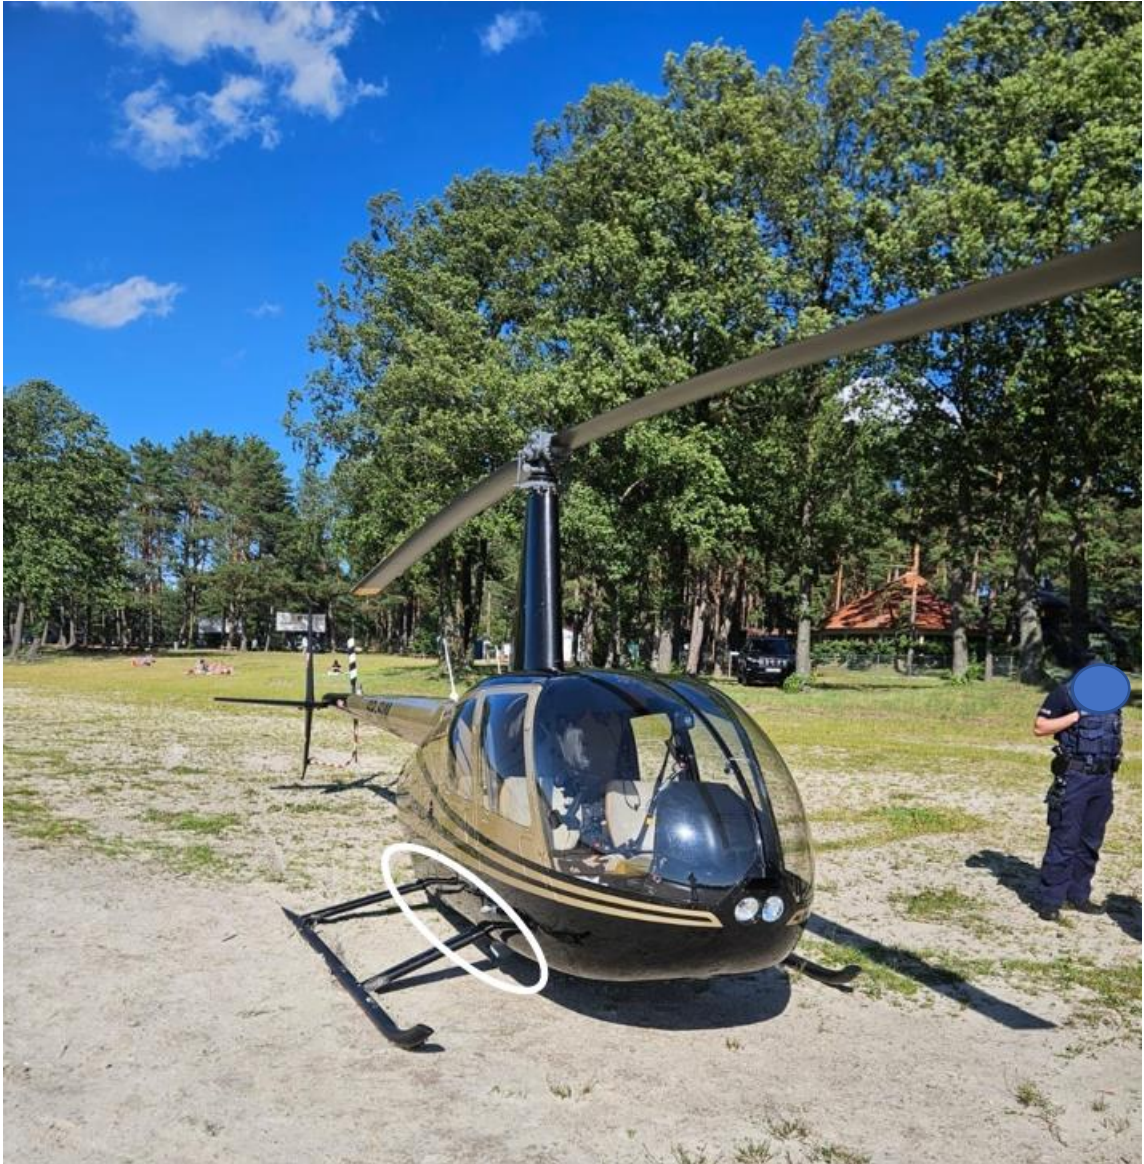
- damage to skid landing gear attachment nodes;
- deformation of the bottom part of the fuselage covering;
- deformation of the fixture of the left passenger door;
- deformation of the main rotor mast cover in the area near the fuselage (left and right side).

Fig. 3. Visible damage to the skid landing gear (left and right side) [source: owner of the helicopter]

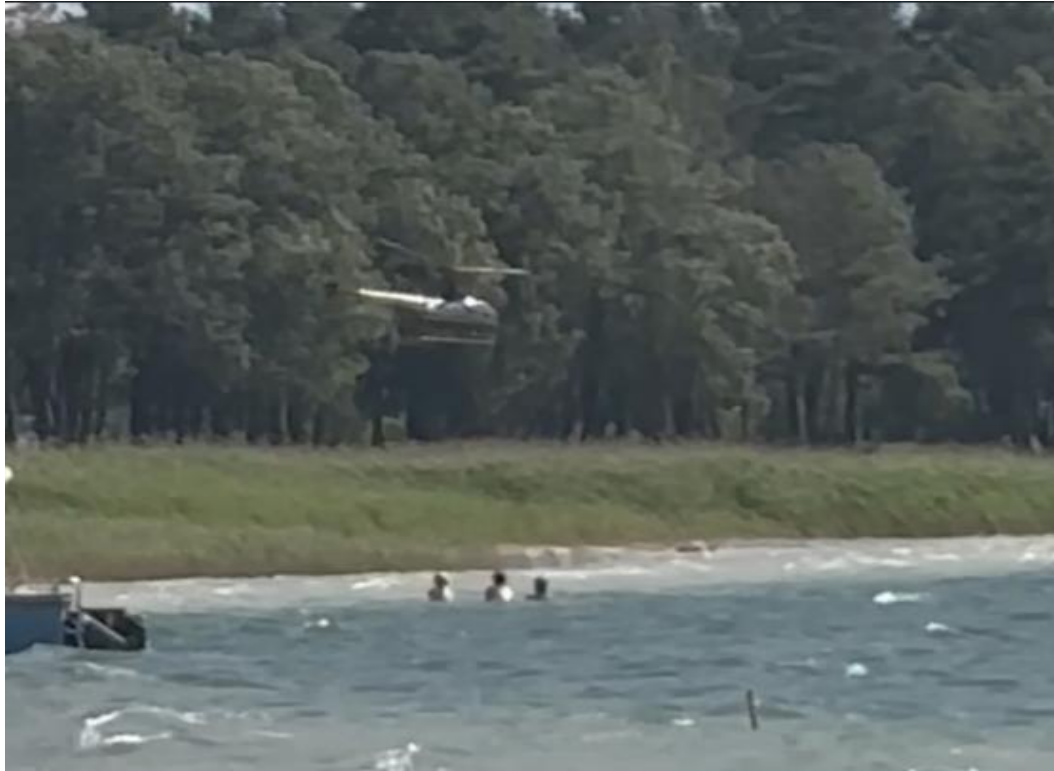
Just before the touchdown, with the small forward speed and the considerable angle at which the main rotor blades were set, the main rotor stalled. The landing was recorded on a mobile phone by a third party (Fig. 4-6).

Fig. 4. The helicopter as it approaches the precautionary landing
[Source: time-lapse photography derived from a third-party recording]

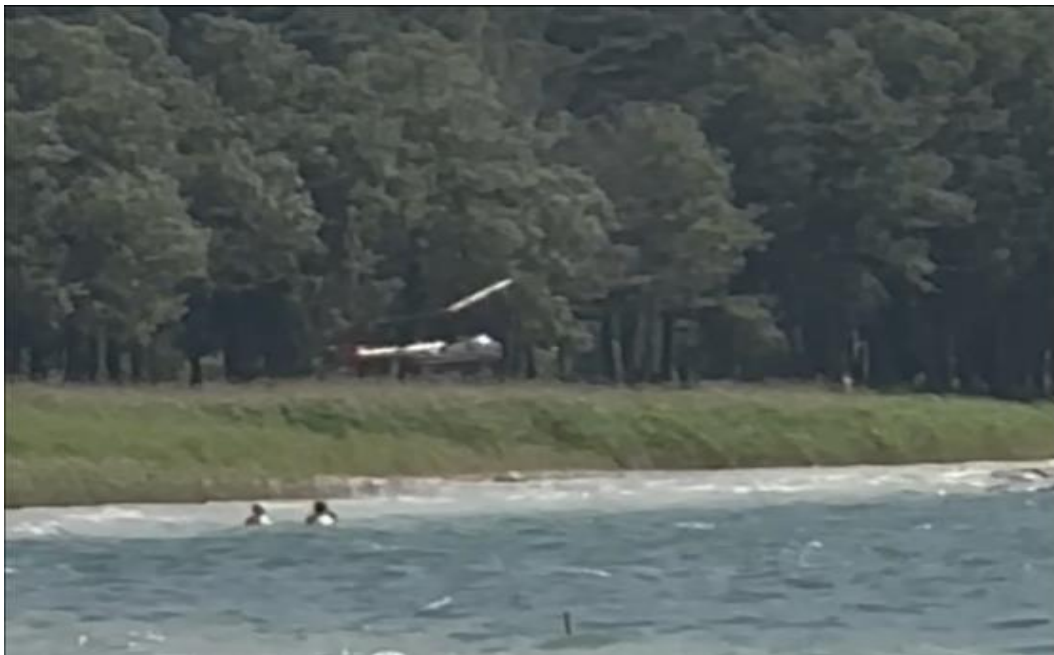
Figure 5. The helicopter as it approaches the precautionary landing
[Source: time-lapse photography derived from a third-party recording]

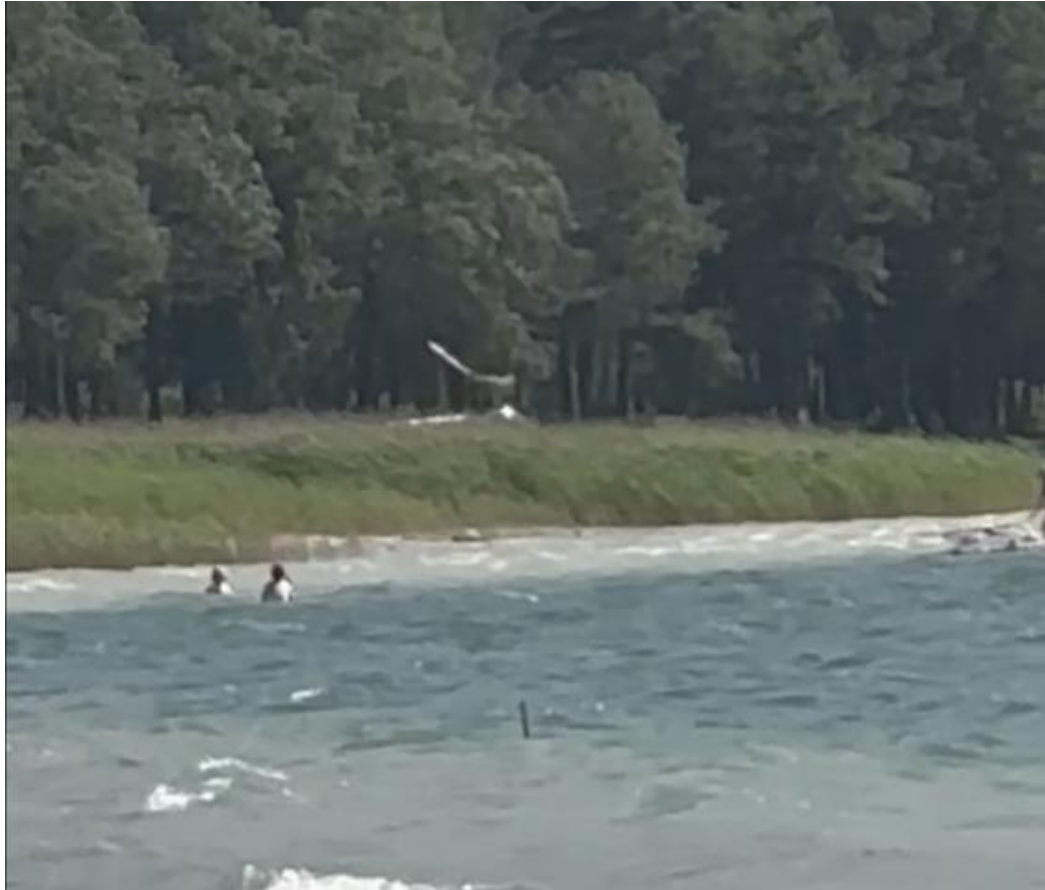
Figure 6. The helicopter as it approaches the precautionary landing
[Source: time-lapse photography derived from a third-party recording]
