FINAL REPORT

of the State Commission on Aircraft Accidents
Investigation

2025-0108

UL aircraft, CH-601 "Zodiak," OK-LUA60

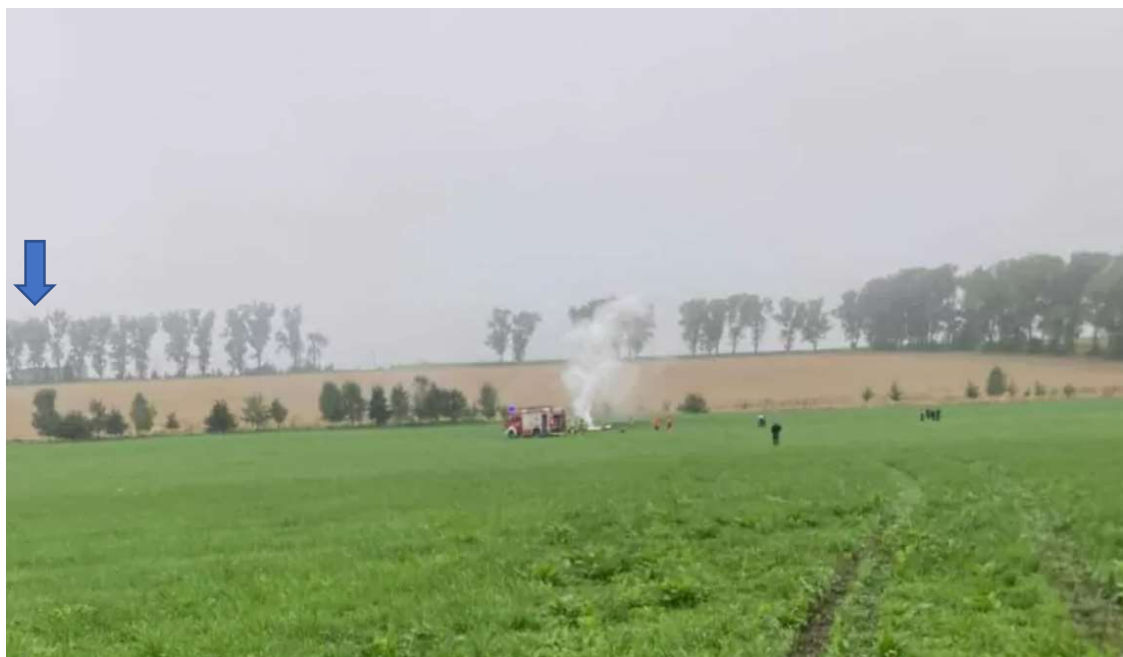
Fig. 4 Fading fire in the wreckage (N view). Eastern edge of the Lipowa airfield is behind the trees on the left of the photo (blue arrow). Photo taken ca. 10 AM. Of note is the continued significant fog [source: Internet/www.bielsko.info]

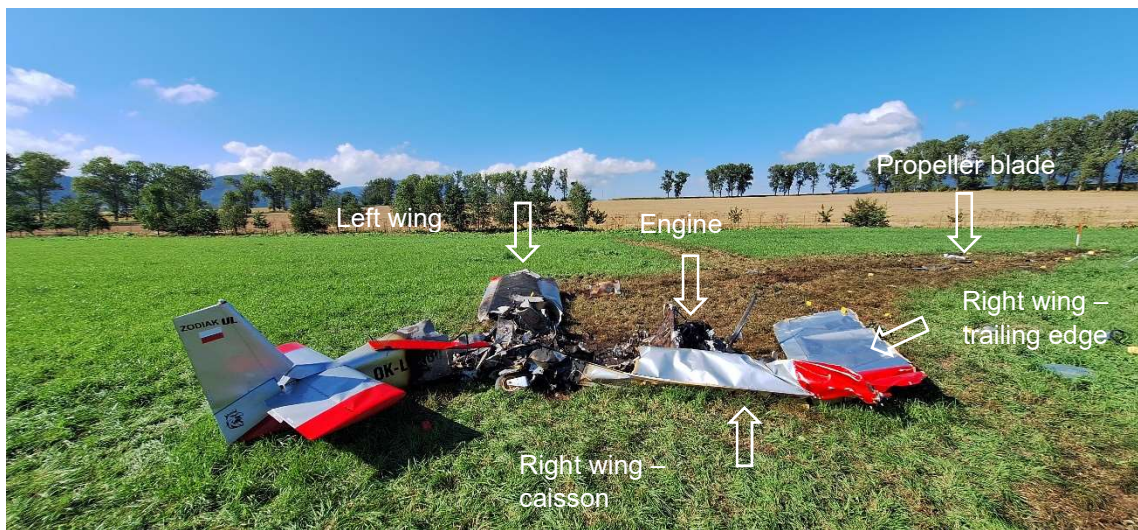
The aircraft was destroyed. Ground marks were on a relatively small area and included disturbed humus and a strip of burnt grass (Fig. 5).

Fig. 5 Wreckage at the site of the accident (N view) [source: PKBWL].

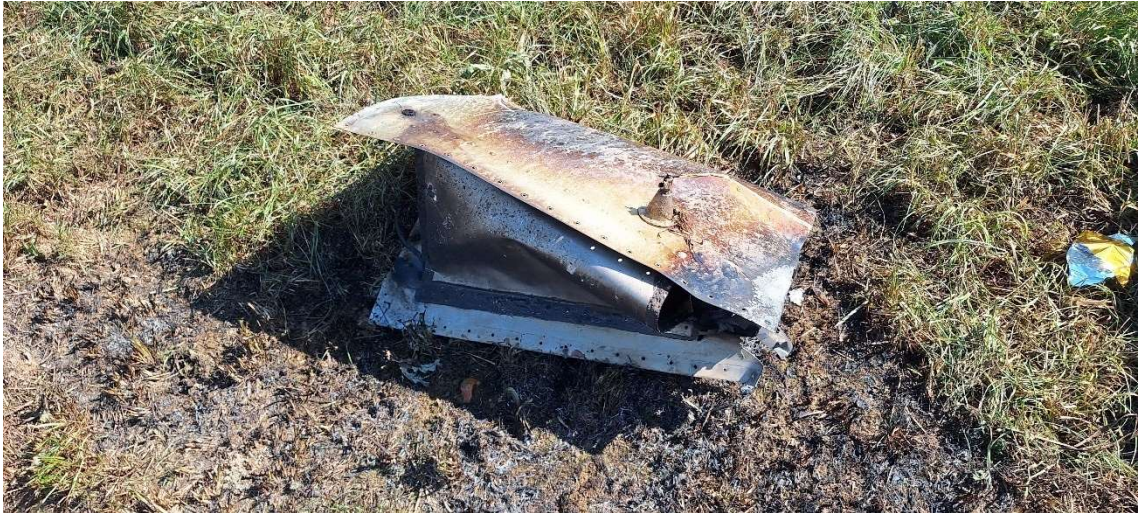
The fuel tanks (Fig. 6), upon impact with the ground, tore through the caissons and fell out of the wings. The tanks ruptured and the spilled fuel exacerbated the fire.

Fig. 6 Fuel tank torn from left wing caisson [source: PKBWL].

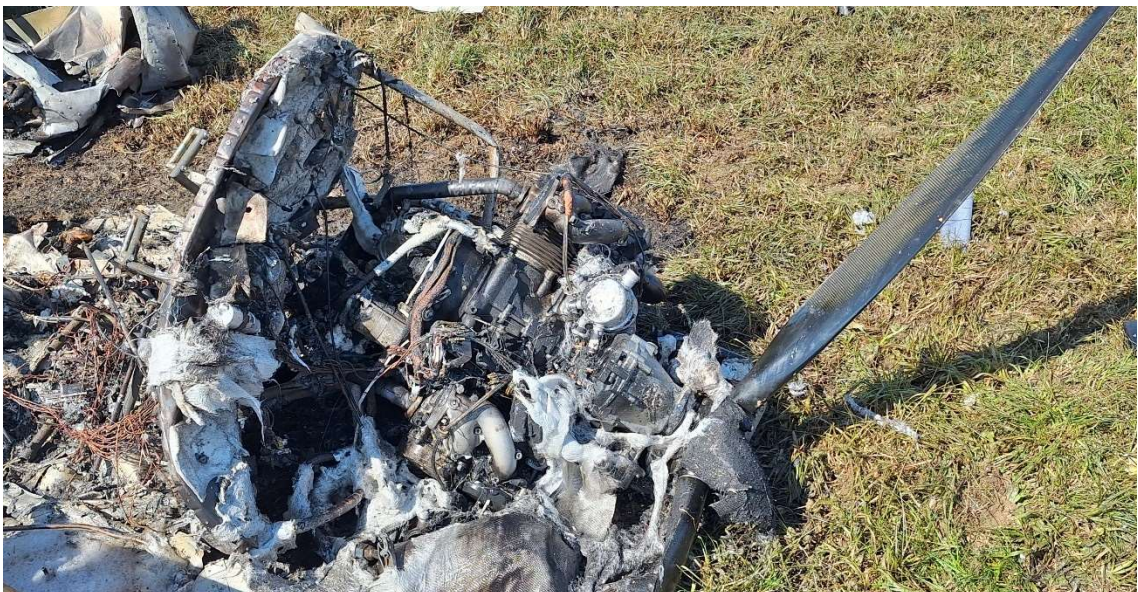
The power unit, including the mount and firewall, separated from the fuselage (Fig. 7). One of the composite propeller blades broke off upon impact and was found several metres away from the wreckage. The other two blades remained on the hub. Apart from the fractured shaft of one of the blades, none of the blades showed signs of mechanical damage.

Fig. 7 Condition of the power unit – firewall, mount and engine detached, hub with two remaining blades. The white fabric is the remnant of a completely burnt engine cowling [source: PKBWL].

3.1.6. The lack of damage to the propeller indicated that the engine was not working at the time of impact with the ground, and was probably switched off by the pilots just before impact.

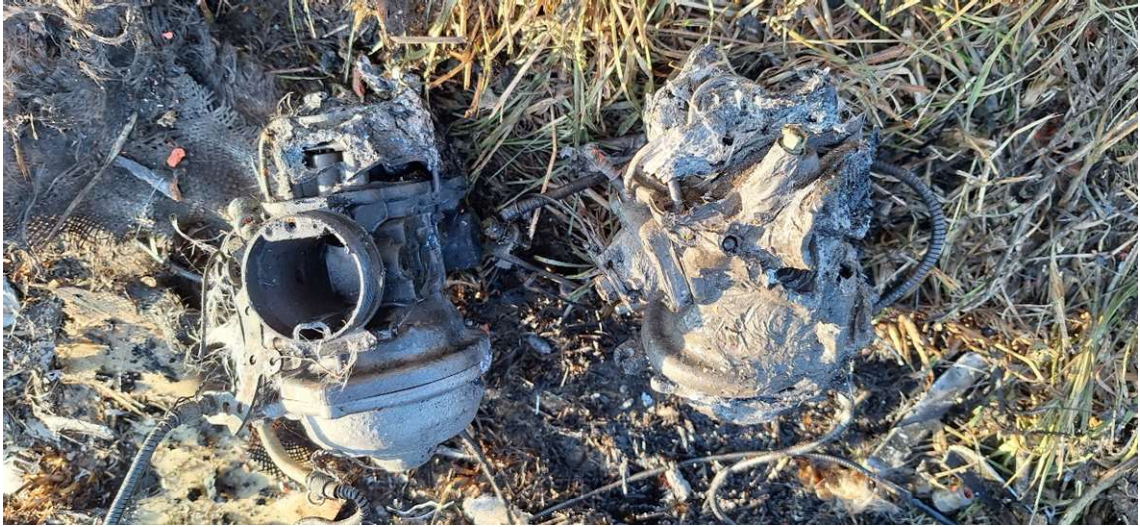
Impact and heat loads caused, among others, the carburetors to detach, tear and partially melt – they were found separately (Fig. 8).

Fig. 8 Condition of the carburetors found in the wreckage, partially melted by the high temperature [source: PKBWL].

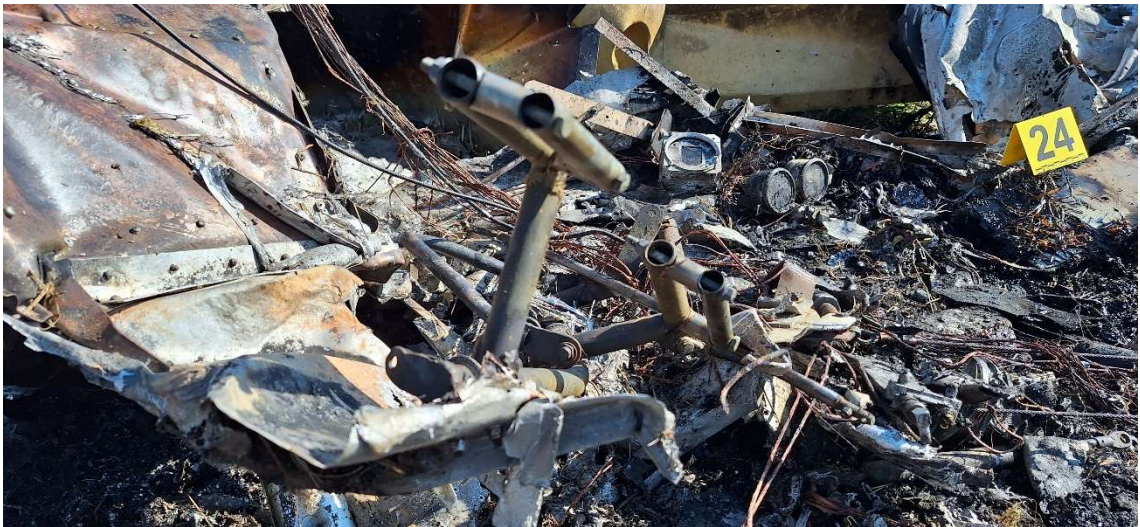
The crew cabin was completely destroyed and burnt out (Fig. 9).

Fig. 9 Remains of the aircraft cabin – among others, visible rudder pedals and a few flight instruments [source: PKBWL].

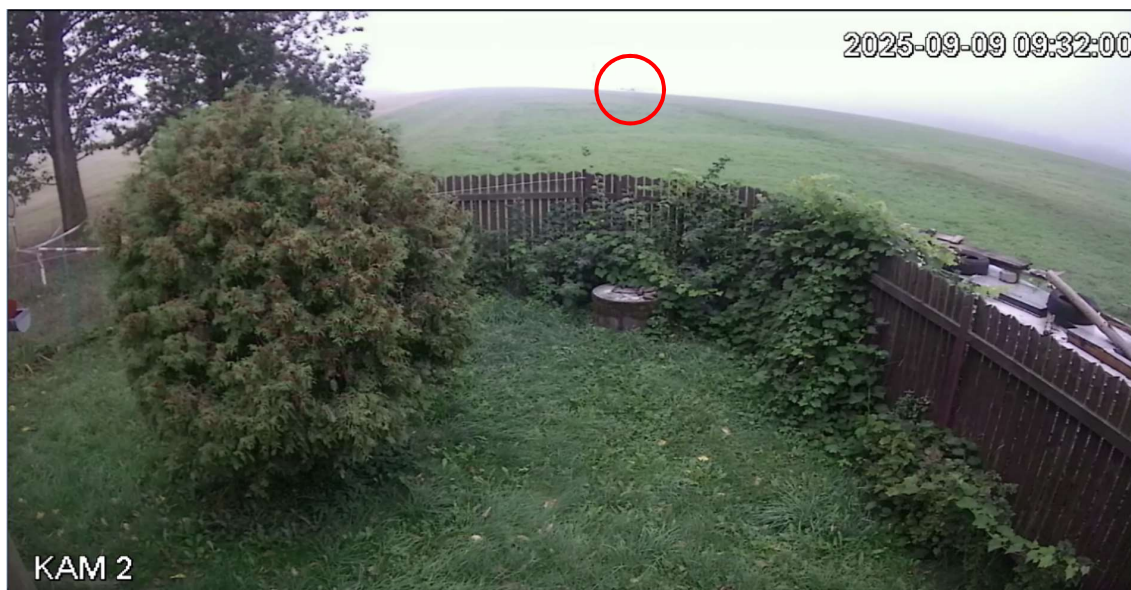
The take-off started from the western edge of the grass runway, heading 063°. At 9:32:00 AM, Camera 2 (facing west) recorded the aircraft lifting off, accelerating and starting to climb (Fig. 11).

Fig. 11 Aircraft lifting off the airfield – distance from camera is approximately 250m [source: airfield monitoring/PKBWL]

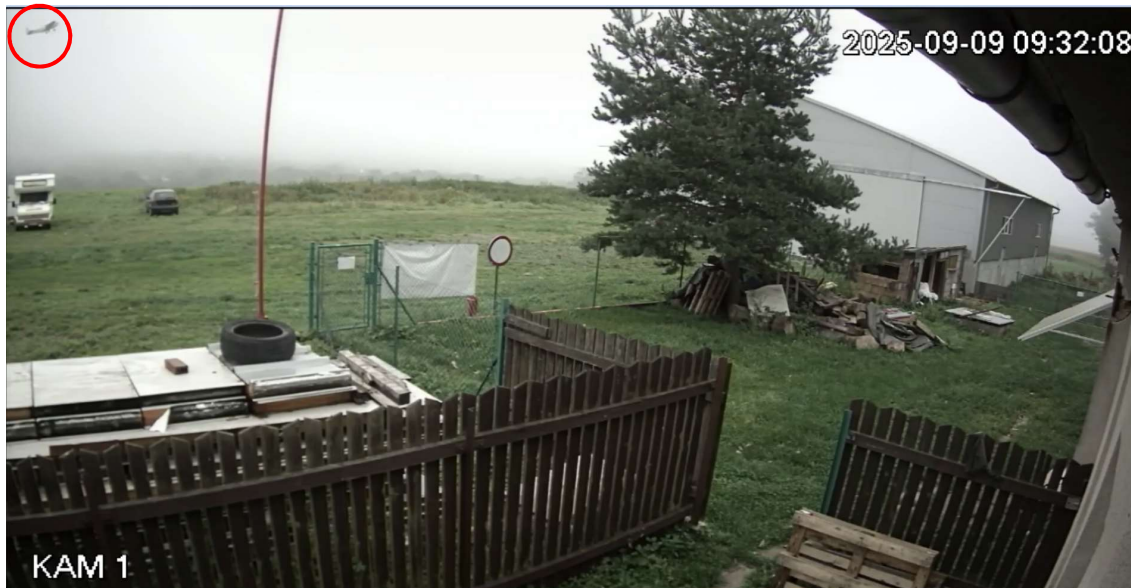
At 9:32:08 AM, Camera 1 (facing north) captured the aircraft flying over the eastern airfield boundary (Fig. 12). It was at an altitude of about 15÷20 m above the airfield, on a clear climb, tilted a few degrees to the left wing, with a course deviating to the left of the take-off axis (to the NE).

Fig. 12 Last frame of the recording showing the OK-LUA60 aircraft taking off [source: airfield monitoring/PKBWL]

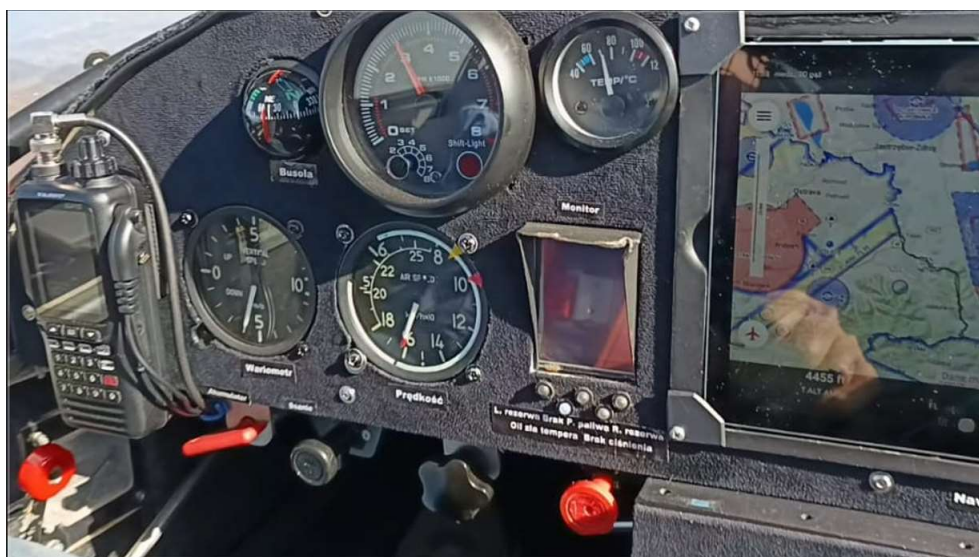
Fig. 14 Probable pilot instrument configuration in the Zodiac OK-LUA60 aircraft [source: PKBWL].

These instruments did not in any way enable the aircraft to maintain balance in flight conditions without external visibility.

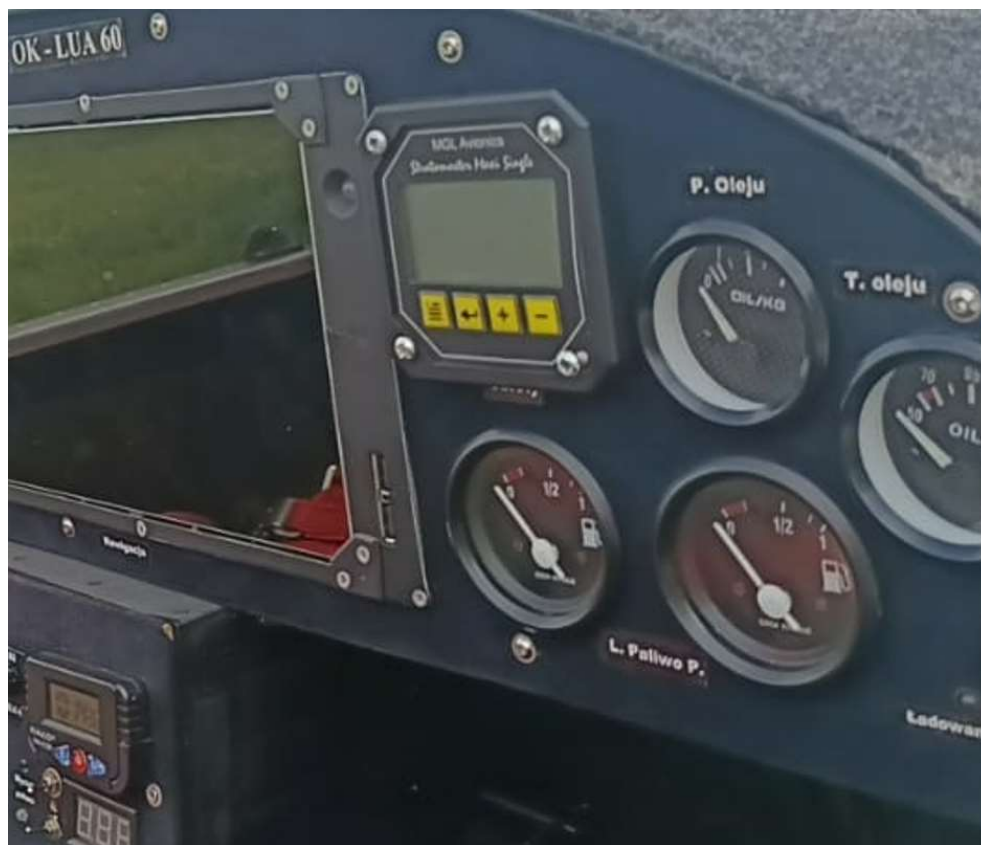
Fig. 15 Probable configuration of engine instruments [source: PKBWL].
