FINAL REPORT

2025-0108

UL aircraft, CH-601 "Zodiak," OK-LUA60

9 September 2025, Lipowa

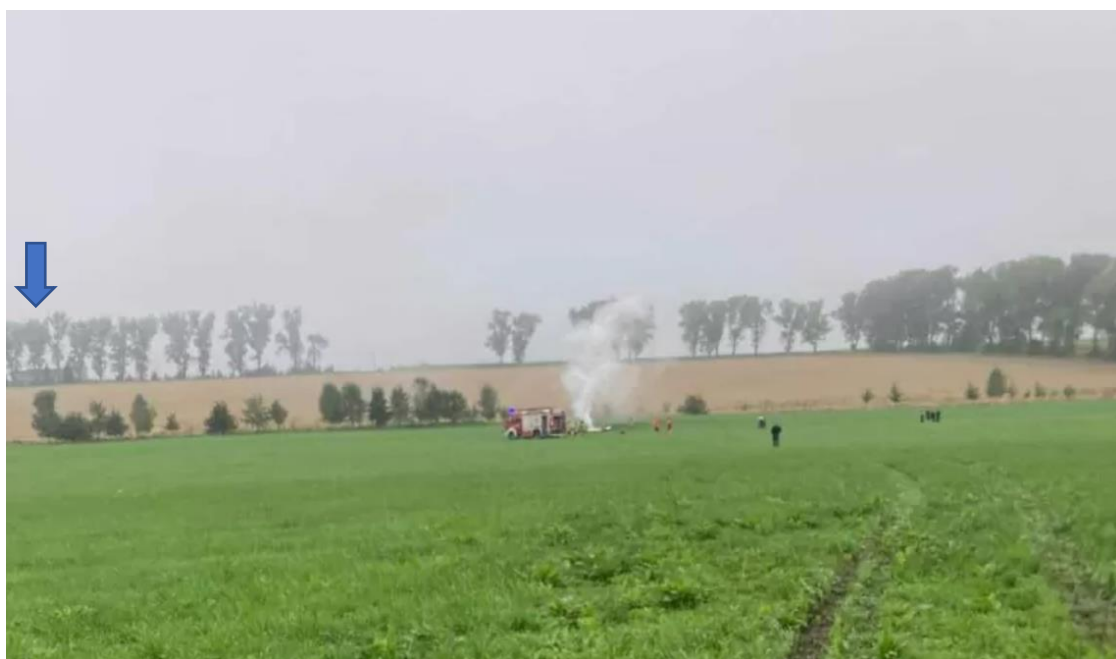
Fig. 4 Fading fire in the wreckage (N view). Eastern edge of the Lipowa airfield is behind the trees on the left of the photo (blue arrow). Photo taken ca. 10 AM. Of note is the continued significant fog [source: Internet/www.bielsko.info]

The fire, which started immediately after the plane hit the ground, spread rapidly throughout the wreckage. The energy of the collision led to the structure of the plane, including the fuel tanks, being ruptured. Hot engine components ignited the fuel vapour and a significant amount of fuel (approximately 60 litres of automotive petrol) fuelled the flames.

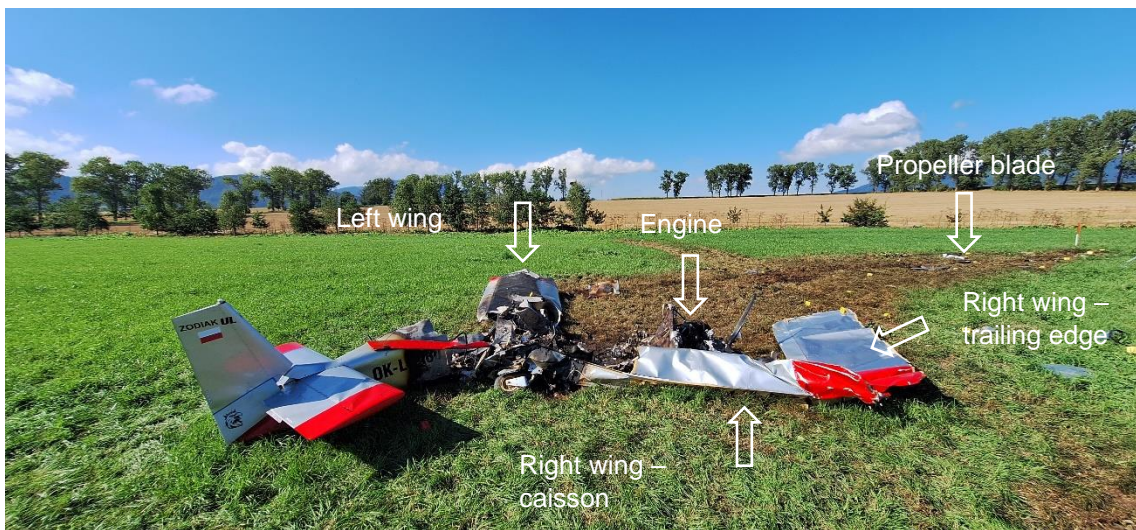
The aircraft was destroyed. Ground marks were on a relatively small area and included disturbed humus and a strip of burnt grass (Fig. 5).

Fig. 5 Wreckage at the site of the accident (N view) [source: PKBWL].

Both wings separated from the fuselage and their internal structure (girders, ribs, riveted reinforcements) was destroyed. The entire trailing edge of the right wing detached from the girder.

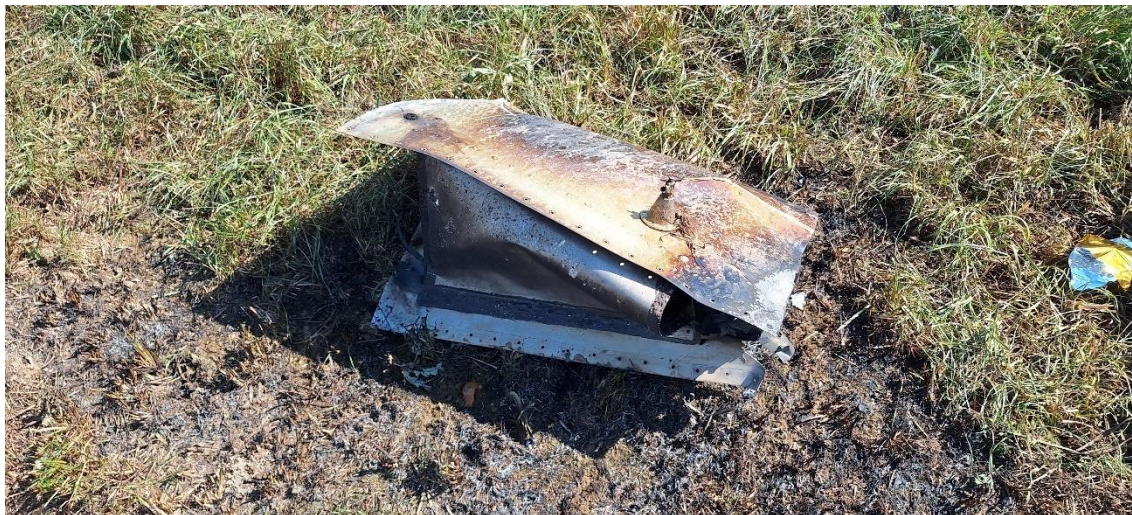
The fuel tanks (Fig. 6), upon impact with the ground, tore through the caissons and fell out of the wings. The tanks ruptured and the spilled fuel exacerbated the fire.

Fig. 6 Fuel tank torn from left wing caisson [source: PKBWL].

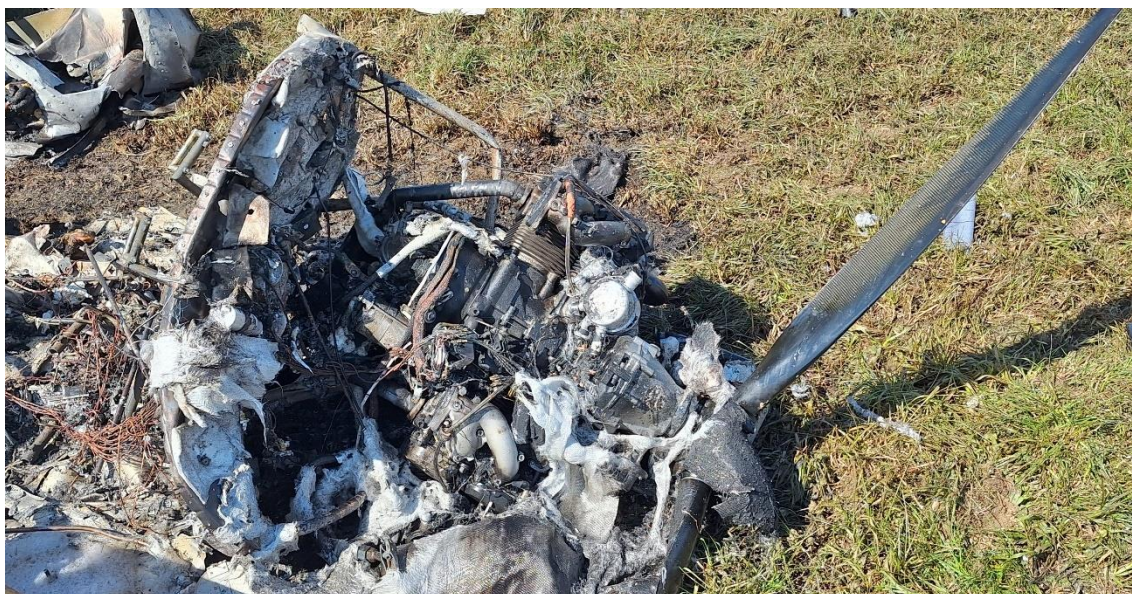
The power unit, including the mount and firewall, separated from the fuselage (Fig. 7). One of the composite propeller blades broke off upon impact and was found several metres away from the wreckage. The other two blades remained on the hub. Apart from the fractured shaft of one of the blades, none of the blades showed signs of mechanical damage.

Fig. 7 Condition of the power unit – firewall, mount and engine detached, hub with two remaining blades. The white fabric is the remnant of a completely burnt engine cowling [source: PKBWL].

3.1.6. The lack of damage to the propeller indicated that the engine was not working at the time of impact with the ground, and was probably switched off by the pilots just before impact.

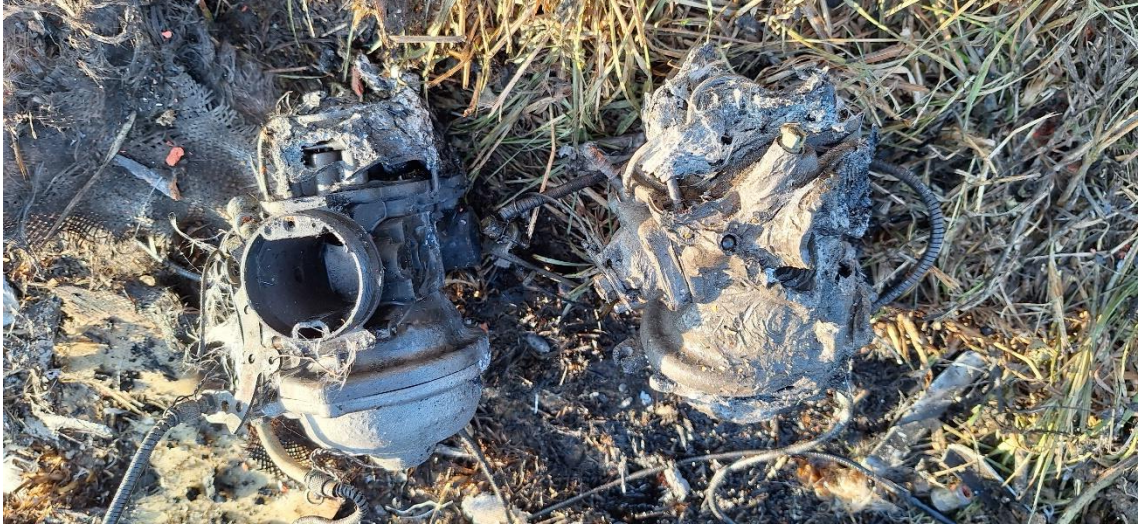
Impact and heat loads caused, i.a., the carburetors to detach, tear and partially melt – they were found separately (Fig. 8).

Fig. 8 Condition of the carburetors found in the wreckage, partially melted by the high temperature [source: PKBWL].

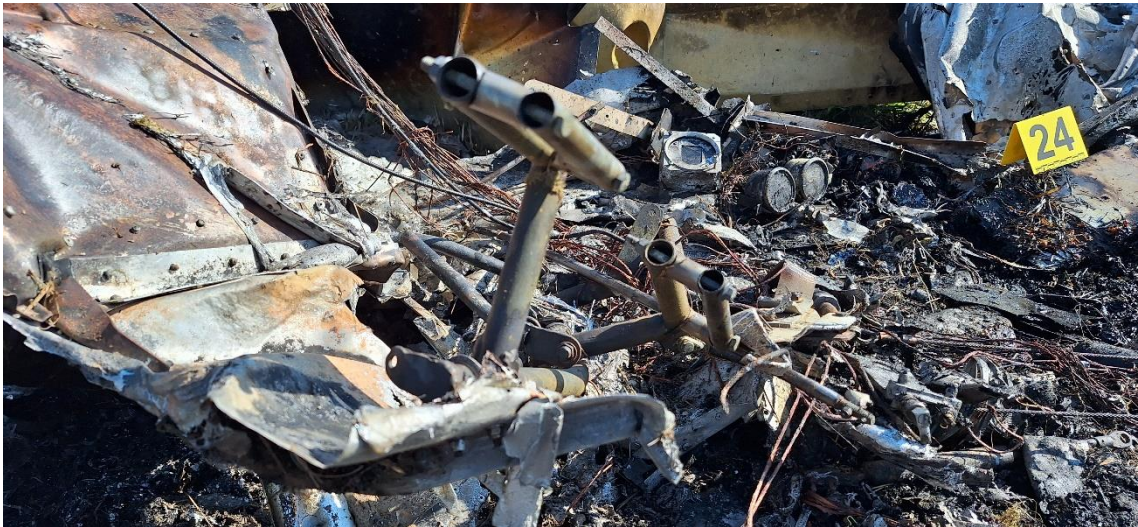
The crew cabin was completely destroyed and burnt out (Fig. 9).

Fig. 9 Remains of the aircraft cabin – among others, visible rudder pedals and a few flight instruments [source: PKBWL].

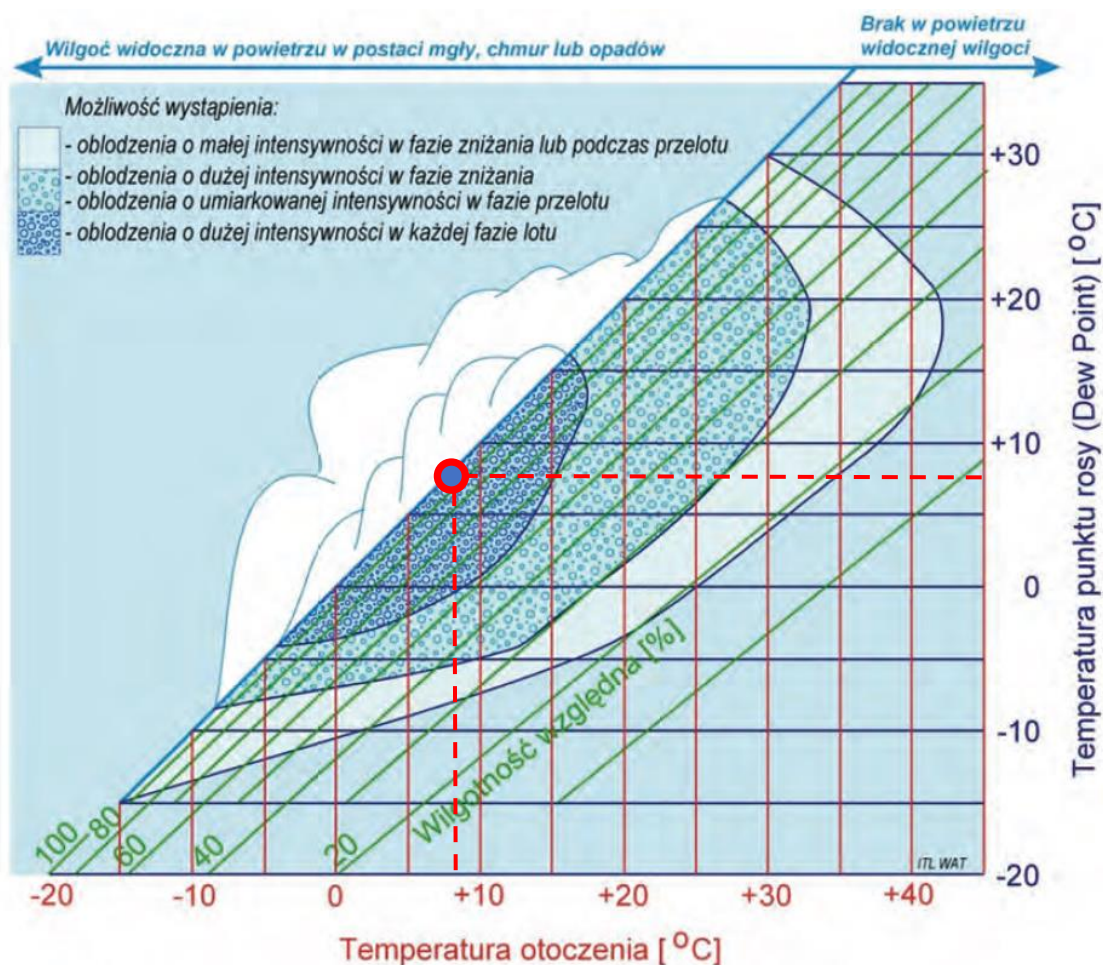
In these conditions, high-intensity icing occurred in every phase of the flight (Fig. 13). As the aircraft was in no way designed to fly in icy conditions, icing built up in the carburettor air intake system was almost certain to occur. This translated into a drop in engine power and may have forced the crew to turn towards the airfield (immediately after take-off) and attempt to find it in low visibility conditions. Perhaps the aircraft going around the airfield, as observed by the witness, was due to the foregoing.

Fig. 13 Conditions for icing to occur in carburettor air intake systems in piston engines [source: Ryszard Chachurski, Military University of Technology]

3.2.3. Likely icing of the carburettor air intake system, resulting in reduced power in the power unit, and thus the aircraft being unable to climb above the fog, where the weather was good.

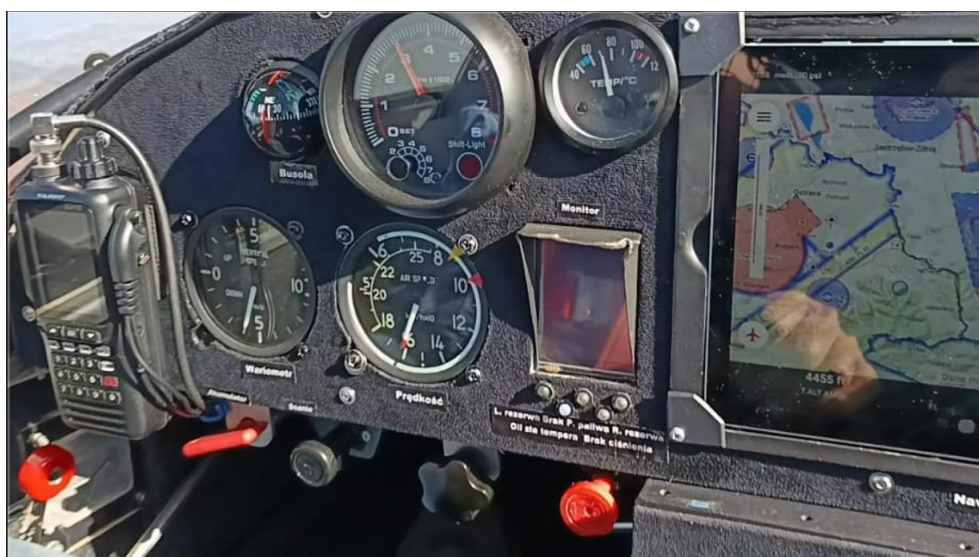
How the instrument panel was equipped was identified mainly on the basis of cockpit recordings obtained from witnesses. They were made many weeks before the accident and do not necessarily reflect the actual condition on the day of the occurrence. The cockpit burnout did not allow the exact identification of the aircraft equipment, but it did allow the conclusion that the aircraft lacked instruments for the effective piloting in IMC.

Fig. 14 Probable pilot instrument configuration in the Zodiac OK-LUA60 aircraft [source: PKBWL].

These instruments did not in any way enable the aircraft to maintain balance in flight conditions without external visibility.

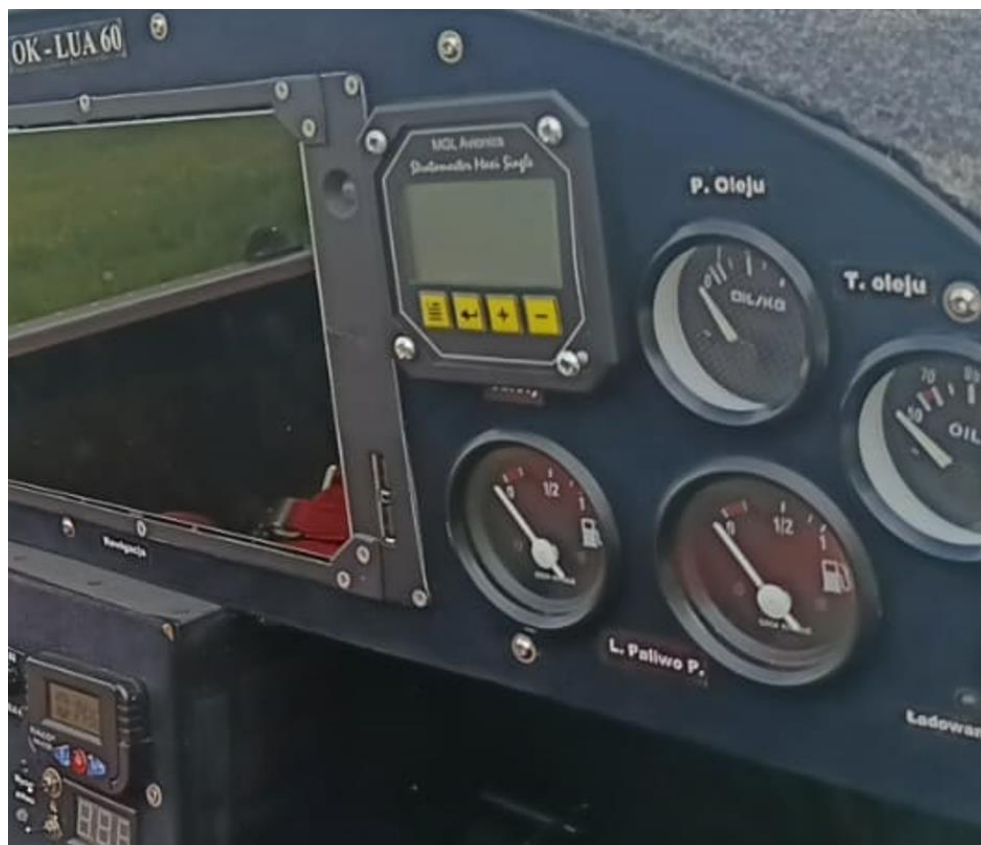
Fig. 15 Probable configuration of engine instruments [source: PKBWL].
