PRELIMINARY REPORT

of 27 November 2025
regarding the **aviation accident**

2025-0126

The New Piper Aircraft Inc., PA-28R-201, SP-TBK

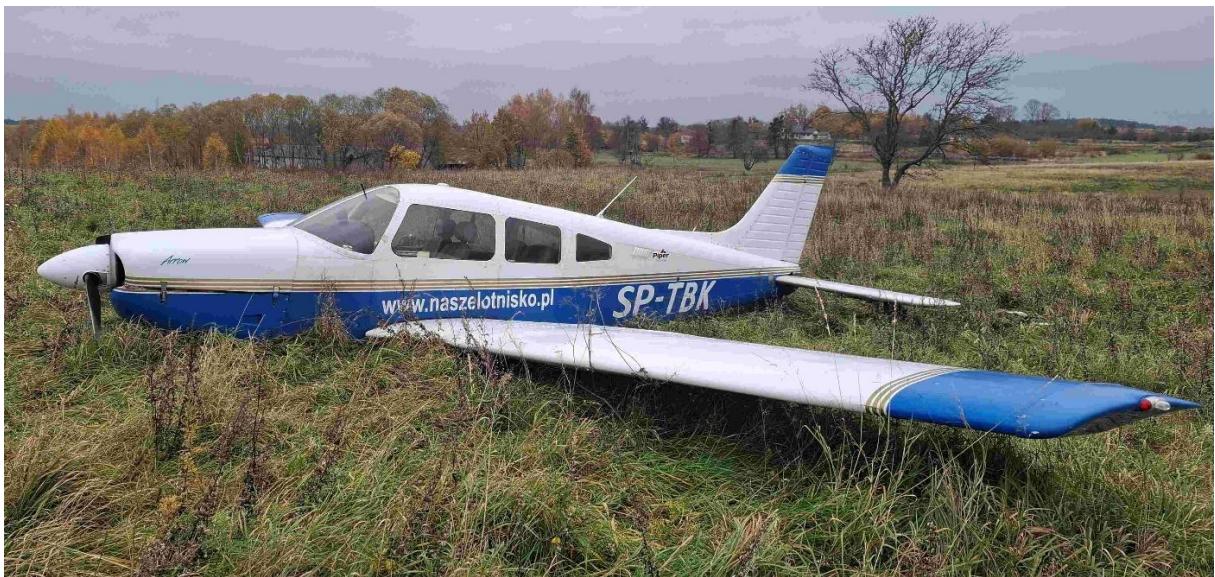
Fig. 1. SP-TBK aircraft after an emergency landing in Trelkowo. [Source: PKBWL]

The accident resulted in significant damage to the aircraft. At the accident site, the following were observed: a broken nose gear, both main landing gear legs fractured, numerous deformations of the structure and skin of the fuselage and wings, and a bent propeller.
