FINAL REPORT

of the **State Commission on Aircraft Accidents Investigation**

regarding the **serious aviation incident**

1. Polish Air Navigation Services Agency
2. Embraer – ERJ190-200, SP-LNF
3. Airbus – A320-214, D-AIZJ

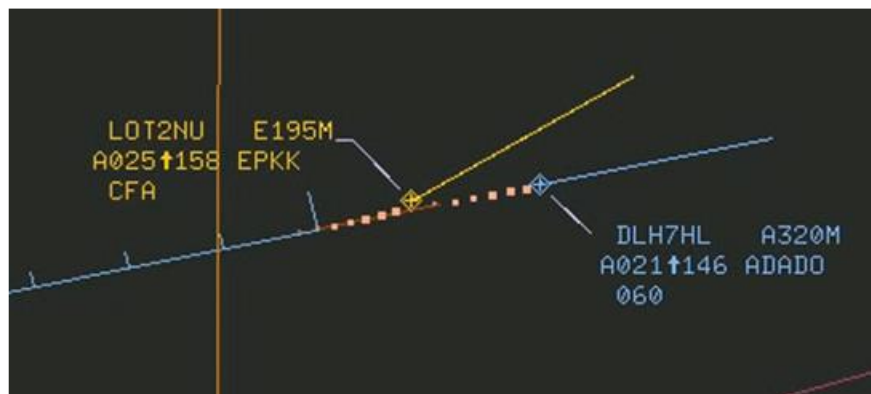
On 18 April 2022, during an RNP approach to land on RWY 07 at EPKK, an Embraer 190-type aircraft, registration number SP-LNF (hereinafter: A/C 1) had a missed approach. Approximately 10 seconds earlier, an Airbus A320 aircraft, registration number D-AIZJ (hereafter: A/C 2), took off in the same direction. After receiving information about A/C 1's go-around, TWR KK controller instructed the A/C 2 crew to continue straight ahead, and the A/C 1 crew to turn immediately left, north. At this point, the separation between A/C 1 and A/C 2 was 1.3 NM horizontally and 300 ft vertically.

Fig. 1. Position of SP1 after commencing left turn, north, and SP2 flying headed RWY 07.
[Source: Incident investigator - PANSA].

The landing clearance given to the A/C 1 crew was issued under conditions of insufficient separation from A/C 2, which was taking off from the same runway.

The immediate cause of the occurrence was the lack of a pre-emptive decision by the TWR KK controller to revoke the previously issued landing clearance for A/C 1 and to issue a go-around instruction, despite the observed high approach speed and the limited ability to provide the required separation.
