# PRELIMINARY REPORT

## 2026-0011

SOCATA TB-9 aircraft, D-EUGA

Zborowo (EPZB), 18.04.2026

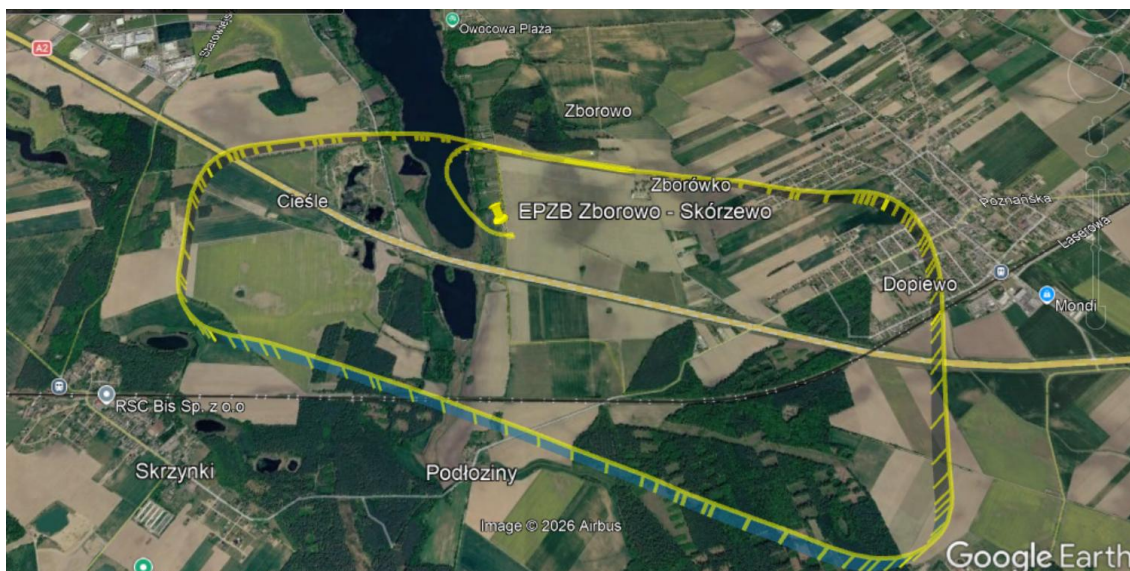
Figure 1. Flight path (including first circle) logged with the tablet. The pin marks the place of crash.

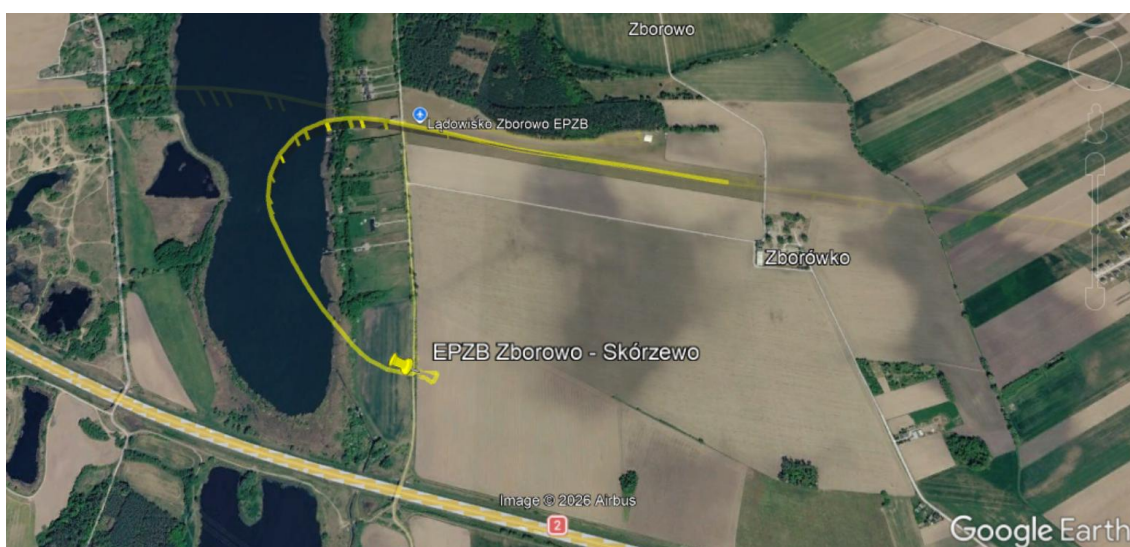
Figure 2. Path of the flight concluded with the accident

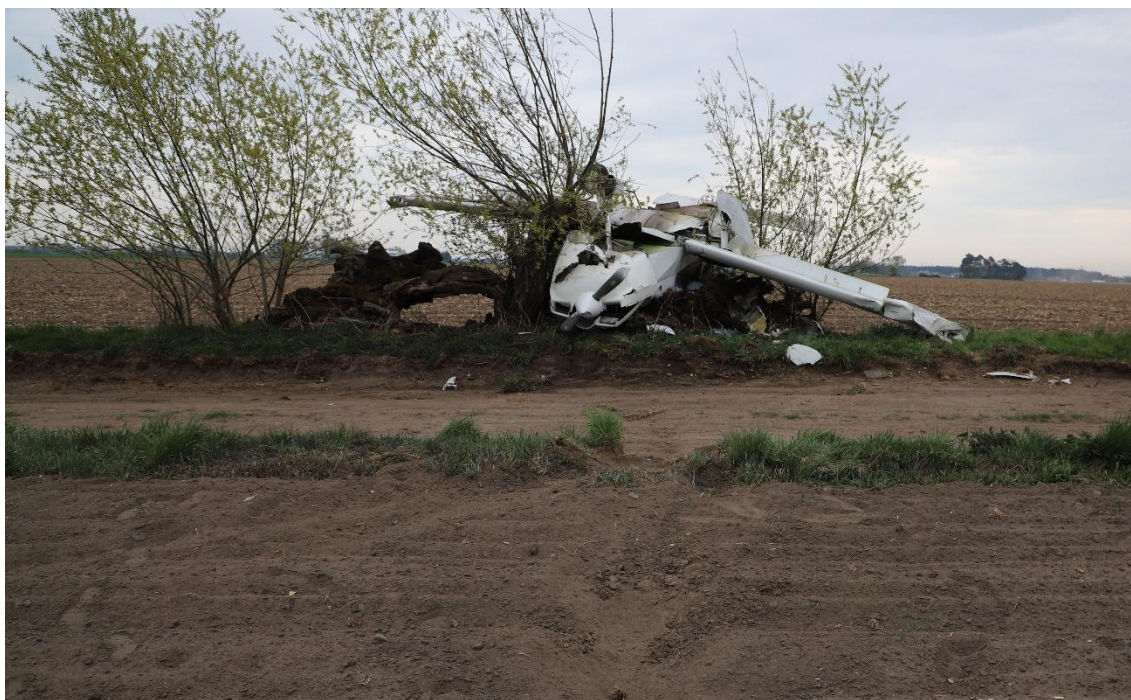
Figure 3. TB-9, D-EUGA aircraft after the crash. In front of the fuselage a mark of ground hit is visible.

The aircraft was destroyed. The damage included, amongst others, cracks of the wing skin, a break the right wing spar, a detachment of the right wing tip, a burst of the left fuel tank, a destruction of fixing both wings to the fuselage, a crack of the fuselage frame behind the cockpit and tearing it from the skin, a deformation of the windscreen frame, a cracking the windscreen and canopy doors, a breaking the engine bed, a crack of engine cowling, a bending of propeller blades, a damage of the front landing gear and a detachment of main gear fairings.
