# PRELIMINARY REPORT

of the State Commission on Aircraft Accidents  
Investigation

## 2026-0073

R44 Raven II SP-SON helicopter

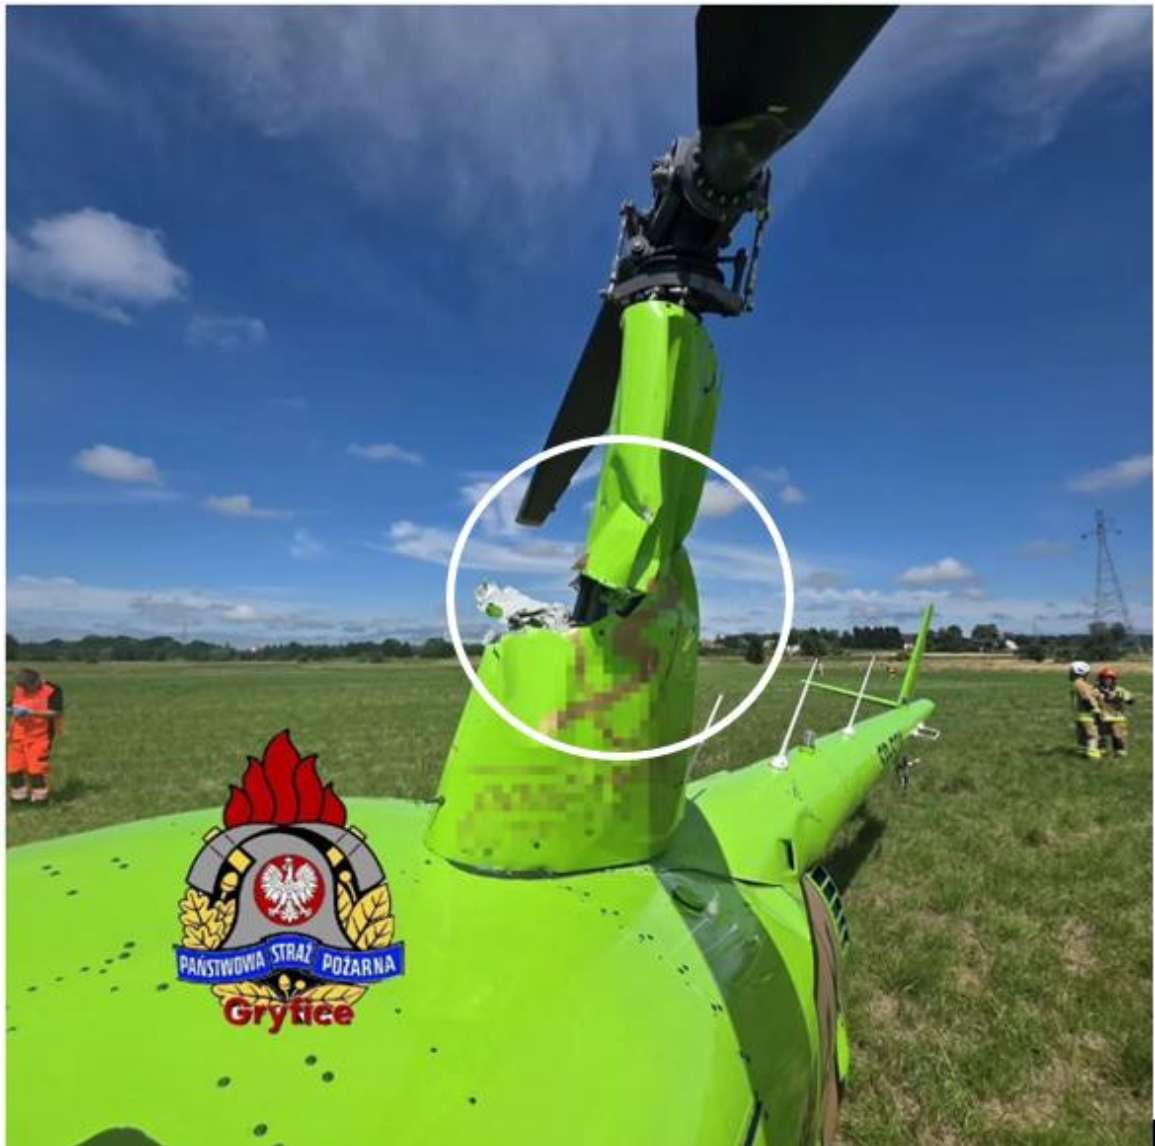
Fig. 2 shows the point of contact between the helicopter and the power line. As a result of the collision, one of the four high-voltage power lines was severed. In an attempt to avoid colliding with the three remaining lines, the pilot performed a manoeuvre similar to a hammerhead. However, another line was severed by one of the tail rotor blades, which, along with the angle gearbox, was separated from the tail boom (Figs. 3 and 4). As a result of the collision with the power line and the hard landing, the helicopter was seriously damaged.

- deformation of the main rotor mast cover across its entire surface;
- damage to push rods;
- deformation of the bottom part of the fuselage covering;
- damage to the skid landing gear;

Fig. 2. The helicopter emergency landing near the city of Mirosławiec, emergency landing coordinates: 53°32'28" N, 20°48'08" E, damage to the mast marked in white circle  
[source: State Fire Service of Poland]

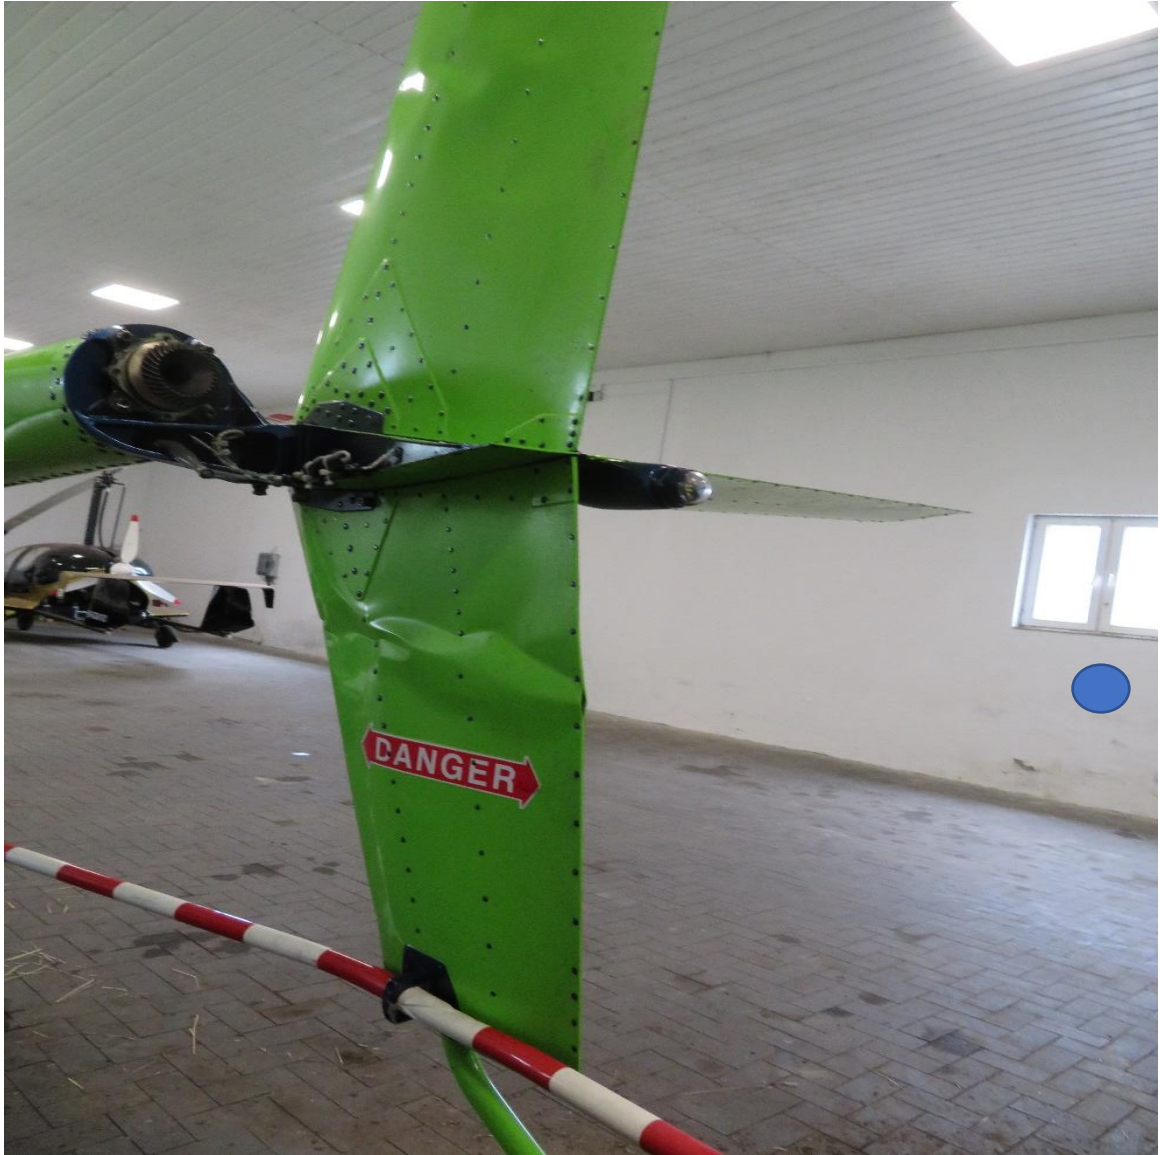
- deformation of the tail boom;
- detachment of the tail rotor along with the tail gearbox;
- deformation of the vertical and horizontal stabilizers.

Fig. 3. Visibly missing tail rotor and tail gearbox [source: PKBWL].

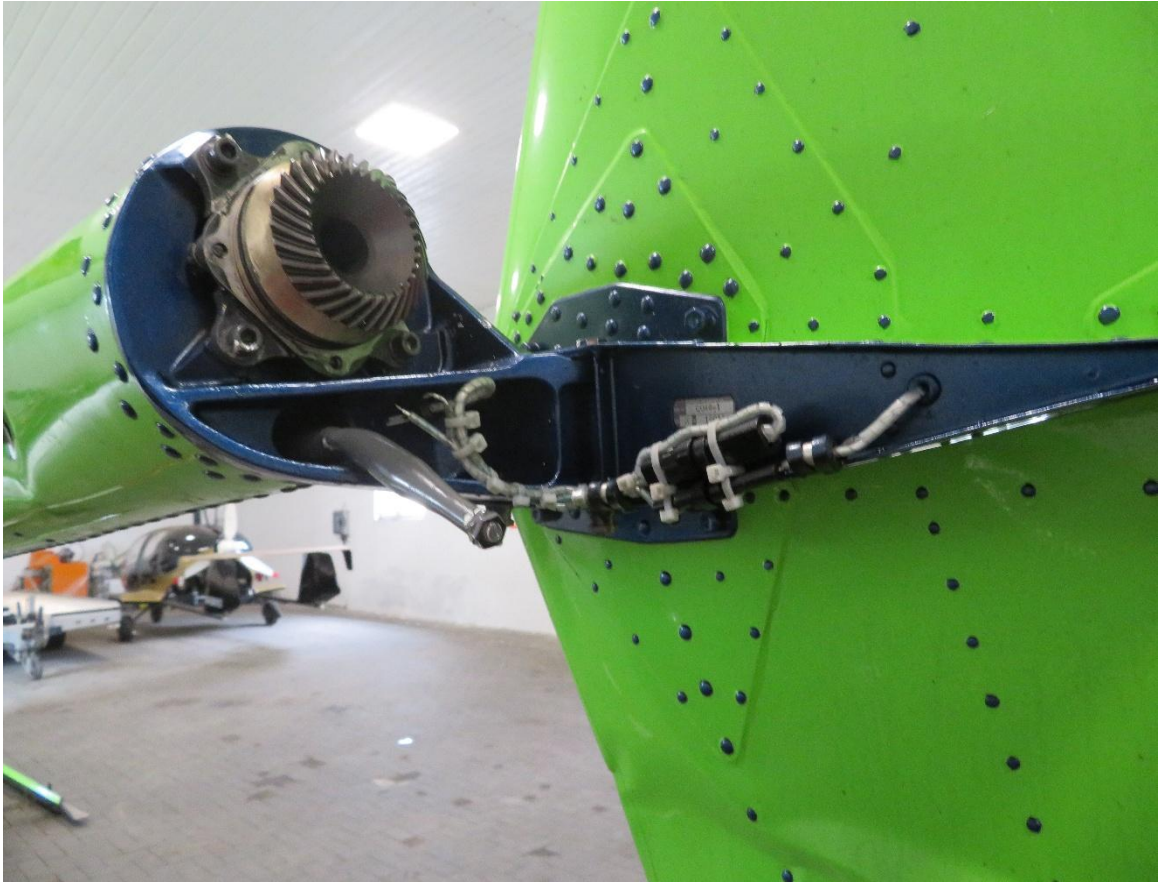
Fig. 4. Angle gearbox detached from tail boom [source: PKBWL].

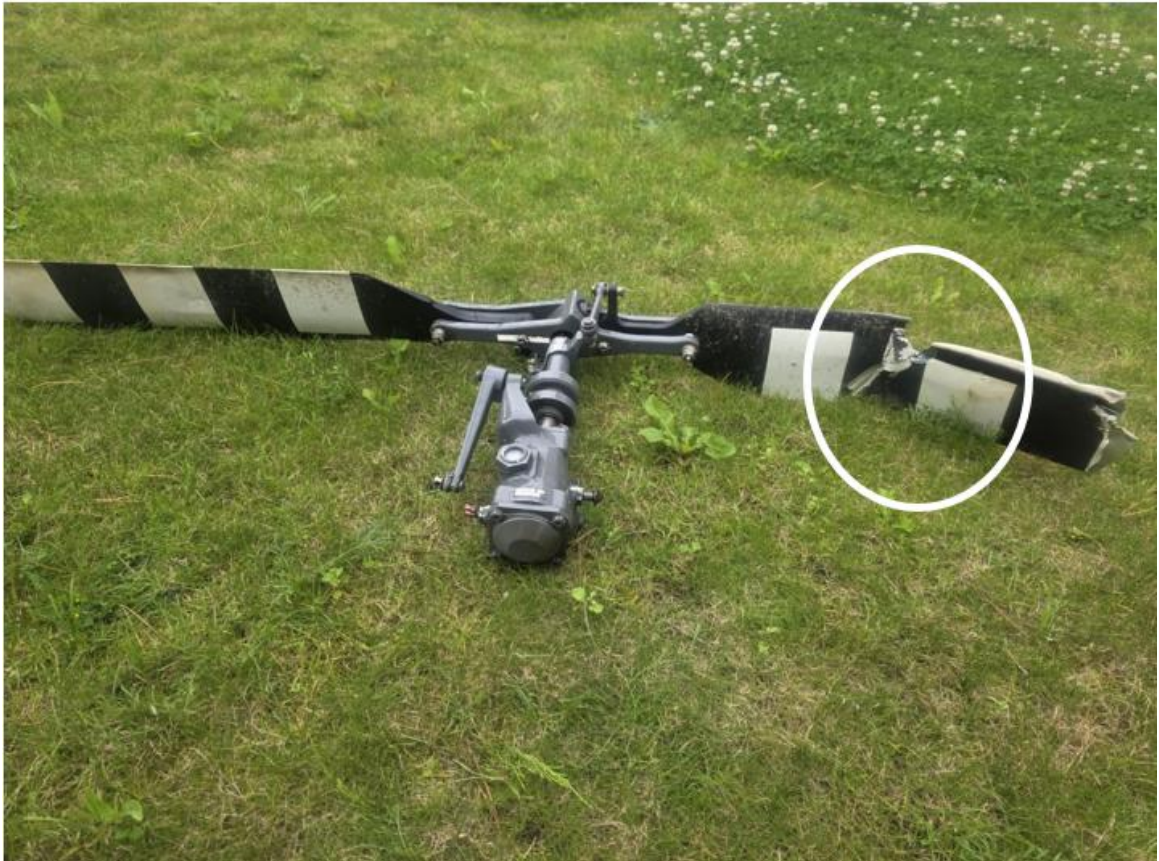
Fig. 5. Detached tail rotor along with angle gearbox. White colour shows the point where the tail rotor blade struck and severed another high-voltage power line [source: PKBWL].
