FINAL REPORT

ACCIDENT 0981/14

OCCURRENCE NO – 0981/14 AIRCRAFT – Piper PA-31P Navajo aeroplane, N11WB DATE AND PLACE OF OCCURRENCE – 5 Jul 2014, Topolów, Mykanów municipality, near Częstochowa

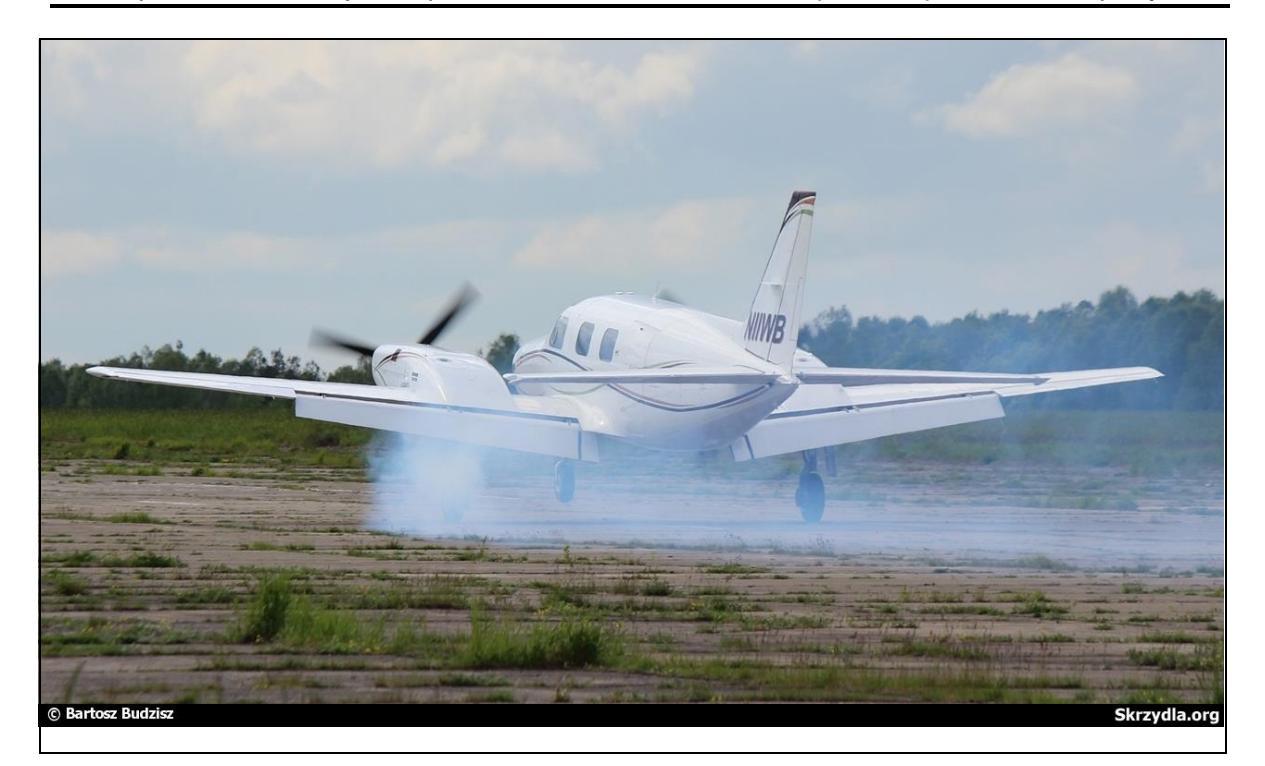
5 – Piper PA-31P N11WB airplane photographed on 13 May 2014 during landing on Rudniki aerodrome. The significant amount of smoke from the LH engine indicates its improper operation. The cabin door still in the original state (pressurized), i.e. prior to the adaptation, which was made in the second half of May 2014. [photo Bartosz Budzisz, Skrzydła.org].

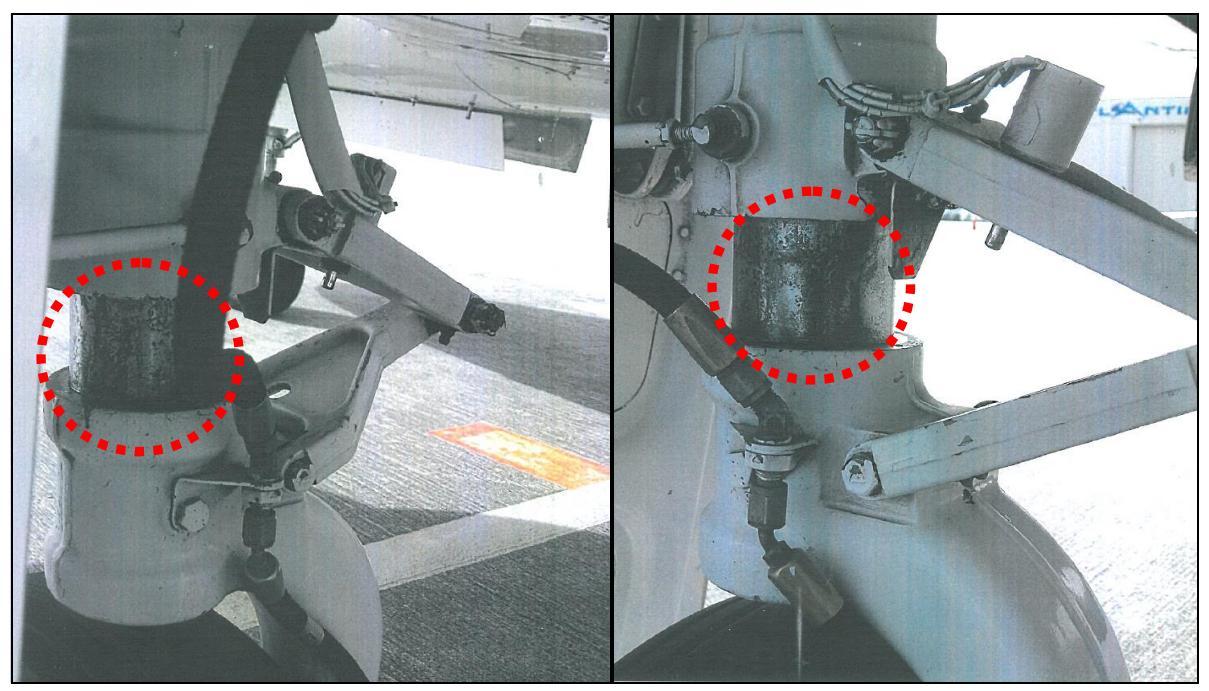
6, 7 - Left and right main landing gears of the aircraft with signs of advanced corrosion [photo via OMEGA].

Noticeable advanced and extensive corrosion on the landing gears (see Figures 6 and 7) could have been caused by a prolonged parking of the aircraft in water with a depth of about 50-60 cm (e.g. at a place affected by flooding, which could not have taken place in Poland).

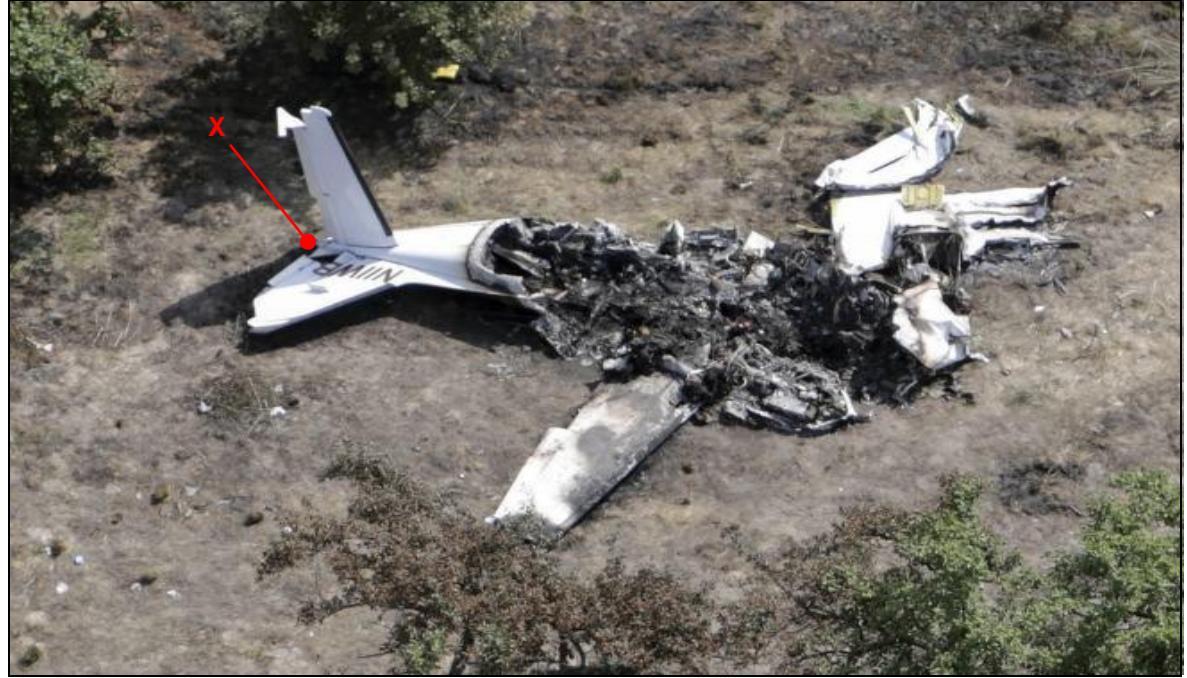
12 – Piper PA-31P N11WB airplane on the accident site photographed on 6 July 2014 in the morning. Fuselage with a burned cabin separated from the wings lies on the right side. The right flap is not visible, folded under the right wing [photo TVN24/internet].

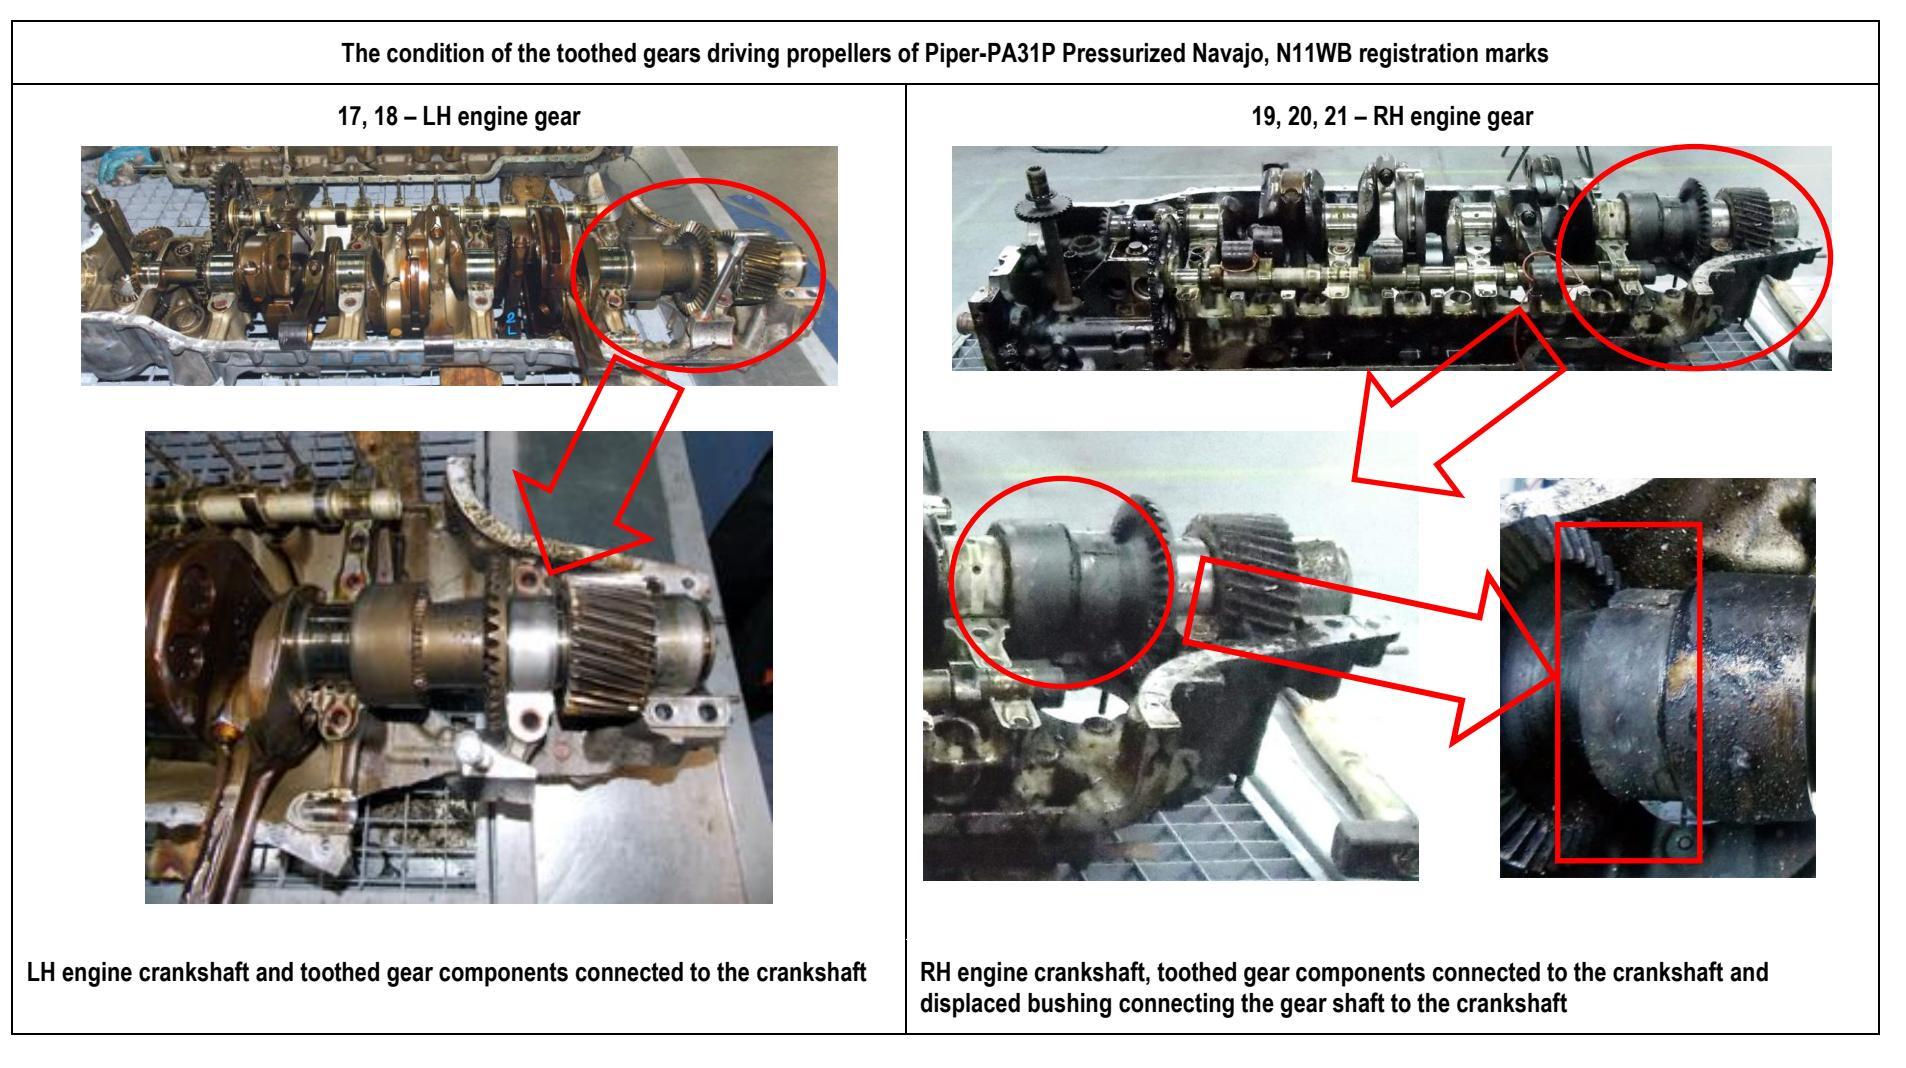
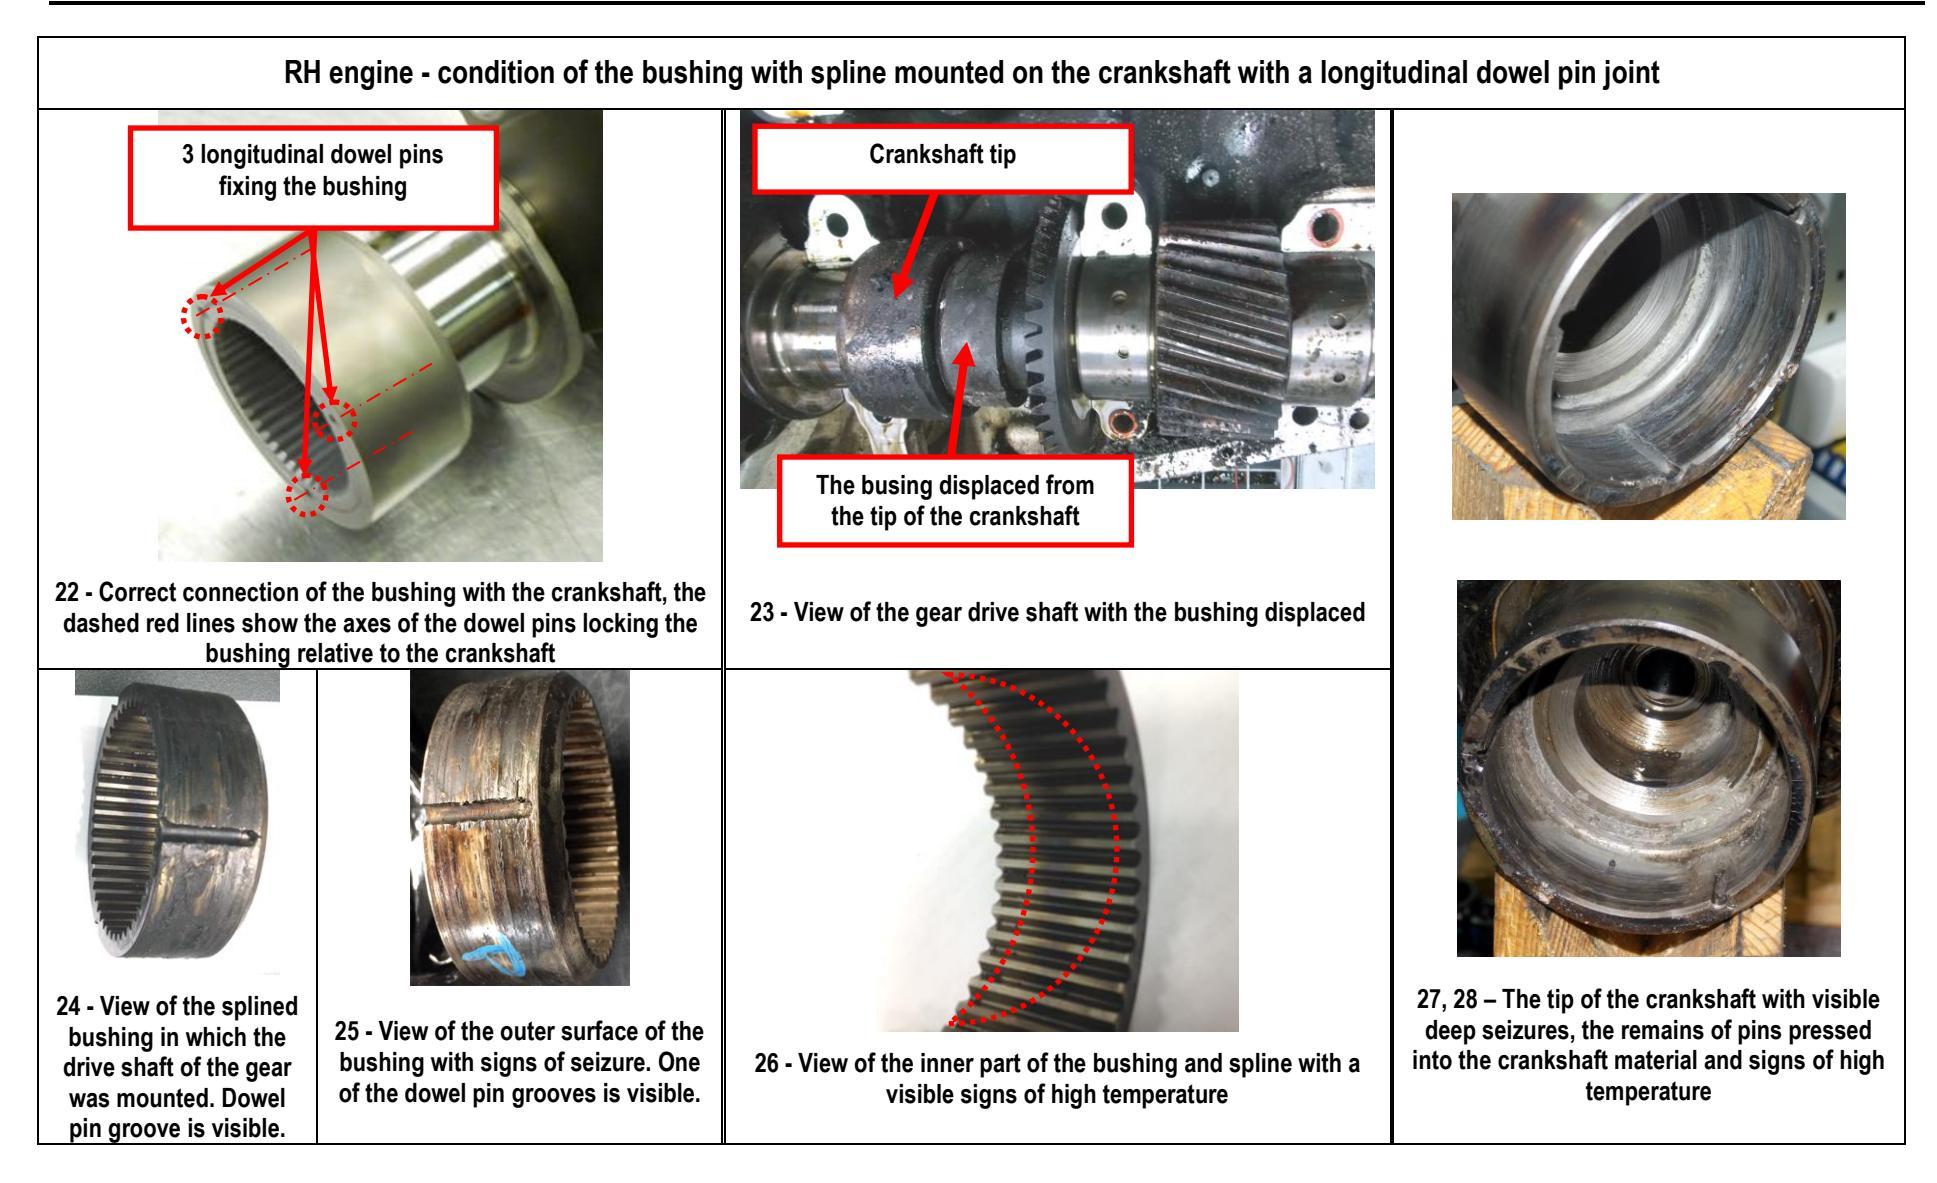
The drive shaft of the LH engine gear properly joined with the engine crankshaft by a longitudinal dowel pin joint. In the RH engine, the bushing connecting the crankshaft with the gear shaft is displaced outwards, which prevents the transmission of torque from the engine to the propeller.

The bushing shown in Figures 23 and 26 could have moved only as a result of the damage to the longitudinal dowel pin joint. Damaged edges of the grooves for embedding pins in the bushing (see Figures 24 and 25), pressed material chips both in the grooves of the crankshaft tip and on its inside surfaces (Figures 27, 28) and a significant amount of metal filings on the inside surfaces of the gear housing indicate that the process of the destruction of the joint was lasting for a relatively long time and could have covered up to several hundred hours of engine operation. The total destruction of the pins caused the displacement of the bushing relative to the crankshaft and, as a consequence, a significant increase in temperature of both mating elements due to their friction. Signs of high temperature effects are visible on both the bushing and the crankshaft tip (see Figures 24 and 25 and 27 and 28). A significant loss of material as a result of its abrasion caused the bushing to displace and completely interrupt the transmission of drive from the engine to the right propeller shaft.

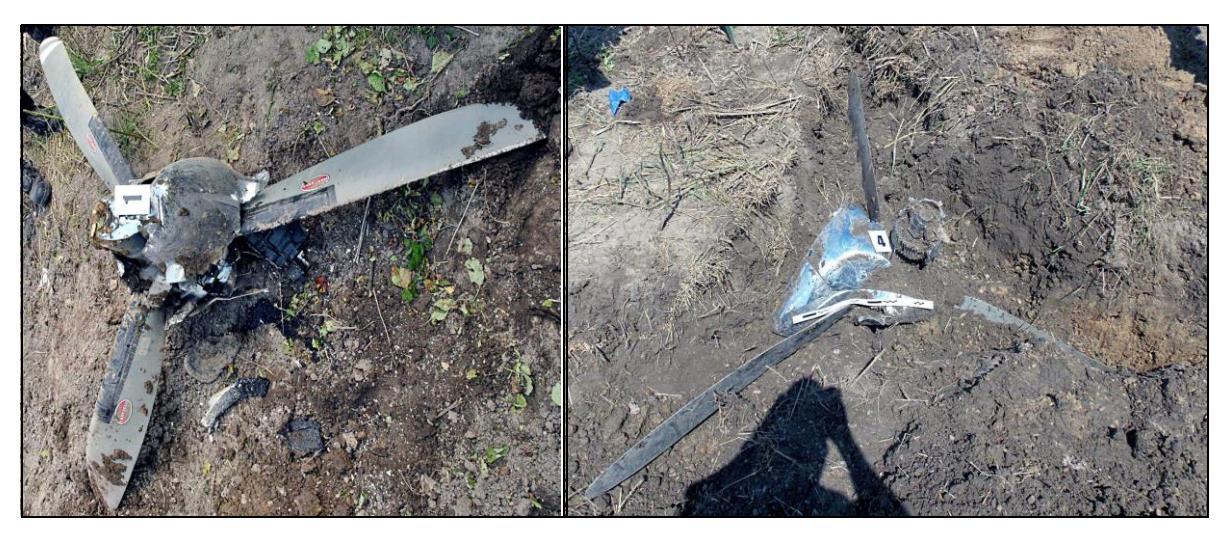
29, 30 - The left and right propeller (driven into the ground) found at the scene of the accident. In both cases the propeller shaft torn out of the gear also visible.

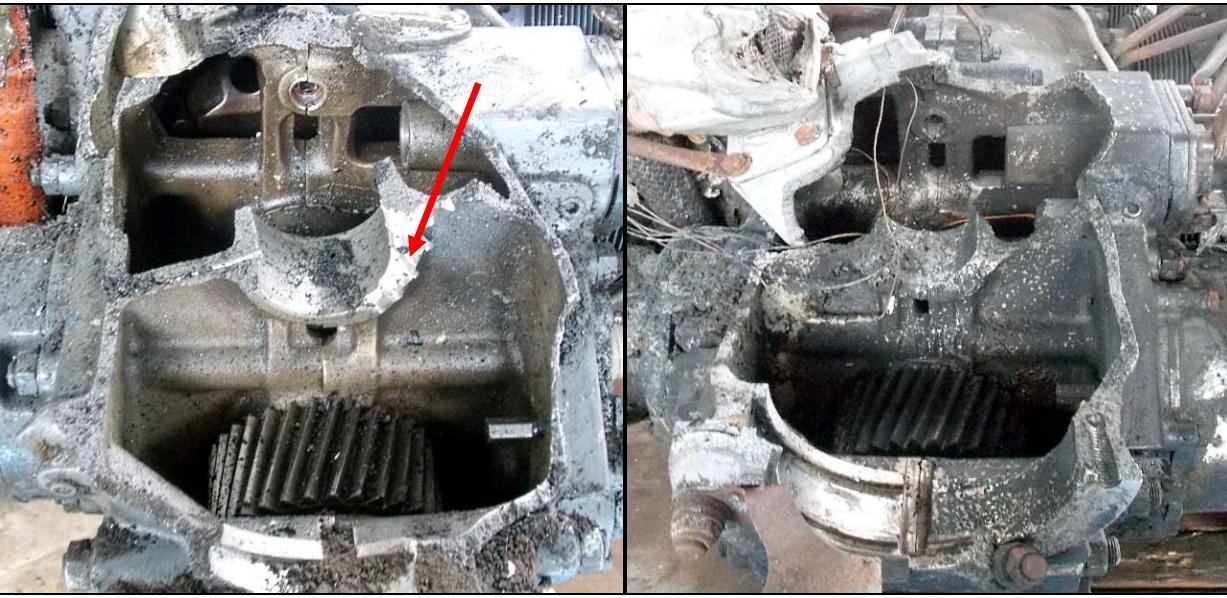
36 – Forward part of the LH engine block – visible fracture of the gearbox casing after separation of part of gearbox. The arrow indicates the dents made by toothed wheel of the gearbox detached together with the propeller

37 - Front the RH engine block – visible fracture of the gearbox casing after separation of part of gearbox and signs of the intensive fire effects

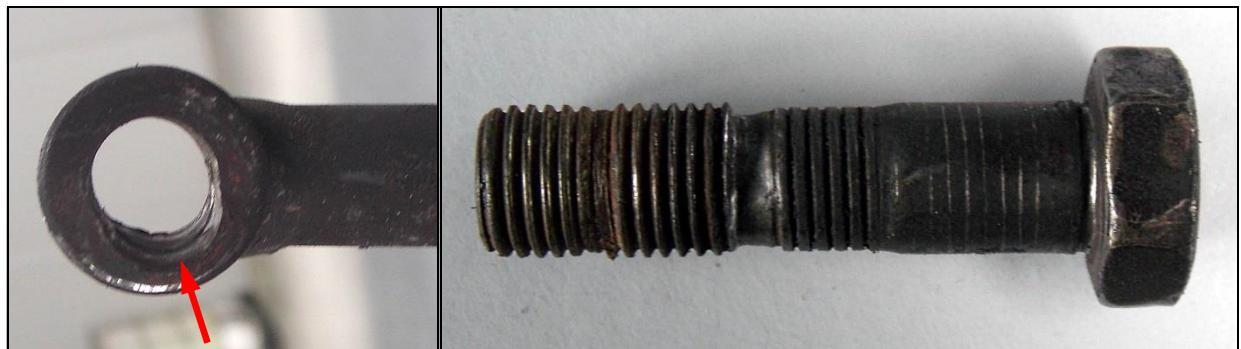
39, 40- The end of the LH engine turbocharger brace with a significantly ovalized hole and substantially damaged screw bolt mating with this hole. The condition of both components showed that the process of their degradation was long-lasting, caused by vibrations and not detected for a long time.

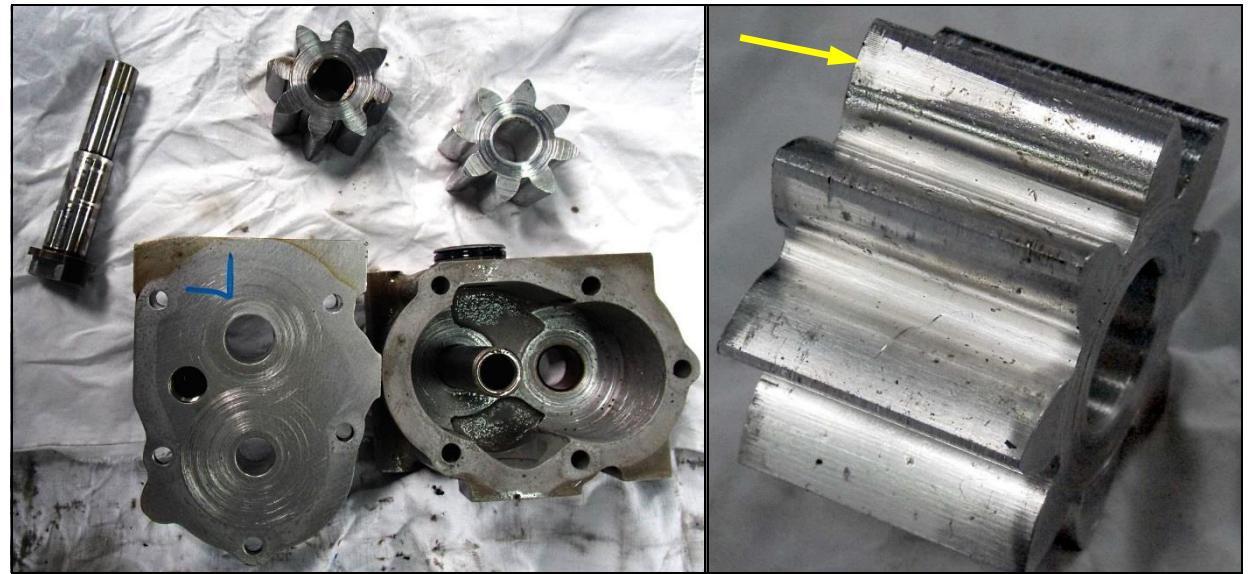
41, 42 - LH engine oil pump with visible scratches on the inside surfaces and close-up on the damaged impeller.

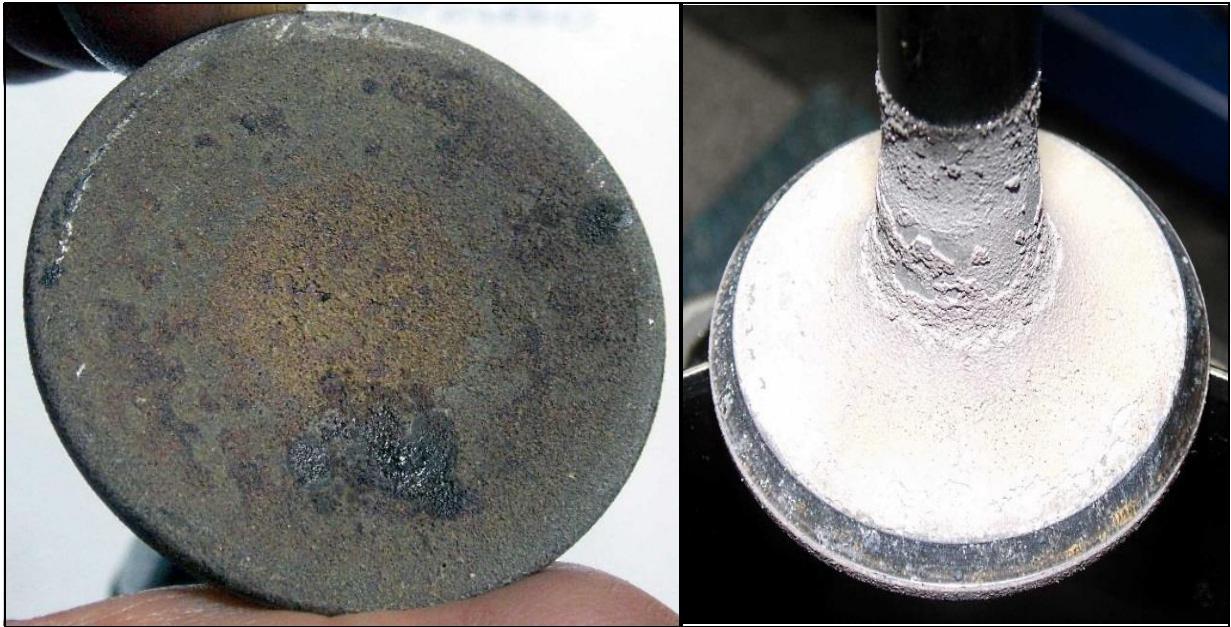
45, 46- Intake valve removed from cylinder No. 1 of the LH engine. Clearly visible condition of the headl surface and significant sediment on the stem side.

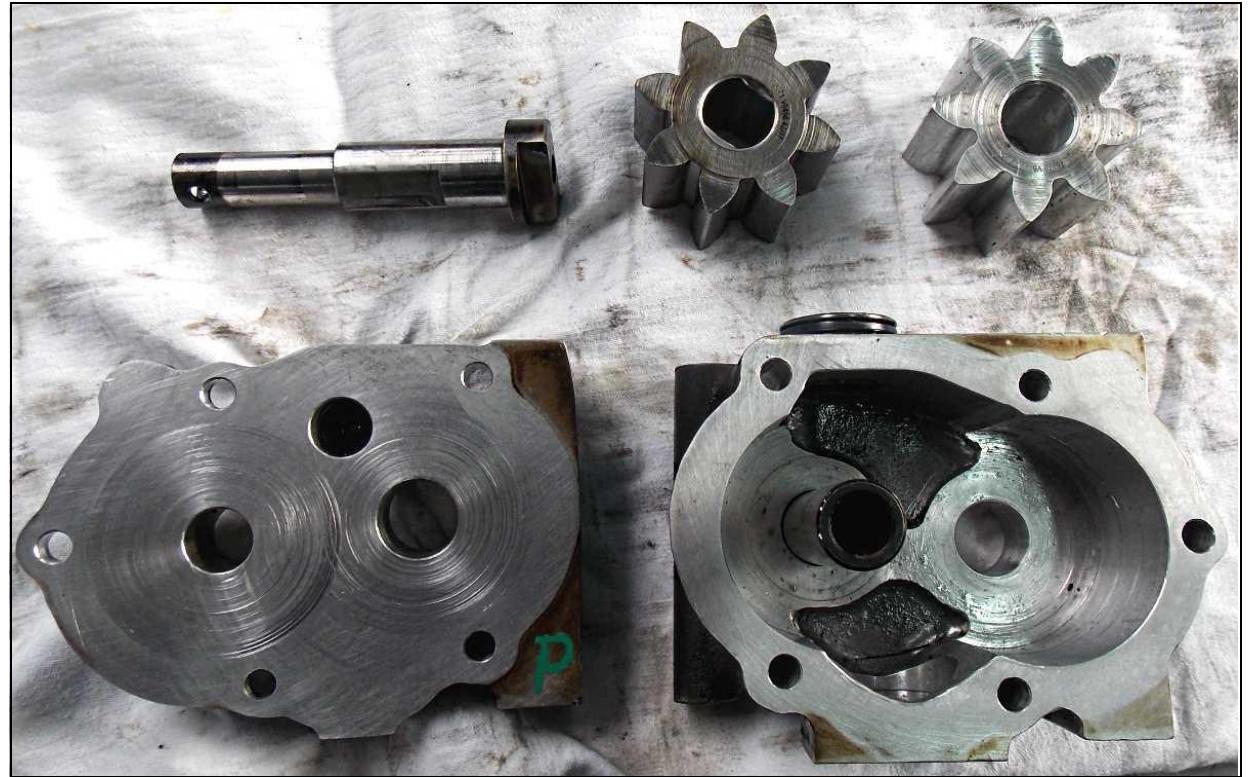
59 - RH engine oil pump - visible scratches on the inside surfaces.
