**State Commission on Aircraft Accidents Investigation**  
**INCIDENT 2022/3446**  
**RESOLUTION**  
**of 16<sup>th</sup> January 2023**

<b>Type and model of aircraft:</b>	Aeroplane, Airbus A321 / Aeroplane, De Havilland DHC8 – 400
<b>Registration marks:</b>	D-AIDG / SP-EQI
<b>Date of occurrence:</b>	14 <sup>th</sup> June 2022
<b>Place of occurrence:</b>	PADKA waypoint area (49°56'02"N 018°17'00"E)

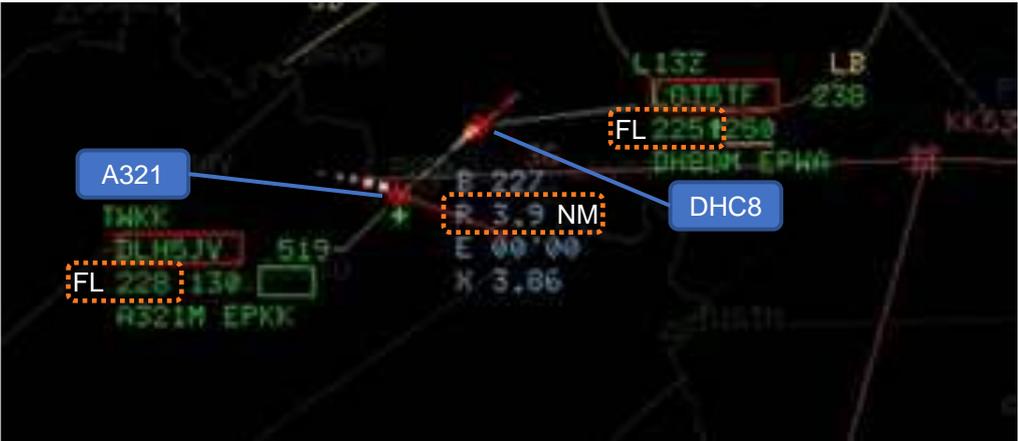
Fig. 1. Shortest distance between aircraft [source: PANSAs]

Corrective actions taken by APP EC increased the horizontal separation from the predicted 3.18 NM to the actual 3.9 NM. The shortest vertical separation was 300 ft. At 16:05:36 hrs, the separation between the aircraft was restored. The involved aircrews did not report activation of TCAS alarms. When the required separation was restored, the crews received the relevant instructions and continued flying as intended.
