FINAL REPORT

SERIOUS INCIDENT

Occurrence No.: 1709/17

Aircraft: Piper P-32R-301T, OH-IJO

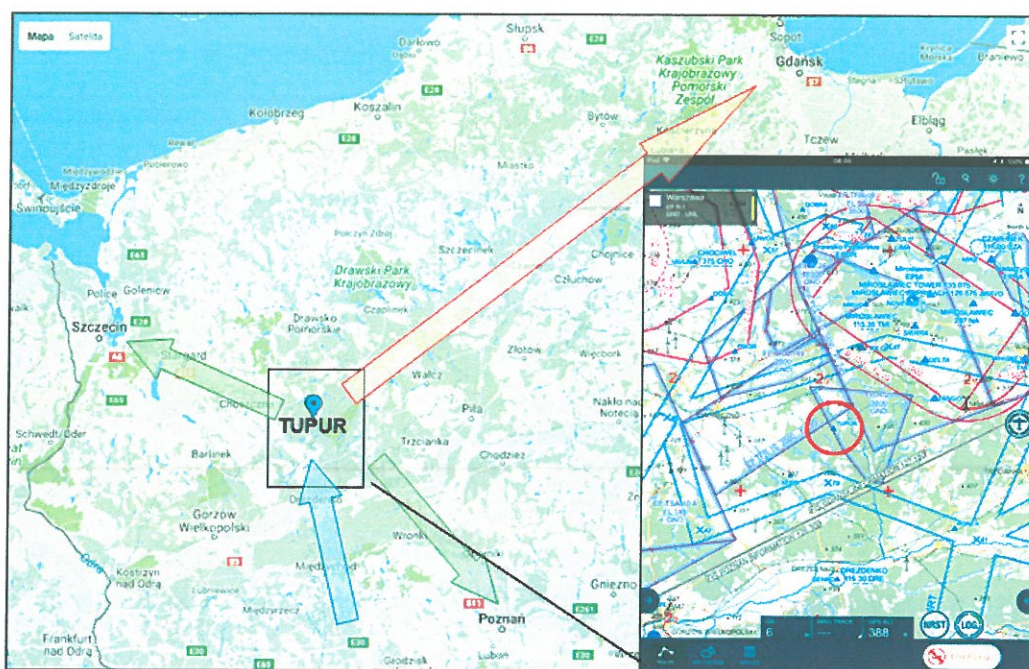
Fig. 3. TUPUR waypoint is the place, where the crew informed EPWW ACC about situation on board. The blue arrow shows the direction of the airplane arrival. The green arrows show the nearest aerodromes indicated by ATC, the red one shows the crew choice.
