# FINAL REPORT

on safety investigation of an aviation accident  
of gliders type **LS8-18**  
registration marks **LY-GOT** and **SP-3893**

Reg. No: **SKA2018002**

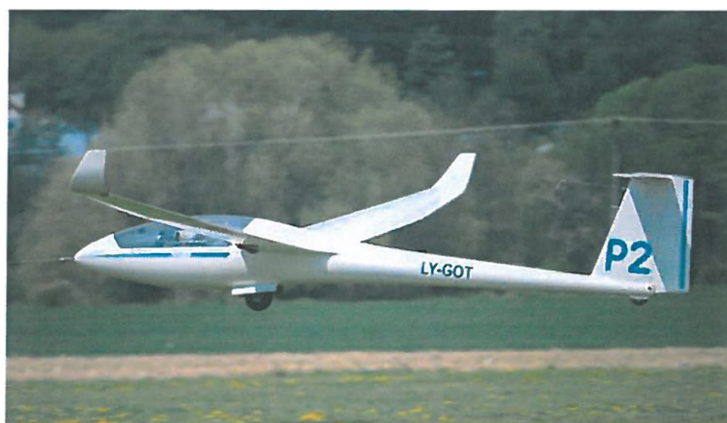
Glider type: LS8-18  
Registration mark: LY-GOT, competition identification sign P2 (hereinafter referred to as "P2")  
Operator/Owner: Kūno kultūros ir sporto departamentas / Kauno apskrities aviacijos sklandymo klubas

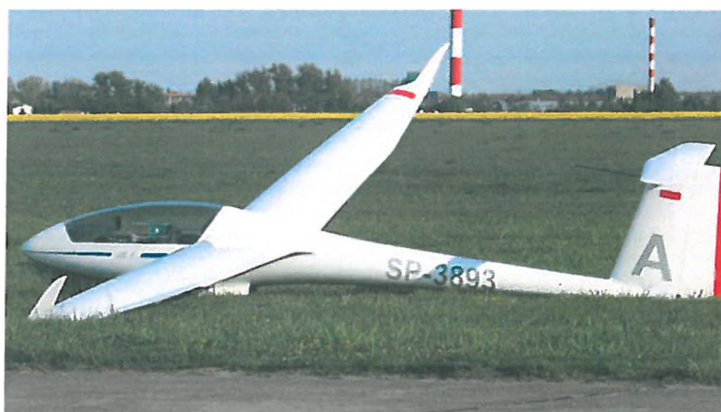
Glider type: LS8-18  
Registration mark: SP-3893, competition identification sign A (hereinafter referred to as "A")  
Operator/Owner: Przemyslaw Bartczak

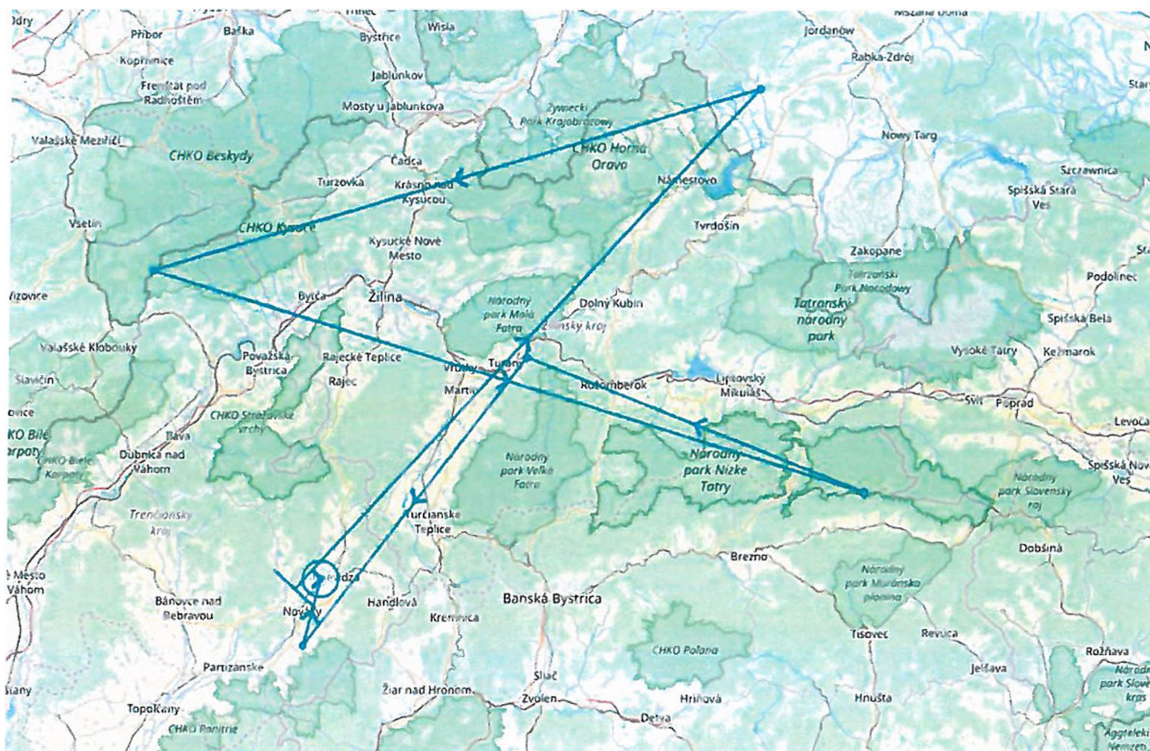
For the 15 m class, the route of the flight had been specified as follows: Dolina – Zubrzica Gorna – Makytká – Heľpa – Krpeľany – Bystričany – Prievidza.

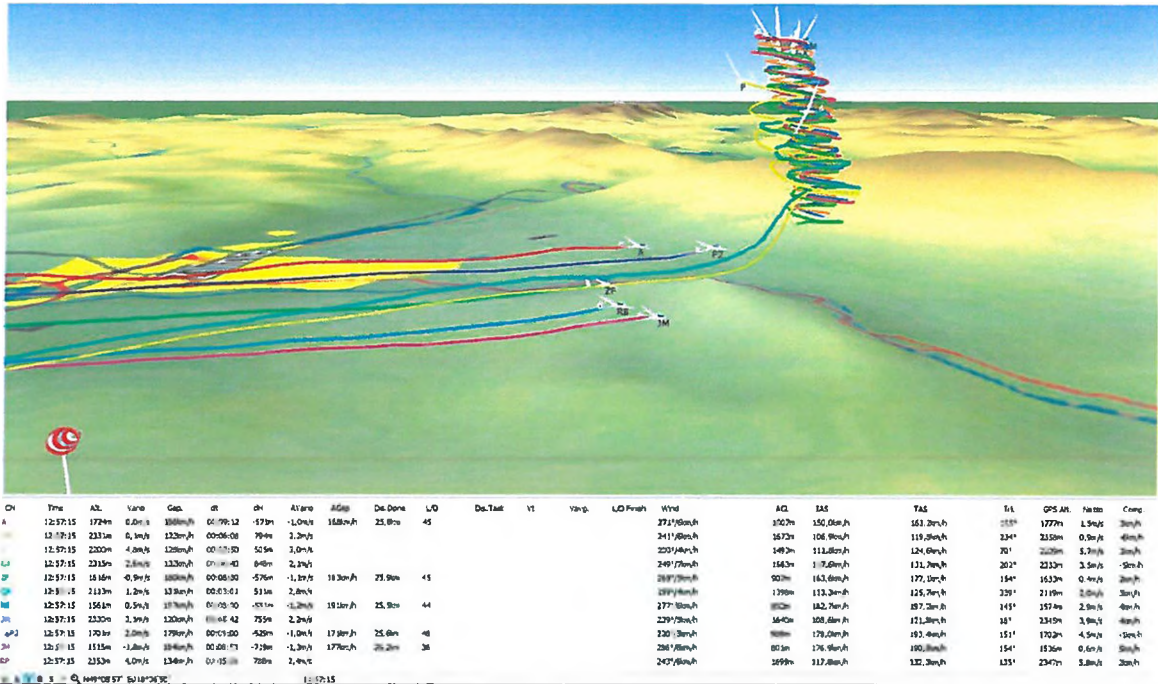
During the third leg of the route, Makytká – Heľpa, heading 150°, at 12:57:15, a group of gliders (registration marks LY-GOT/"P2", SP-3893/"A", LY-6M2/ZM, D-KCRB/RB, YU-4466/ZF) joined other gliders (registration marks SP-3724/RP, D-KUNT/HM, OK-3370/JW, OK-7000/GX, YU-4467/P, OK-2992/QX) which were manoeuvring in a common upward flow in a right turn.

At 12:57:23 the pilot of the "P2" glider was the first one to initiate a manoeuvre with a right turn at an altitude of 1,785 m; position N 49°08'48", E 018°36'58". At that time, the "A" glider was 350 m far from the "P2" glider.

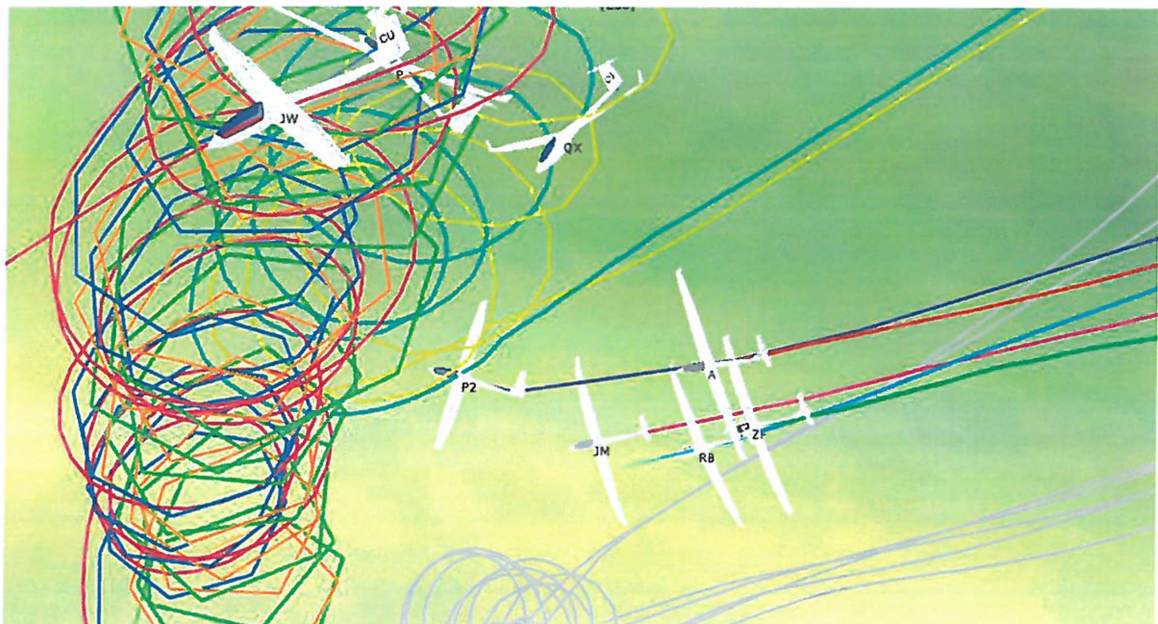
At 12:57:27 the pilot of the "A" glider was the second one to initiate a manoeuvre with a right turn at an altitude of 1,794 m, position N 49°08'54", E 018°36'56", with a horizontal separation of 320 m.

During the right turn, the pilot of the "A" glider got above the "P2" glider in the upward flow and subsequently lost visual contact with it.

At 12:57:37 the gliders approached each other so closely that they collided in the right turn; position N 49°08'47", E 018°36'49".

Being 4 m above the "P2" glider, the "A" glider's left wing hit the left wing of the "P2" glider at an altitude of 1,850 m; 710 m above the terrain.

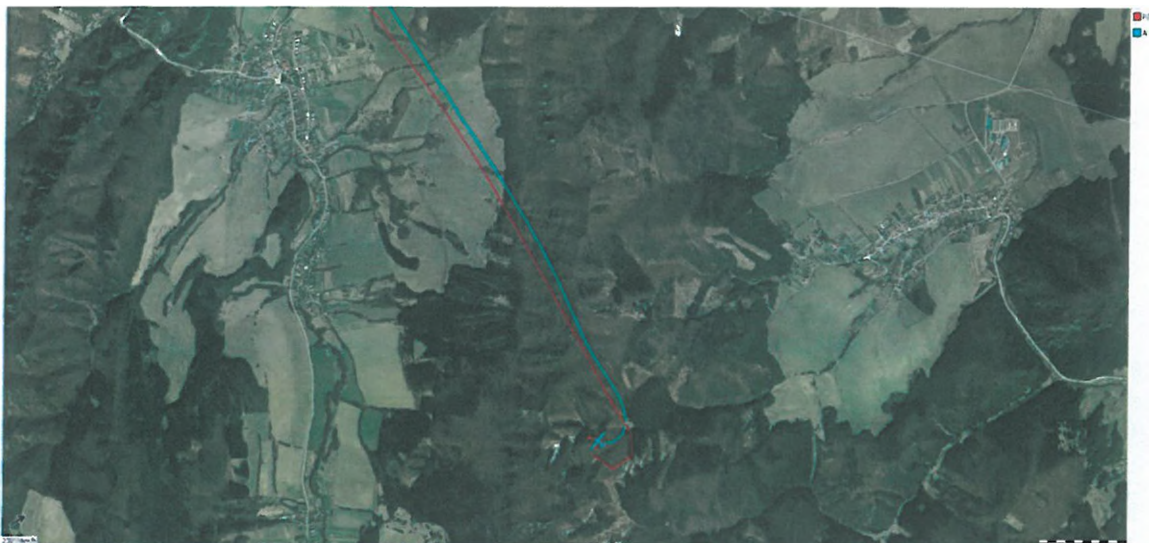
"P2" glider crash site: N 49°09'60"; E 018°37'21"

"A" glider crash site: N 49°08'45"; E 018°36'58"
