FINAL REPORT

OCCURRENCE NO – 1511/18

AIRCRAFT – aeroplane, VANS RV-10, UR-PMAV

DATE AND PLACE OF OCCURRENCE – 9 June 2018, Rzeszów (EPRZ)

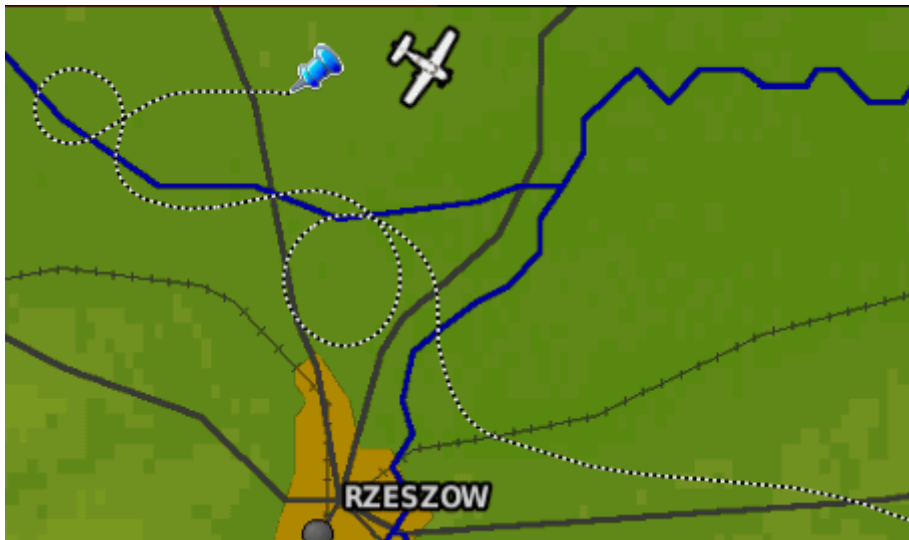
Prior to entering the EPRZ control zone the crew of the leading airplane established communication with EPRZ Tower and received clearance for both aircraft to land (the leader as number one and UR-PMAV as number two). In order to increase the separation between the planes, the pilot of UR-PMAV made two circles and only then turned on final for landing (Fig. 2).

Fig 2. Final portion of the flight according to GPS recording.

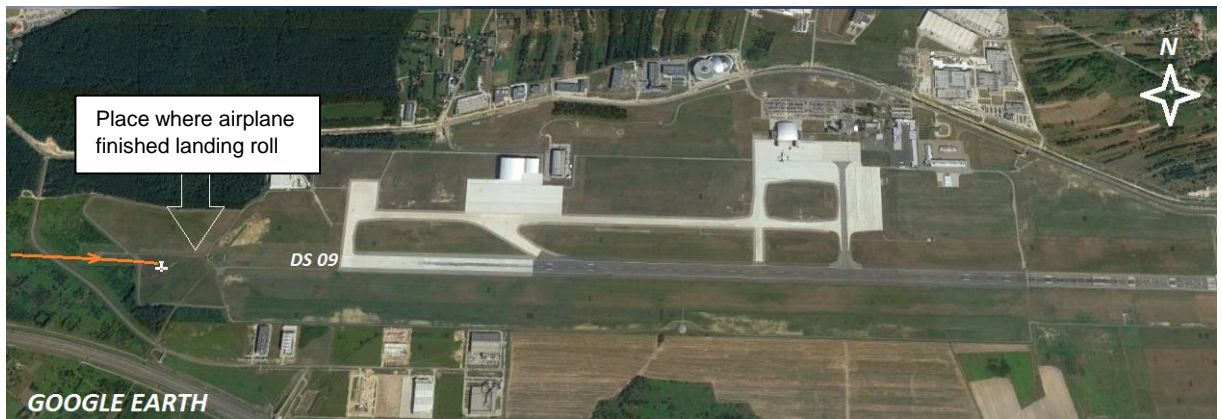
After landing on RWY 09 and vacating it the crew of the leading aircraft expected that UR-PMAV was on final and would land just after them. Because it did not land, the crew of the leading aircraft and EPRZ Tower attempted to establish communication with it but failed. Around 12:42 hrs the crew of the leading aircraft reported to the Tower that UR-PMAV had made an emergency landing short of RWY 09 threshold (Fig. 3). They obtained such information by phone from the crew of UR-PMAV.

Fig 3. Sketch of the accident site.

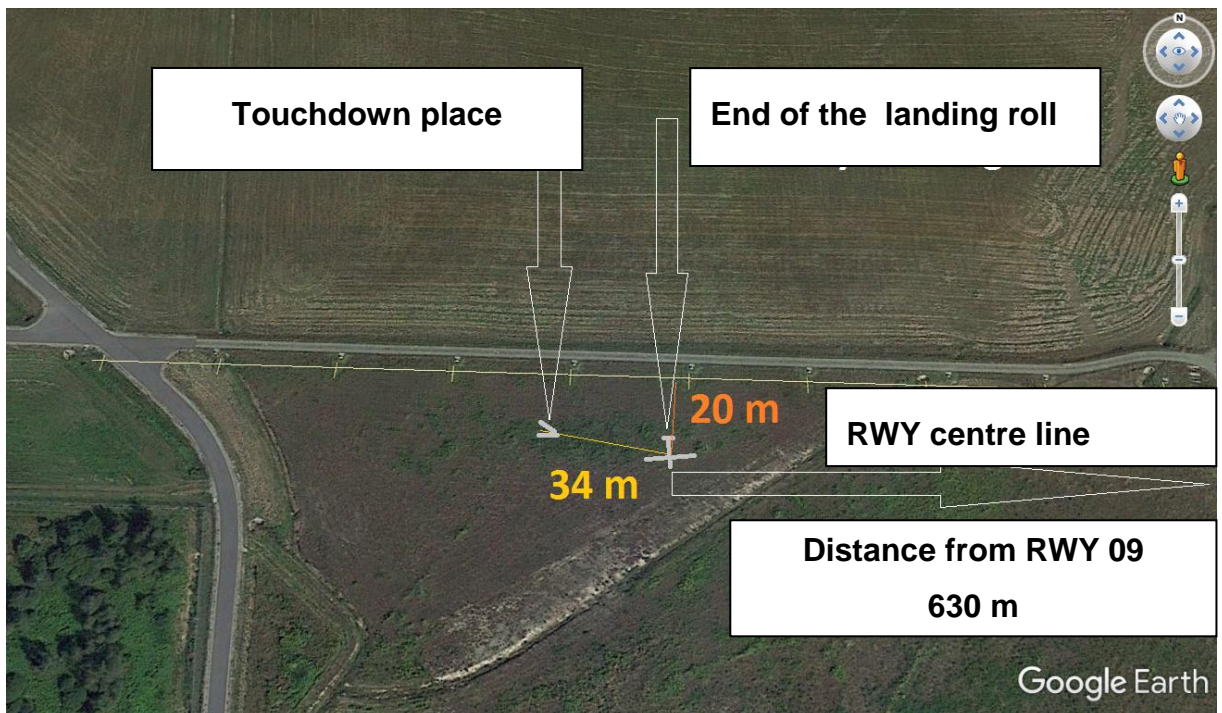
The touchdown took place about 630 m from RWY 09 threshold and about 20 m from its centre line (Fig. 9).

Fig. 9. Sketch of the occurrence place [source: PKBWL]

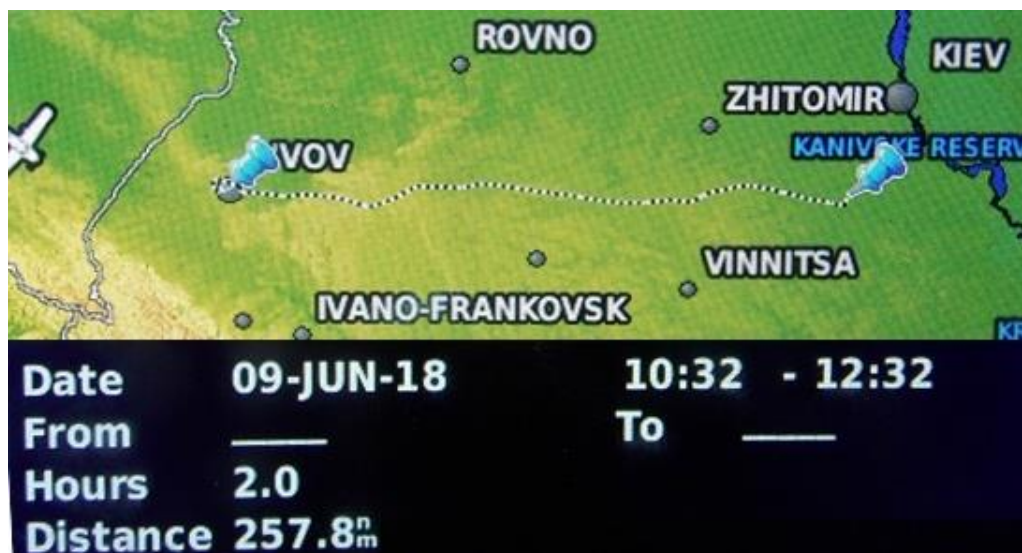
The first segment of the flight began in Biała Cerkiew near Kiev at 8:32 hrs and ended in Lviv at 10:32 hrs (Fig. 20).

Fig.20. The flight route from Kiev to Lviv and the flight time as recorded by GPS.

The pilot stated that during the flight to Lviv the fuel selector valve was set to the sum (the engine was taking fuel from both tanks). The pilot stated *"I refueled aircraft in Biała Cerkiew with 220 liters of fuel, i.e. 110 liters in each tank, I checked visually in Lviv, it was half in each tank. The plane consumes up to 45 liters per hour, I would fly to Dresden with this fuel"*.

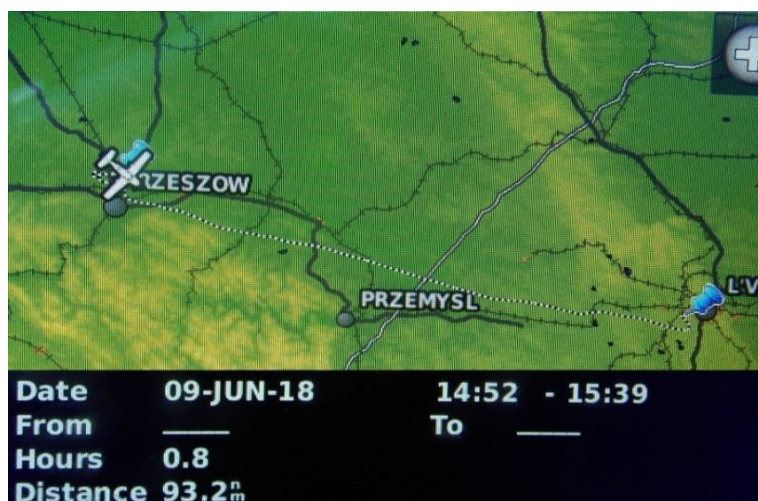
The flight from Lviv to Rzeszów lasted 48 minutes (Fig. 22 (Fig. 22)).

Fig.22. The flight route from Lviv to Rzeszów and the flight time recorded by GPS

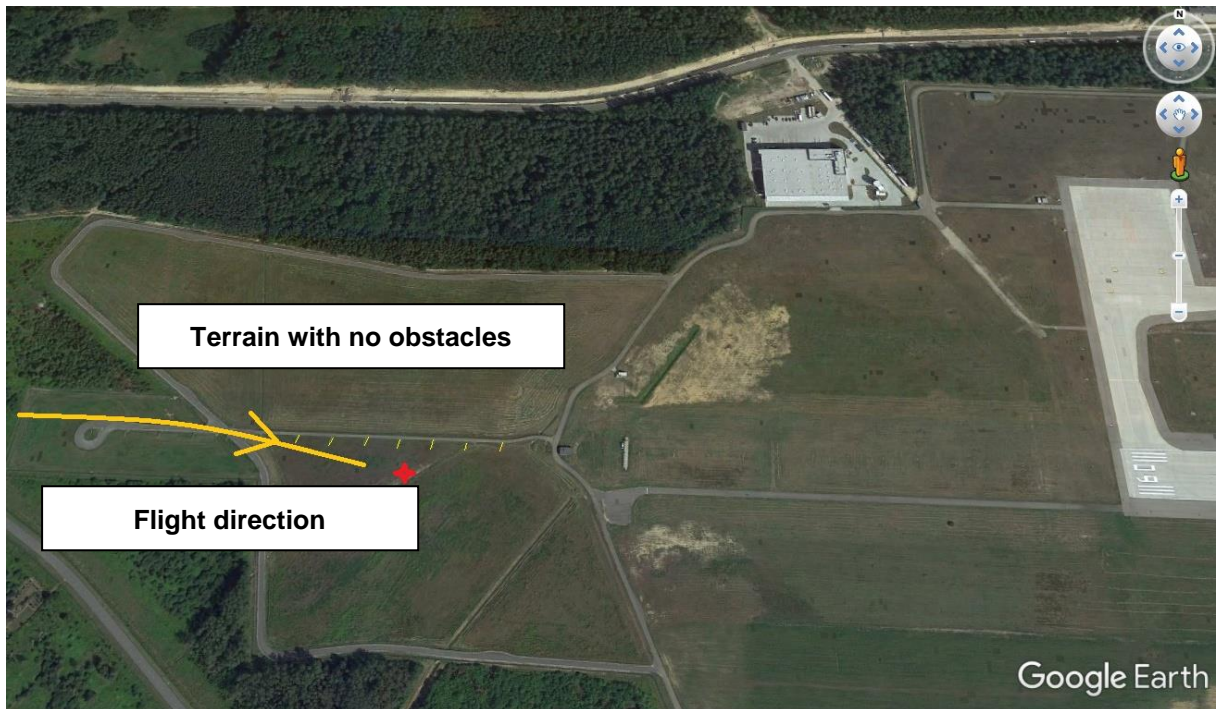
Pilot 2 stated that when he noticed that they were not able to reach the runway, he took control of the aircraft. He noticed in front of him the poles of approach lights and to avoid collision with them he turned right. The area on the left of the approach lights was better for emergency landing (Fig. 23).

However, it should be noted, that the pilots operated in a time deficit and the choice of a landing site was rather a matter of impulse. Immediately after correcting the flight direction, Pilot 2 pulled the joystick backward. The plane raised nose and entered the first phase of a stall and a moment later hit the ground with the main landing gear.

Fig.23. Terrain in front of the runway.
