FINAL REPORT

DRAFT FINAL REPORT

OCCURRENCE NO— 2464/18

AIRCRAFT—glider, HPH 304 S Jet, D- KTGM

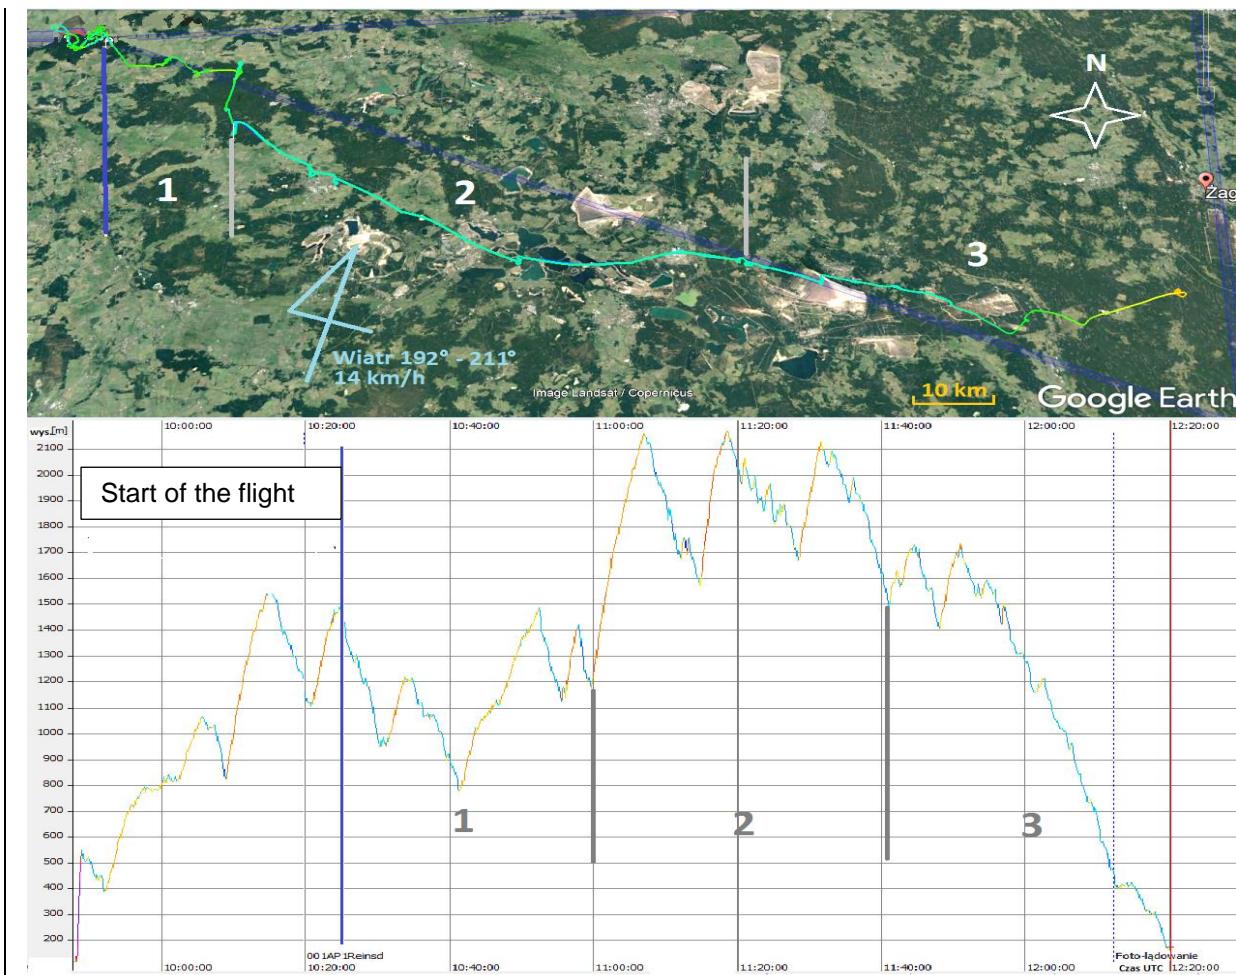
Fig. 3. Flight route and altitude derived from GPS recording [source: PKBWL]

The average value of thermal lifts during the flight was 1.3 m/s. The pilot started the flight at 12:25hrs LMT from a height of about 1450 m (the glider was south of the aerodrome – Fig. 3 – blue line). The initial section of the flight (Fig. 3 – 1) was performed in the range from about 780 to 1450 m.

In the fourth thermal column (Fig. 3 – section 2) the pilot started circling at an altitude of about 1200 m and the glider climbed to about 2150 m. The next two thermal columns were left by a glider at a similar altitude (probably it was the cloud base in this region). The next two thermal columns (Fig. 3 – section 3) were left by the glider at about 1,700 m (probably the cloud base have decreased).
