FINAL REPORT

2018-169-4

Accident

PW-5 "Smyk"

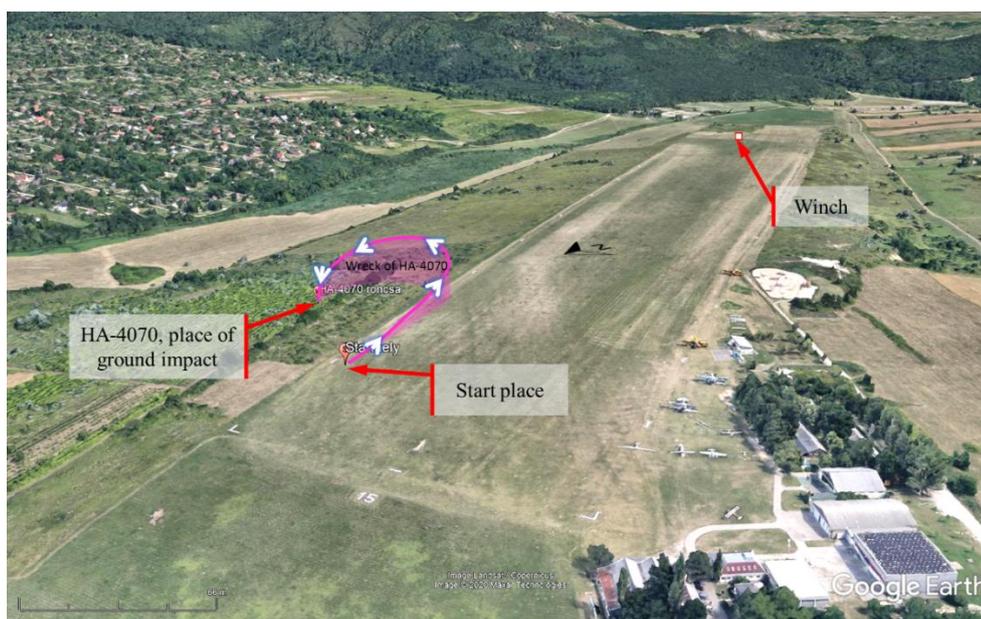
Figure 4: The path of the flight ending up in accident

According to the winch operator, he had to operate the winch very carefully because of the strong wind, but nothing special had happened during the winch launches until the accident; not even a rope-break simulation had been planned, so he had to perform normal launches. In the morning, he checked the machine before use, and found everything all right. He had winched the PW-5 several times on that day, and, as it is a light aircraft, he started the launch very carefully, accelerating the aircraft gradually. Due to a hump on the strip, he did not see the aircraft at the beginning of the launch, only after it appeared above the horizon (Figure 4). Then he saw that the aircraft suddenly “broke” to the right (from the winch operator’s perspective). The winch operator immediately applied the brake and stopped the drum.

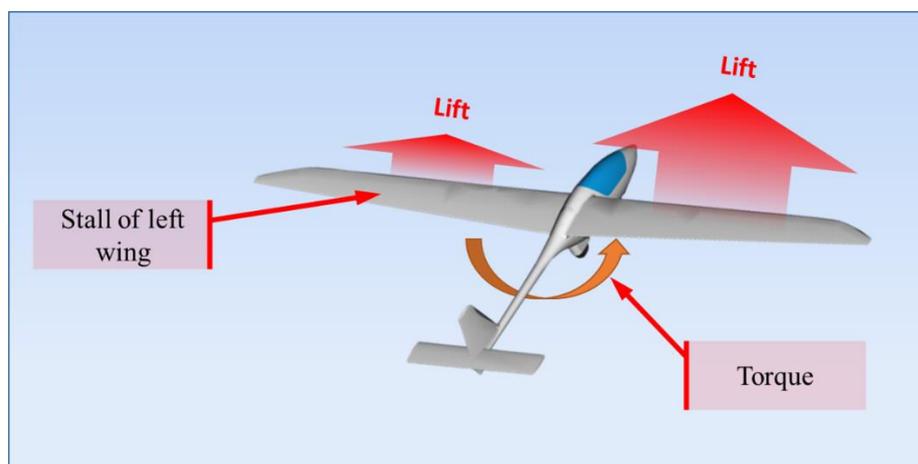
Figure 9: asymmetric stalling of an aircraft

According to reports from witnesses and the fact that the aircraft crashed to ground left of the line of winching (Figure 8/ (2)), it may be stated that, during the stall, the airflow separated from the left wing first, thus creating an asymmetric lift distribution (Figure 8/ (3) and Figure 9). As a result, the sailplane deviated from the intended flight path in a left rolling movement (Figure 8/ (4), (5)), and finally it crashed to the vegetation and the ground.

According to the IC, it cannot be stated with certainty that the Student Pilot caused the stalling of the aircraft solely by control stick handling. It cannot be verified either that excessive pitch angle was caused by possible stalling of the stabilizer in the initial phase of winch launch.
