# Final Report

Accident with the helicopter Sokol W-3A,  
on 14.01.2019, at approx. 11:34 UTC at Bürglkopf,  
Gemeinde Fieberbrunn, A-6391, Tyrol,  
GZ.: 2021-0.905.481

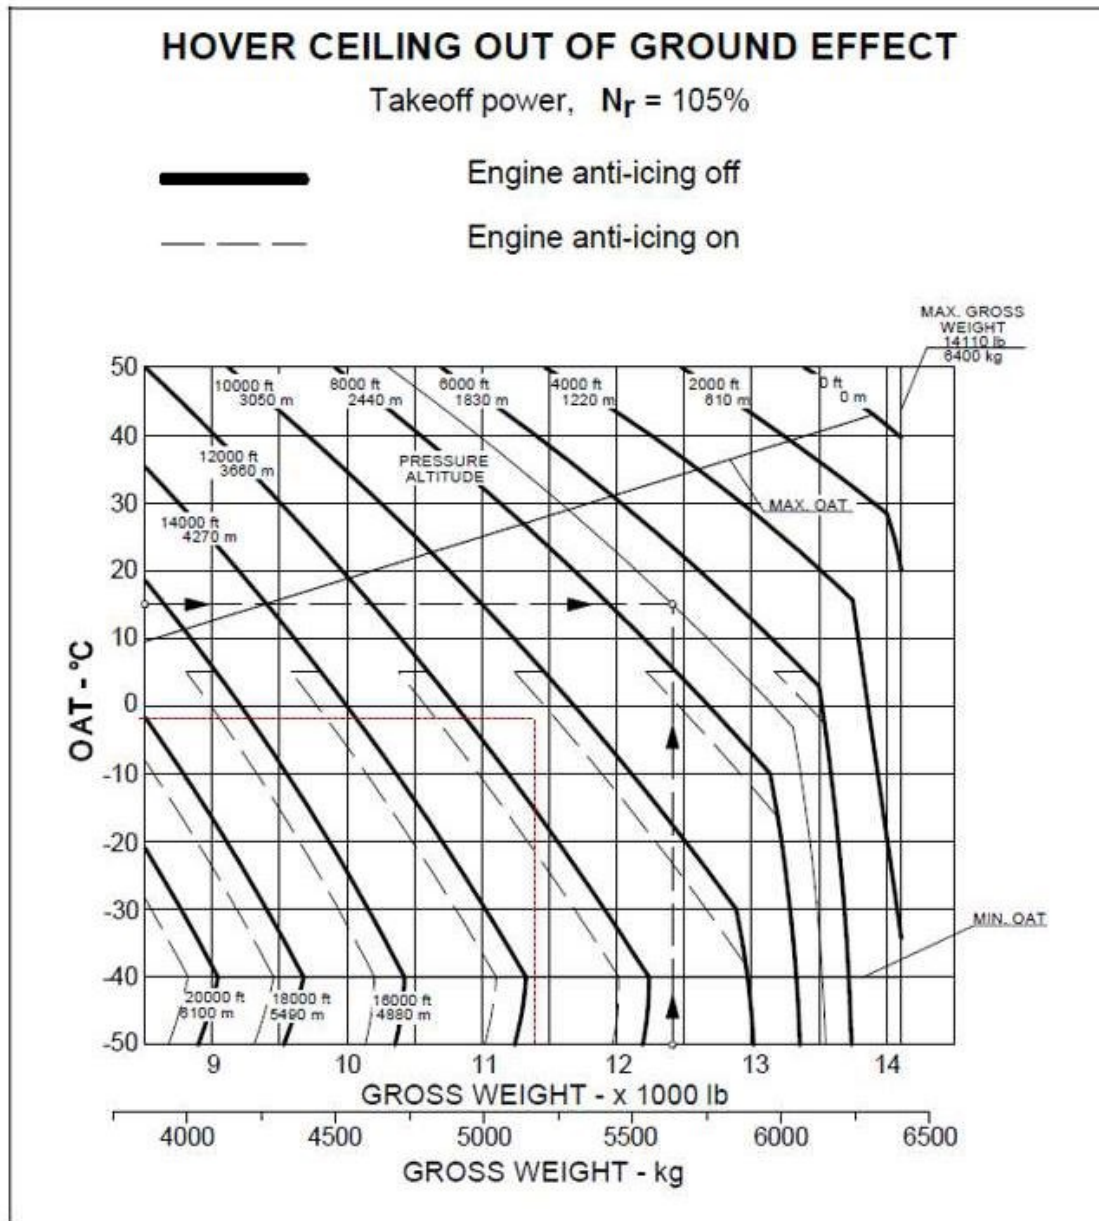
Figure 3: Hover ceiling out of ground effect

The pilot had a power of OEI 30 min at his disposal.

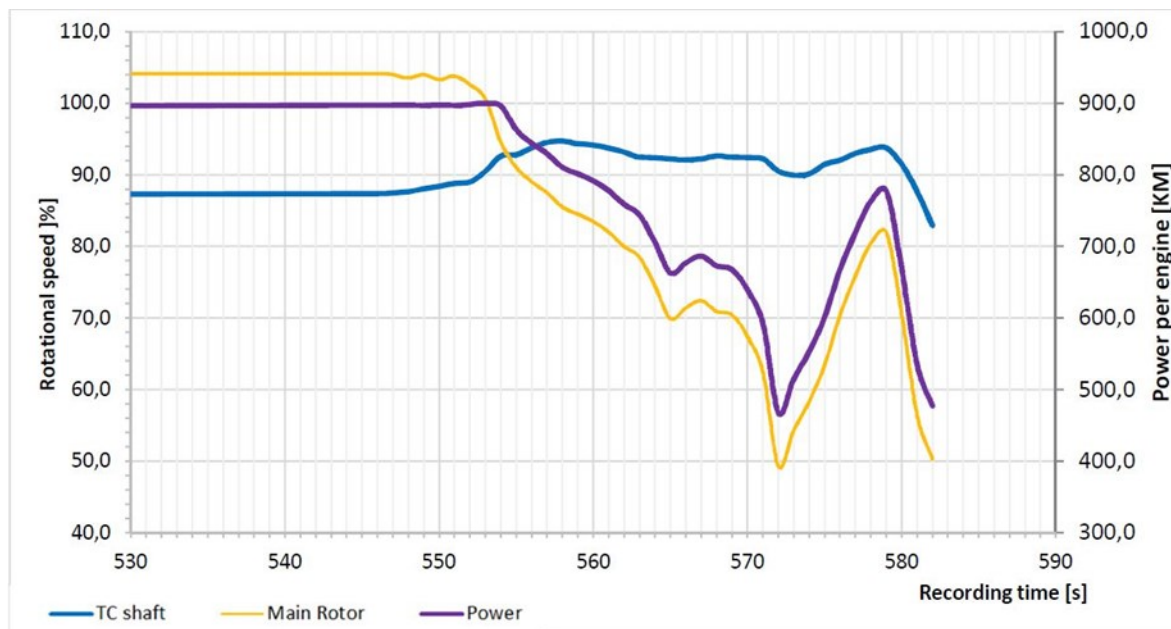
Figure 4: Extract from the report RB/P/401,64/4/2019

„...If only OEI 30min. power from one engine is available (no disposable power provided by the other engine), it is not possible to perform the hover in windless conditions for the undisturbed rotor characteristics (without icing). For the disposable power value presented in Figure 4 and the WN RPM, the hover IGE in windless conditions would have been possible

with undisturbed main rotor characteristics (no icing) until the moment of the detected ground contact. This suggests that at the time of the incident, the power demand of the engines for flight and hover was greater than that corresponding to the undisturbed rotor characteristics. In addition, the amount of disposable power of the engines prior to the onset of the event, shown in Figure 4, suggests a significantly higher demand for power needed for flight (the use of take-off power to perform a level flight shown in Figure 4 suggests an excess power demand of 400-600[hp] over the baseline level of the power needed). The accurate determination of the power required for flight is very difficult due to the lack of helicopter airspeed data at the time of the incident...”

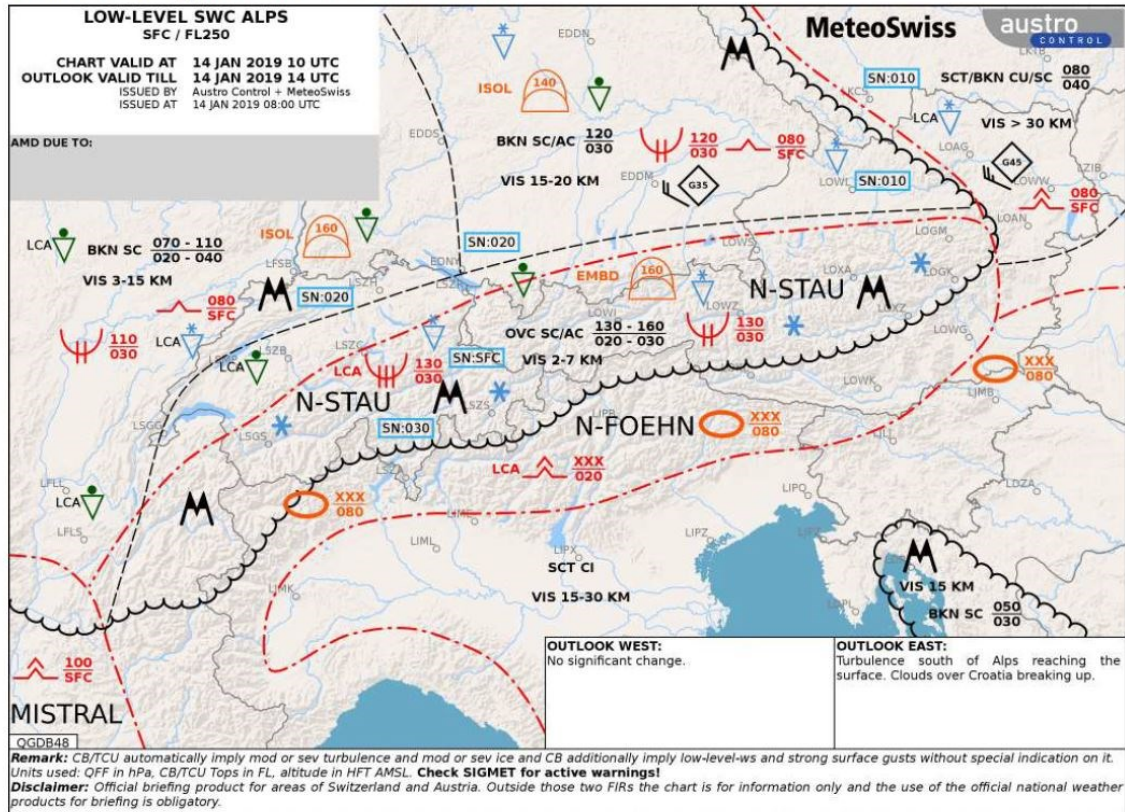
Figure 10: Low-Level Significant weather chart

The contents of the Low-Level Significant and the W/T Chart applicable at the time of the accident predicted snow showers, moderate icing conditions between 3,000 feet (915 metres above MSL) and 13,000 feet, and main cloud bases of approximately 2,000 feet to 3,000 feet for the incident site and its wider surroundings.

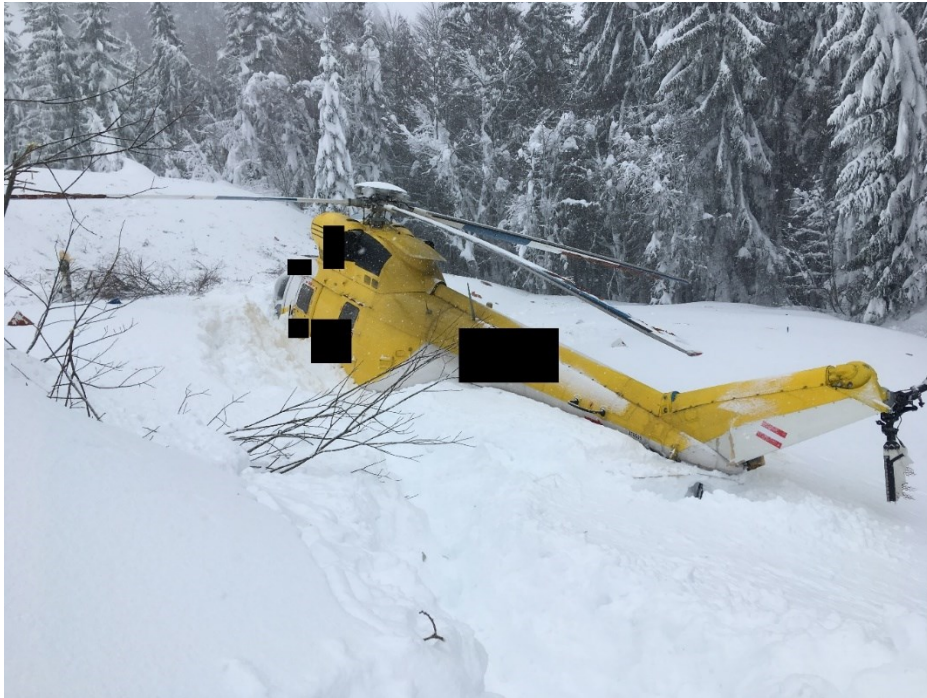
Figure 13: Position of the helicopter direct after the emergency landing

The picture of the emergency landing site (see Figure 12) was taken the day after the emergency landing. The pictures in Figure 13, Figure 14 and Figure 15 were taken by the flight helper immediately after the emergency landing. The snow on the rotor blades

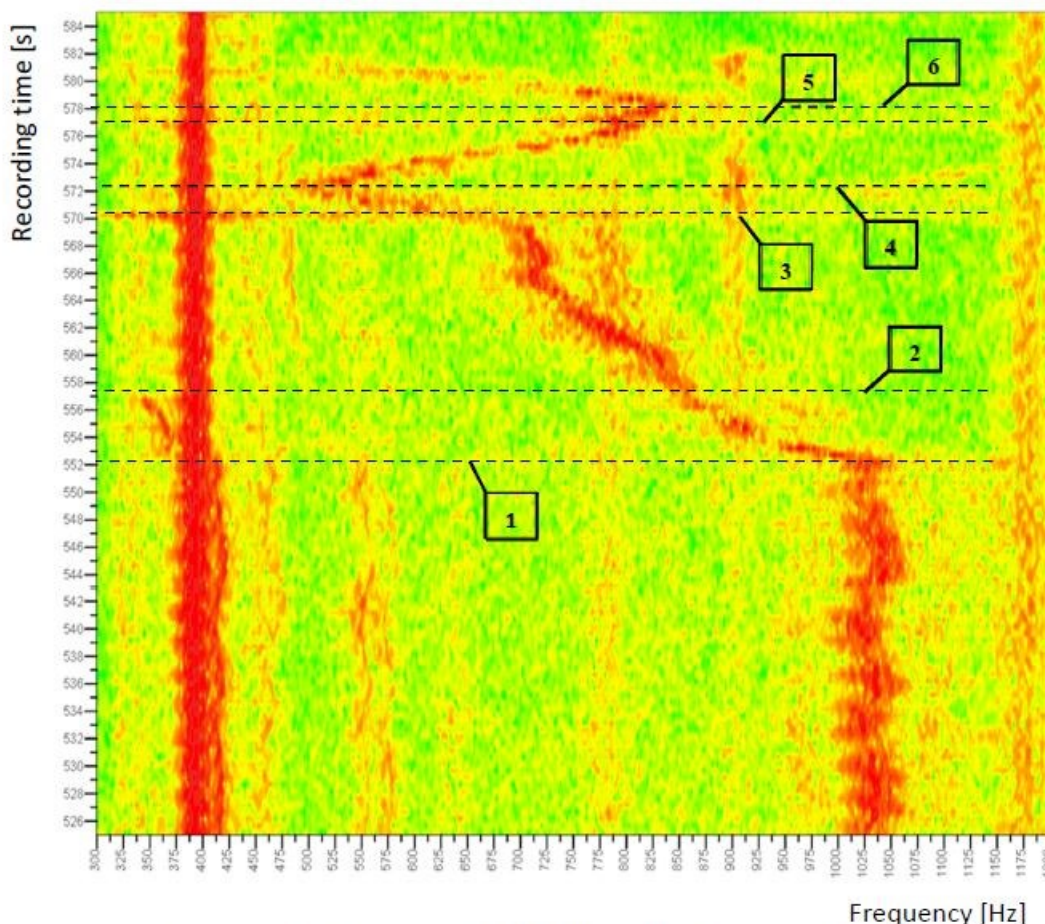
Figure 16: Extract from the report RB/P/401,64/4/2019

The figures 16, 17 show the analysis of the acoustic recording. The figures show the signal spectrum for the recording fragment when the main rotor speed decreased and the engine was shut down.

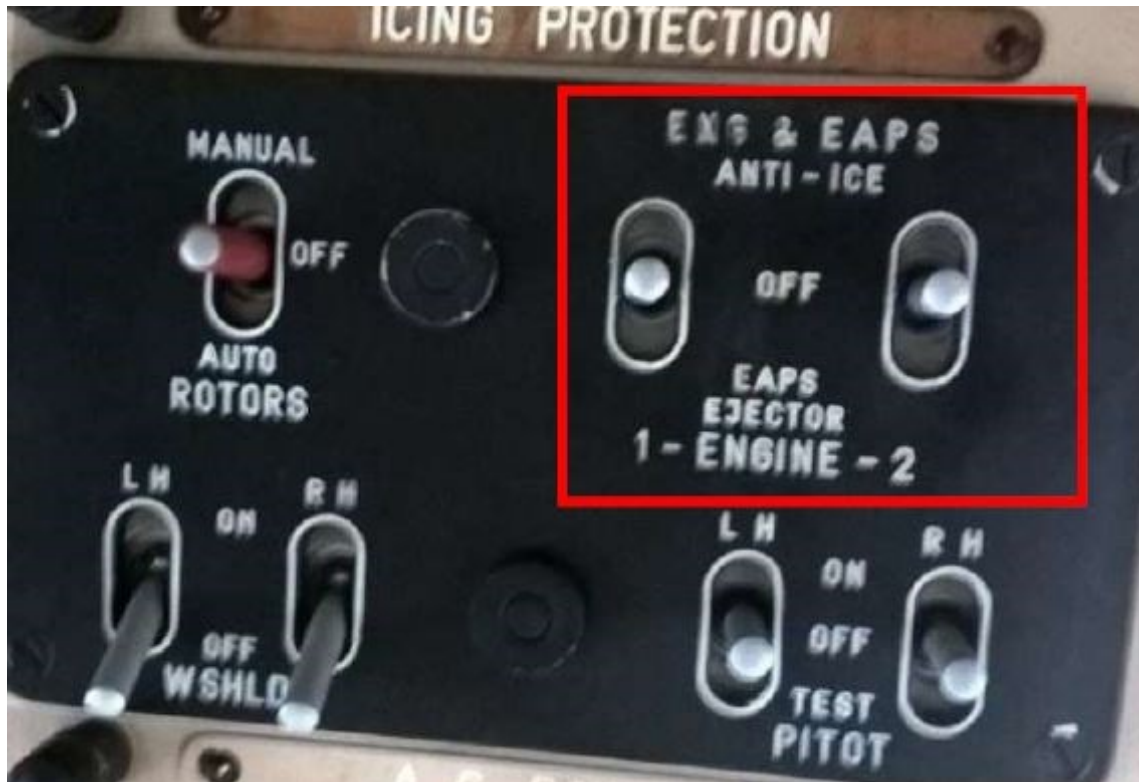
Figure 25: Icing protection

The Engine Inlet Anti-Icing System is actively activated by the pilot by means of toggle switches in the cockpit, whereby both engines have separate switches and technically speaking, fully separate systems. The two toggle switches in the cockpit (one per engine) on the "ICING PROTECTION" panel (positioned on the overhead panel) have three positions each. In the middle position the entire EAPS and Engine Inlet Anti-Icing system is switched off, in the forward position only EAPS Anti-Icing is activated, in the aft position both Engine Inlet Anti-Icing and EAPS Anti-Icing system are active. The Engine Inlet Anti-Icing System must be activated when the outside temperature is less than 5° Celsius.

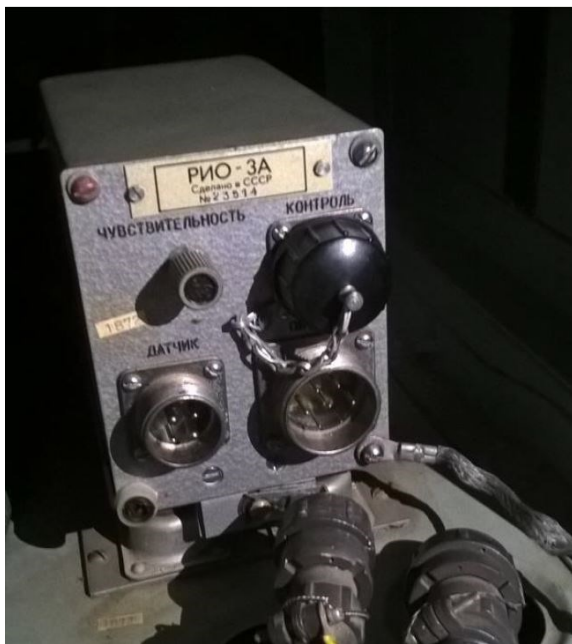
Figure 28: Controll unit RIO 3A

- helicopter de-icing system in Manual Mode verification – proper operation
- helicopter de-icing system in Auto Mode verification
  - no illumination of the "ICE" warning light, no activation of the installed de-icing system.
  - system electric circuit verification in order to failure localization. It was found that two connectors were not connected to the control unit of the RIO 3A sensor, see Figure 28.
  - When the connection with the RIO 3A control unit was established, it could be determined that the "ICE" warning lamp was permanently activated (regardless of which signal the RIO 3A sensor had transmitted). Afterwards the RIO 3A sensor including the cabling up to the RIO 3A control unit was checked, this was done without any abnormalities.
