FINAL REPORT

OCCURRENCE NO – 2019/436

AIRCRAFT – BOEING 777-258, 4X-ECC

DATE AND PLACE OF OCCURENCE – 15 February, 2019, EPWA

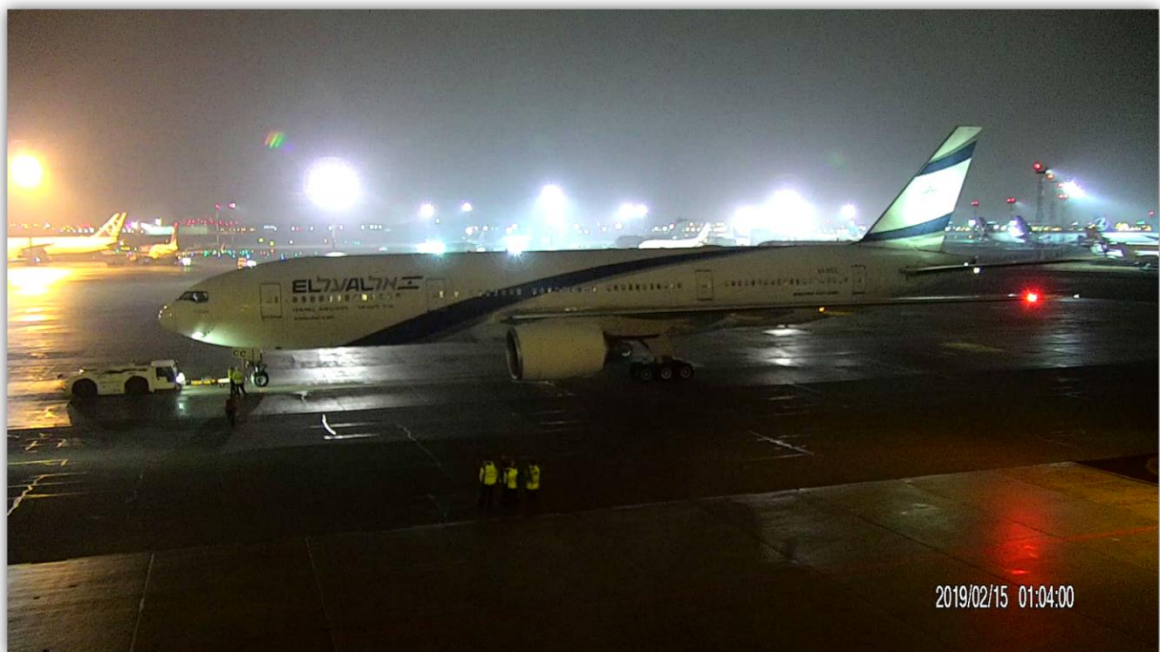
Fig. 1. Boeing B777-258, accident aircraft before push-back [source: CCTV camera of VIP terminal on EPWA aerodrome]². Note: The date and time in the lower right corner are in the LMT.
