FINAL REPORT

OCCURRENCE NO – 2021/345

AIRCRAFT – Helicopter, Bell 429, SP-KKS

DATE AND PLACE OF OCCURENCE – 22 February 2021, EPPY

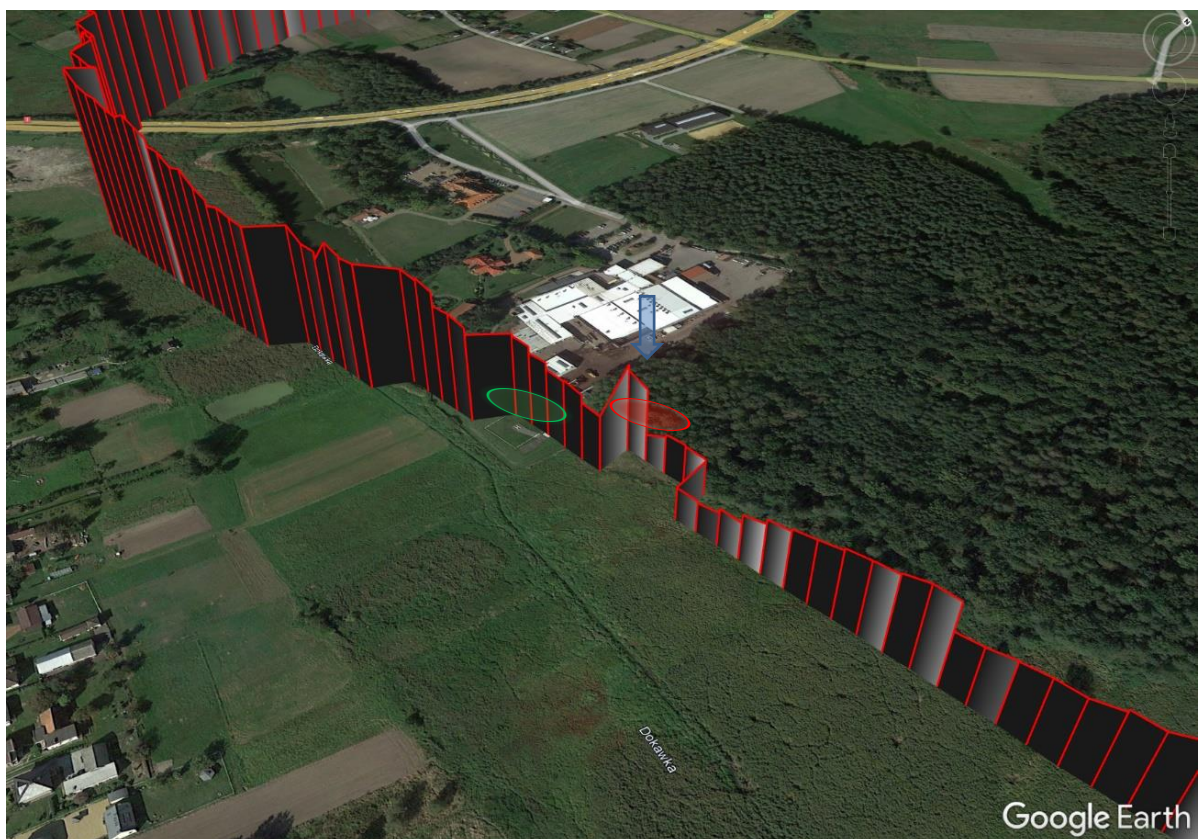
Fig. 13. Helicopter flight path: the place of the first approach to landing is marked with a red circle, the place of intended landing is marked with a green circle, the place of exceeding the TQ is marked with a blue arrow [source: PKBWL]

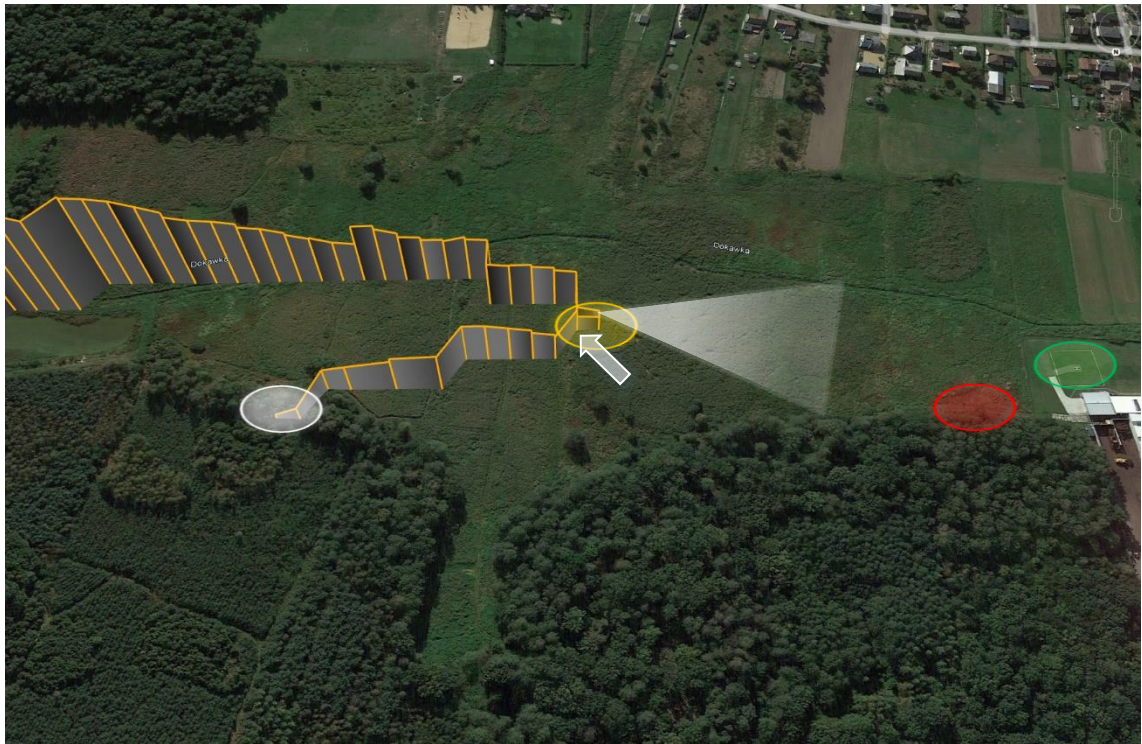
Fig. 14. Second approach flight path: the accident site is marked with a white circle, the place of the second approach is marked with a yellow circle, the place of the first approach is marked with a red circle, the place of intended landing is marked with a green circle, the place of turning on the landing light is marked with a white triangle, and the second exceeding of the TQ is marked with a white arrow [source: PKBWL]

During the second attempt to land, the pilot turned on the landing light, which, in the presence of fog, caused a temporary loss of visibility by the pilot (according to the passenger's statement, everything outside turned "completely white").

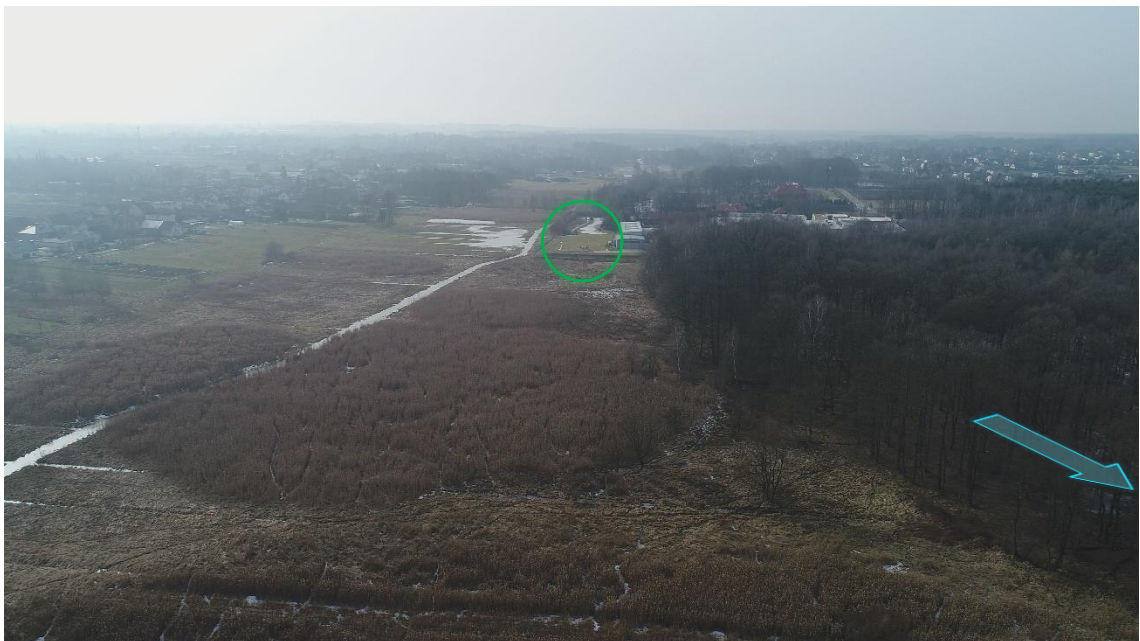
The general view of the accident site is shown in Figs. 15, 16, 17 and 18.

All the wreckage of the helicopter was found at the edge of the forest, in one area of several hundred square meters. No part of the helicopter was found to detach from it prior to collision with trees.

Fig. 15. Accident area – the blue arrow indicates the direction of the flight, EPPY helipad is marked with a green circle [source: PKBWL]

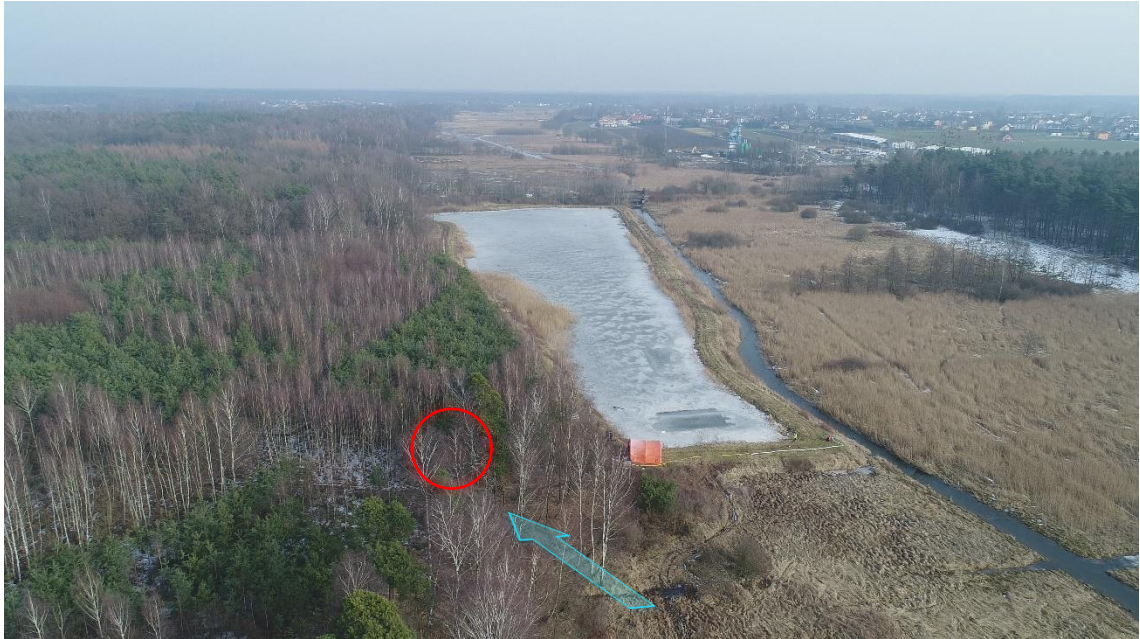
Fig. 16. Accident area – the blue arrow indicates the direction of the flight, the red circle indicates the accident place [source: PKBWL]

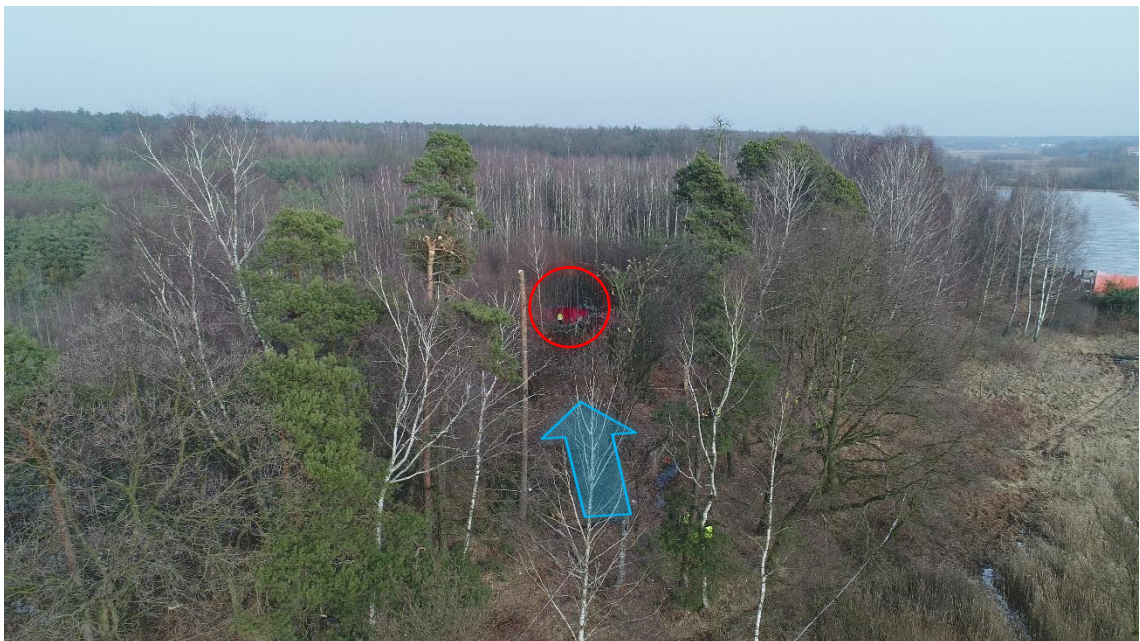
Fig. 17. Accident area – the blue arrow indicates the direction of the flight, the red circle marks the accident place [source: PKBWL]
