FINAL REPORT

State Commission on Aircraft Accidents Investigation (PKBWL)

OCCURRENCE NO – 2022/1340

AIRCRAFT – ULTRALIGHT AMPHIBIA, N27ZX

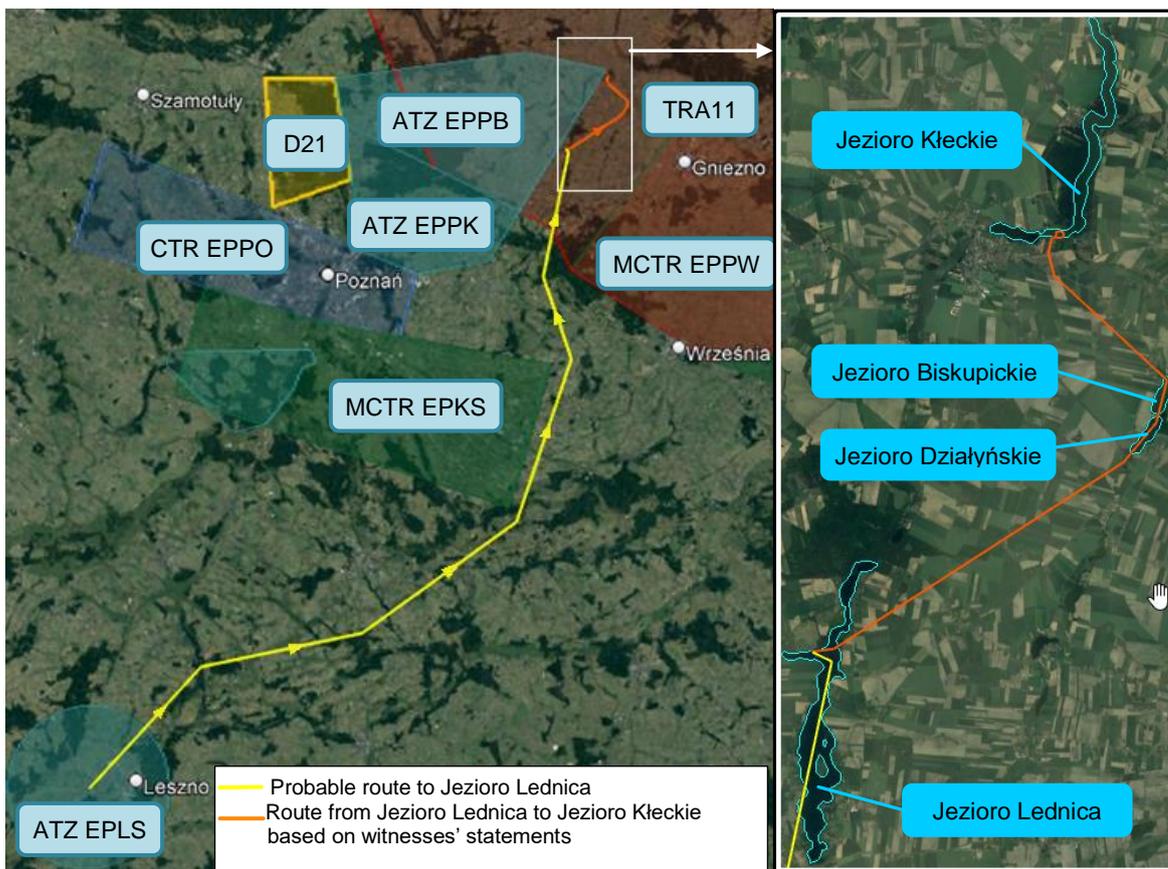
According to the statement of a witness, who spoke with the pilot via phone around 15:00 hrs, by the time of the conversation the pilot performed landings and take-offs on 13 lakes, and during the conversation he rested at the shore of the lake Jezioro Lednica. In addition, he said that he refuelled the plane with fuel from a canister (20 l) and planned to return to EPLS. However, around 15:15 hrs, the witnesses saw the airplane flying north at low altitude and, according to their assessment at low speed over Jezioro Działyńskie lake (Fig. 2).

Fig. 2. Recreated flight route [source: PKBWL, Google Earth]

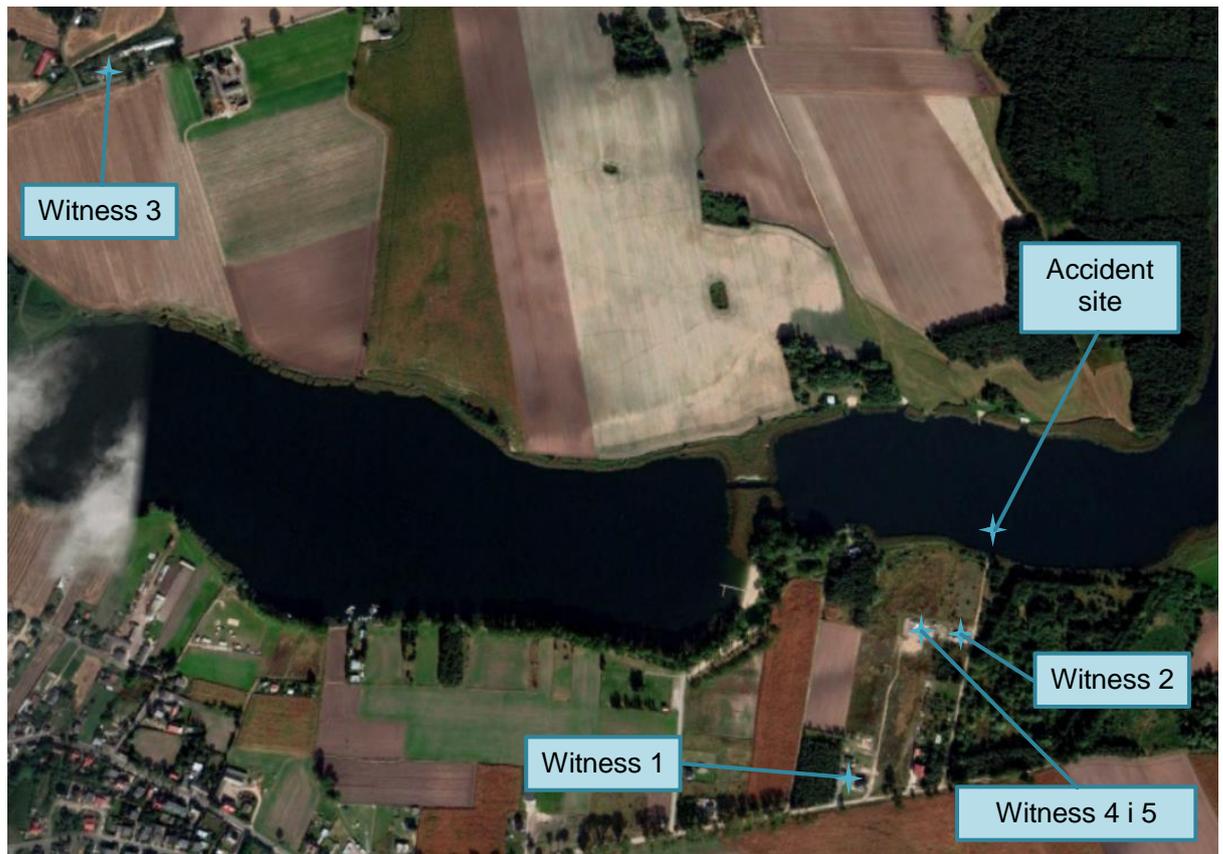
Three witnesses of the accident were identified and questioned by the Police on 29 March 2022. The PKBWL investigation team analysed the statements and regarded them as too general and insufficient to recreate the course of the flight in the area of Jezioro Kłeckie. Therefore, the investigation team conducted interviews and on-site verification with the participation of witnesses in the places from which they observed the occurrence. Witness 3 attended the on-site session on 30 March 2022. Witnesses 1 and 2 attended the session on 9 June 2022.

Fig. 12. Location of witnesses during observation of the occurrence [source: PKBWL]

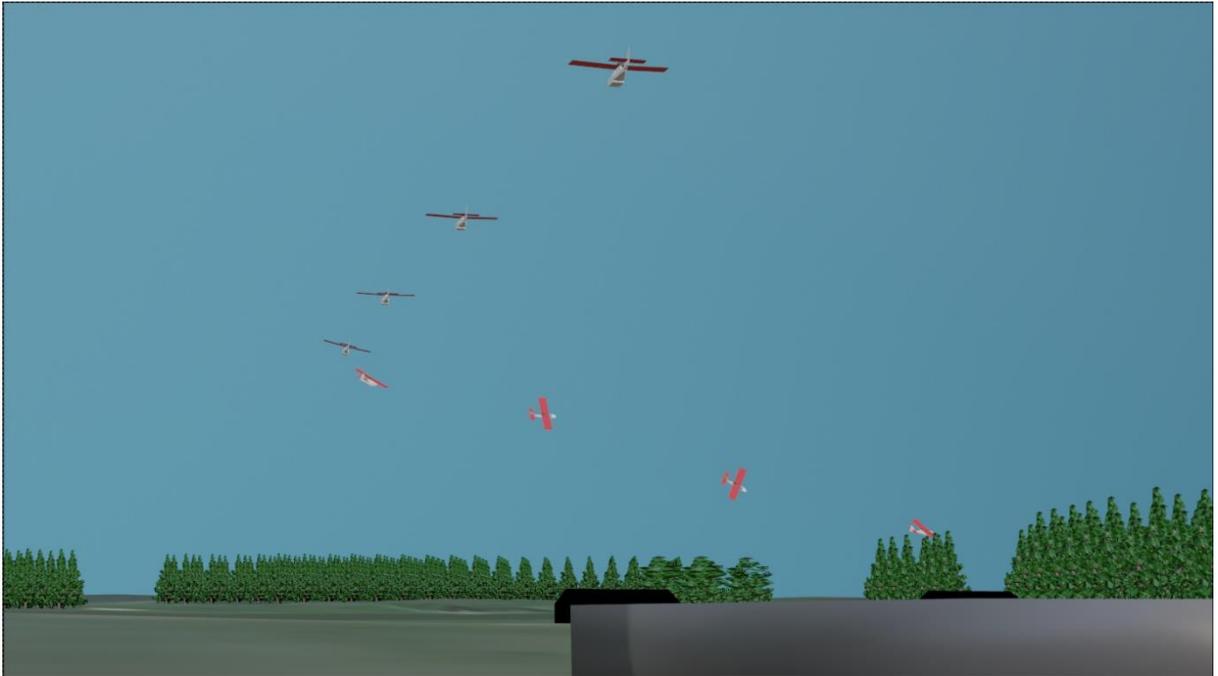
The witness noticed a plane flying from the south. The plane flew at a height of about 50 m, passed the house (Fig. 13) and then straight ahead to the lake area, where it made a right turn.

Using a model, the witness showed the position of the airplane during a turn made with a bank angle in the range of 50 - 60°. With such a bank angle the aircraft started descending quite quickly, but after about 3 seconds it flew behind obstacles preventing its further observation.

Fig. 13. The flight path in the area of Jezioro Kłeckie, reconstructed on the basis of the statement given by Witness no. 1 [source: PKBWL]

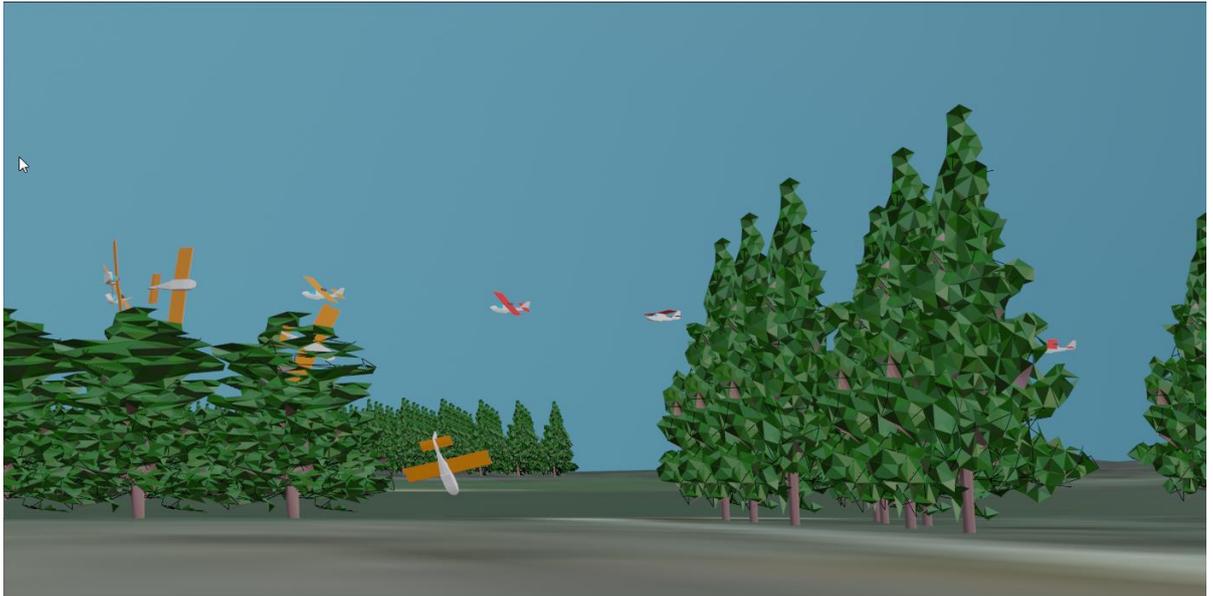
The witness stood in front of the house where the surface of the lake is visible (Fig. 14). The witness did not see the arriving plane, but clearly heard it from somewhere behind the building (on the south side). After a dozen of seconds, he heard a different and louder sound of the engine coming from the eastern part of the lake. The witness stated that probably several seconds after hearing the plane flying over the lake, he noticed it arriving from the east. The plane was in a level flight at a height of about 30 m. After a few seconds, the plane began to turn left with increasing bank angle.

Moreover, the witness reported that shortly after the plane rolled sharply, he heard a loud "howl" of the engine continued until the front part of the plane was submerged.

Fig. 14. Airplane flight path in the area of Jezioro Kłeckie, reconstructed on the basis of the witness' statement [source: PKBWL]

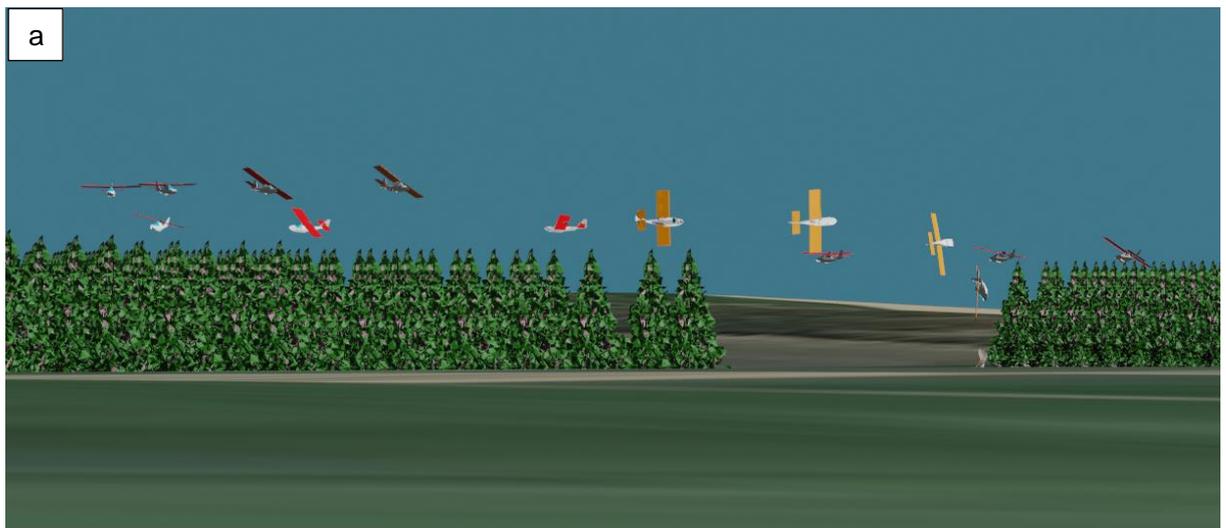
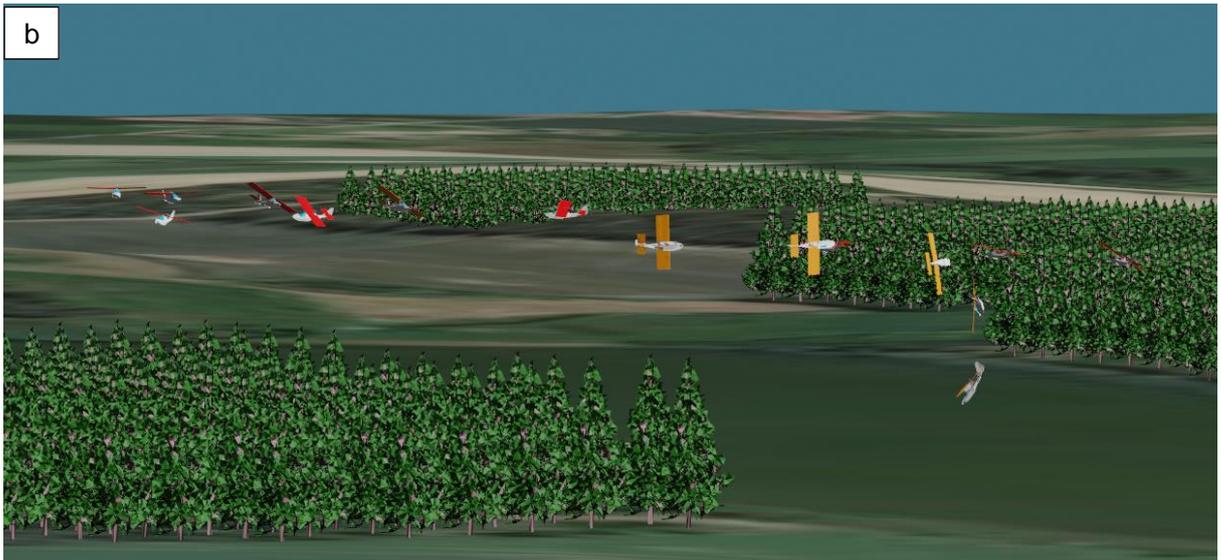
The witness observed the airplane from a distance of about 1200 m, but he had the best view of the lake area where the accident occurred (without the lake's surface being visible). The witness began the observation when the airplane was flying east over the lake (he did not see the right turn). According to the witness, the airplane made two turns to the left and indicated stability problems (he compared the observed flight to that of a paper airplane). During the last turn, the aircraft began to descend sharply and flew down almost vertically (the witness did not see the collision with the water). He calculated the flight height (about 50 m) by comparing it with the height of the trees (Fig. 15a).

Like witness 2, he heard the engine's "howl" in the last phase of the flight.

Fig. 15. Flight path in the area of Jezioro Kleckie, reconstructed on the basis of the testimony of witness no. 3, a – view from the level of the witness no. 3 eyes, b – view from the height of 50 m AGL [source: PKBWL]

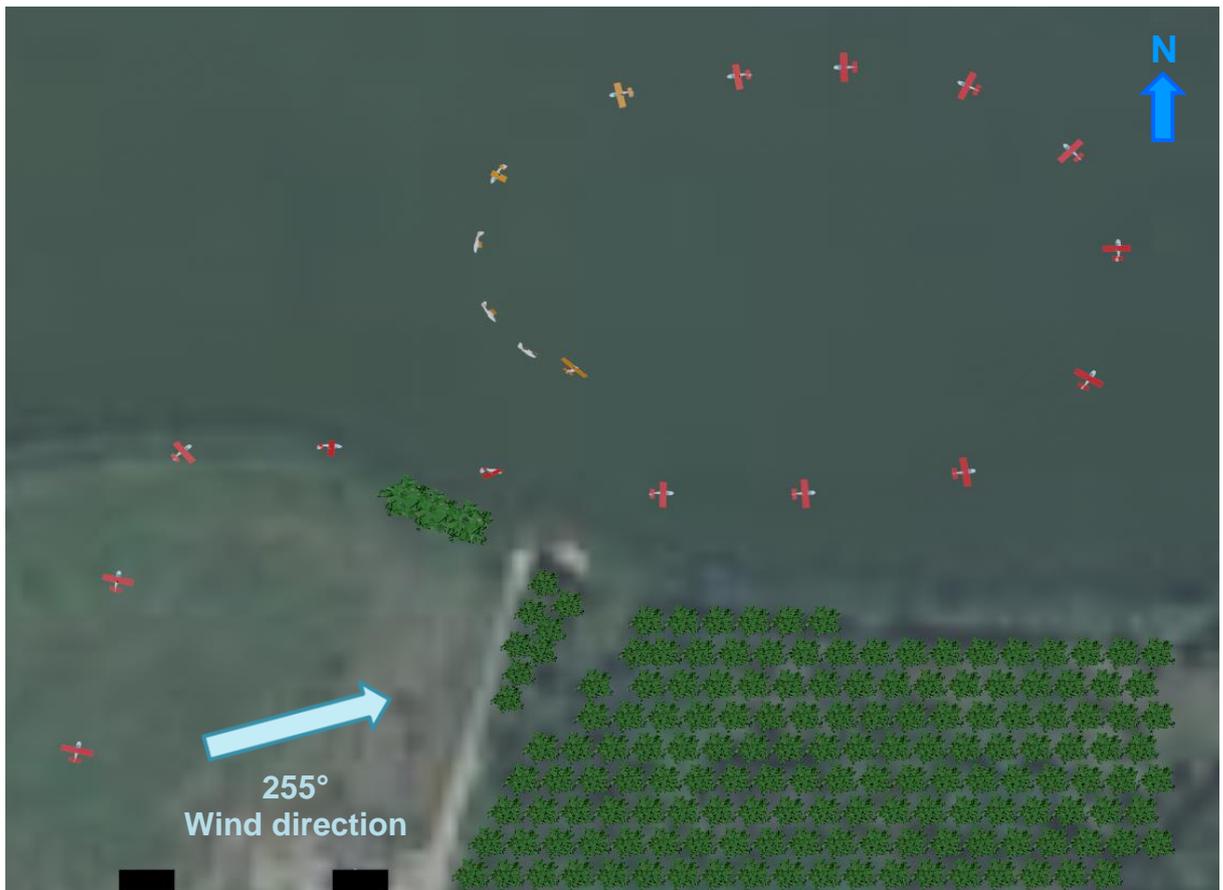
The flight path in the area of Jezioro Kleckie, recreated on the basis of the statements of five witnesses, is shown in Fig. 16.

Fig. 16. Flight path in the area of Jezioro Kłeckie, recreated on the basis of witnesses' statements
[source: PKBWL]
