# FINAL REPORT

2022/2454  
OCCURRENCE NUMBER

## ACCIDENT

**Helipoland Sp. z o.o.**  
**Aerospatiale AS350B3e, F-HCHB**  
**Rogoźnik Lake, 23 May 2022**

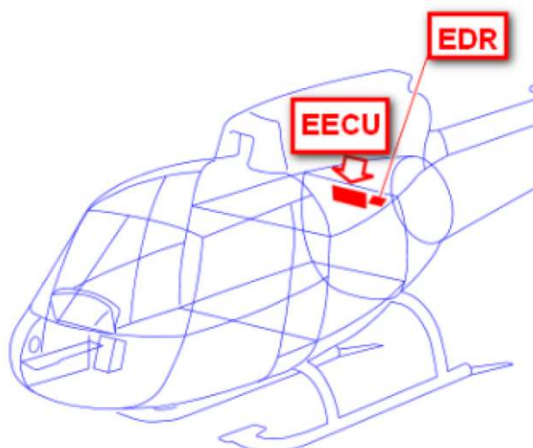
The position of the EDR and EECU in the airframe is shown in Fig. 5.

Fig. 5 The positions of the EDR and EECU in the helicopter's fuselage [source: BEA]

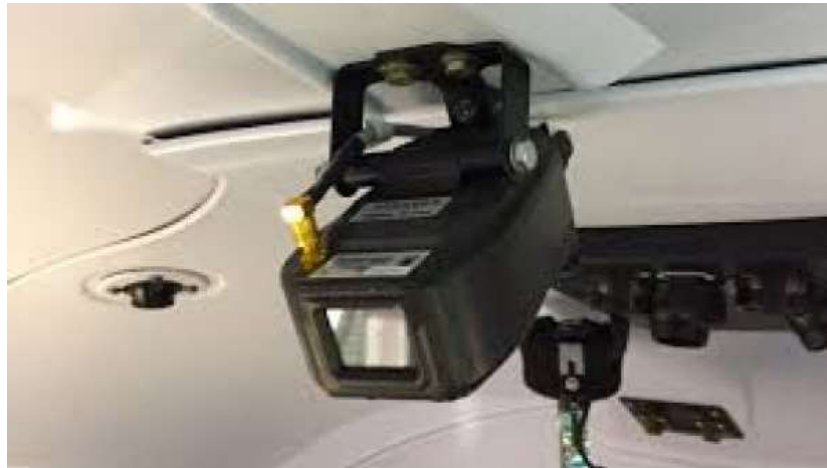
The camera (Fig. 6), designated Vision 1000 and manufactured by Appareo, was pre-installed by the manufacturer under the cockpit ceiling (left side of the helicopter's central axis) between the front seats.

In the description of the camera, the manufacturer noted that the camera had two independent memories: internal and external. The external memory, made as crash resistant, can serve as the first source of information for investigation of occurrences. It contains the last 2 h of video and sound from the camera, as well as aircraft position data in the last 200 h. The sampling rate is 0.25 s.

Fig. 6 APPAREO Vision 1000 camera [source: Internet].

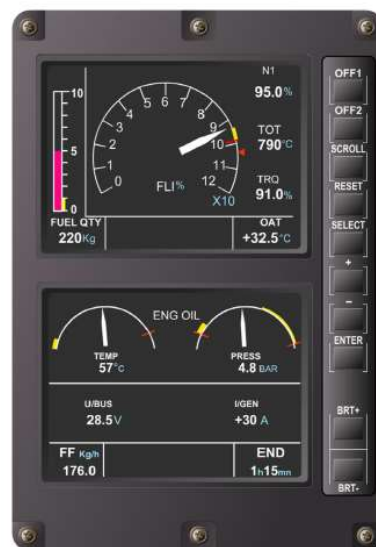
VEMD is installed in the centre of the instrument panel (Fig. 7). It provides graphical presentation of the main parameters of the helicopter and the engine. The VEMD consists of redundant data processing module and data display module which has a double display.

Fig. 7 VEMD [source: Internet / Airbus Helicopters]
