ACCIDENT 2021/1048

on investigation of an accident of an aircraft with MTOW below 2250 kg

OCCURRENCE NO – 2021/1048

AIRCRAFT – Gyrocopter TERCEL, SP-XERO

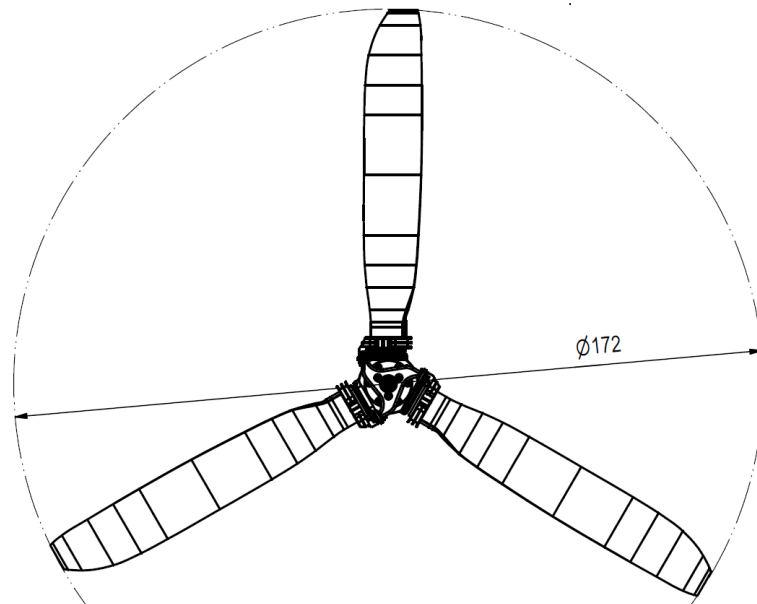
Fig. 4. Kašpar propeller KA – 2/3-LT [source: Kašpar a synové - strojírna Kalmar s.r.o.]

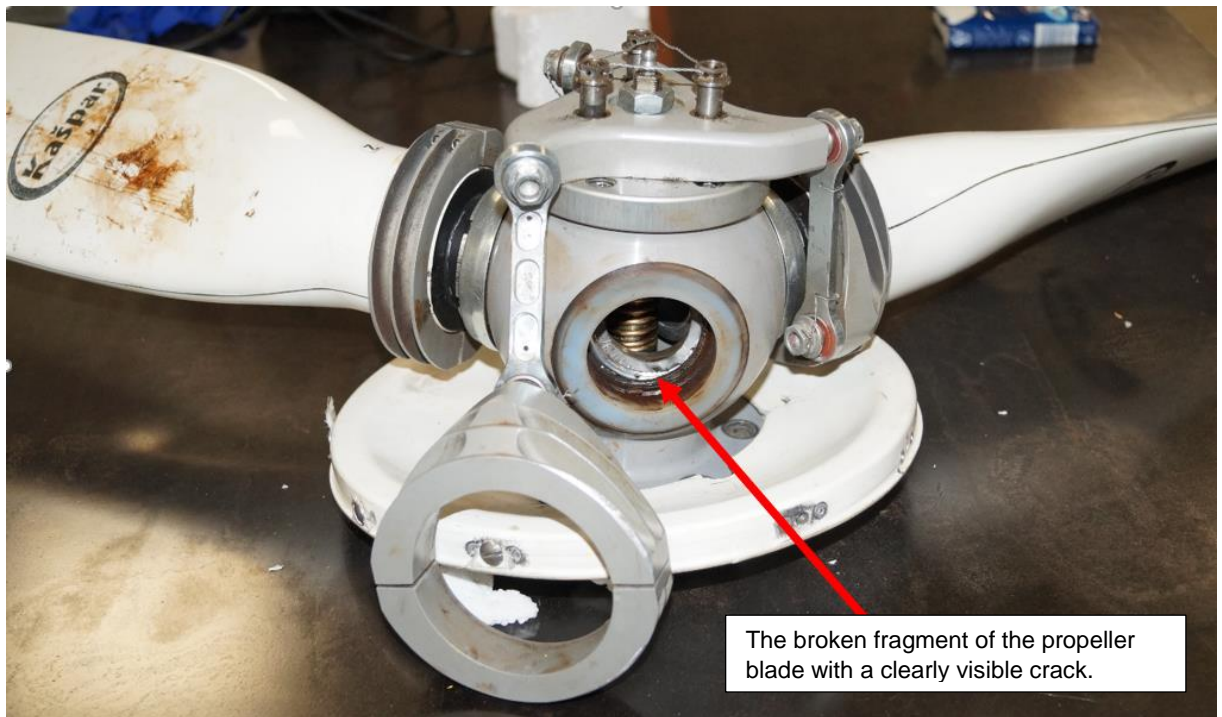
Fig 7. Propeller hub mechanism prior to disassembly.

During tests, it was found that the propeller blade broke off in flight as a result of a crack in its mounting part in the area of the thread securing the blade to the propeller hub. Based on visual tests, it was found that the intact mounting element of the damaged blade had fatigue cracks. Analysis of the deformation shape of the damaged blade fragment showed a characteristic fracture area with a clear narrowing indicating large plastic deformations and the surfaces of the fatigue crack. A very characteristic part of the crack is a spherical chipping and bending of the thread. It can be assumed with high probability that the fracture was initiated on the opposite side of the chipping, but the focus is not clearly visible.
