FINAL REPORT

OCCURRENCE NO. – 2020/1581

AIRCRAFT – Guimbal Cabri G2, SP-NCA helicopter

DATE AND PLACE – 2 July 2020, Nowe Miasto nad Pilicą, EPNM

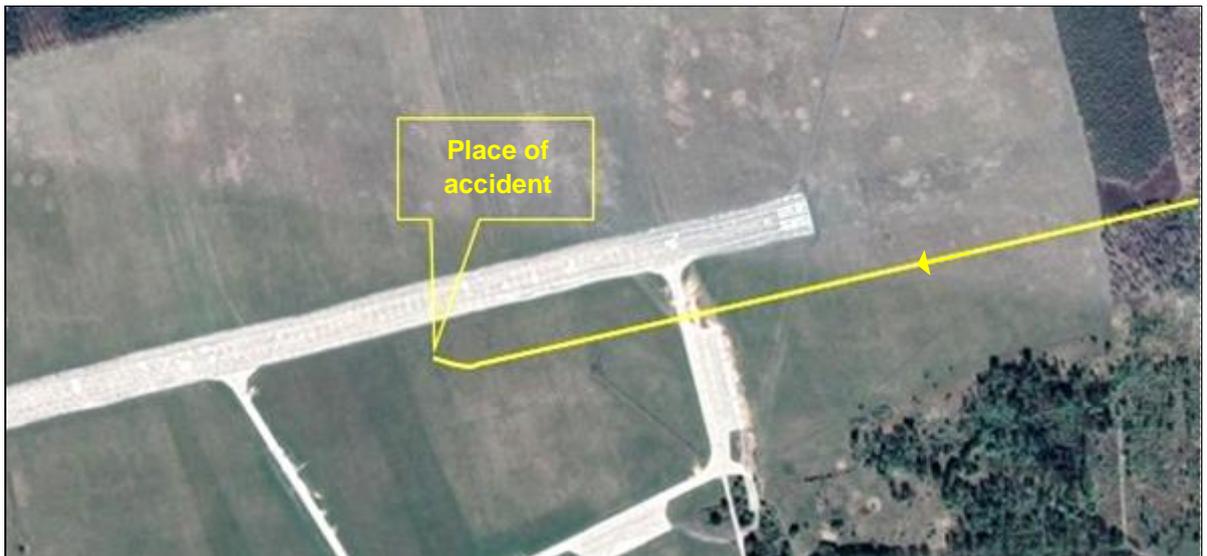
Fig. 10. Occurrence site – final flight phase route marked. [source: ACSL LAW, background: Google Earth]

The Commission determined that the helicopter touched down with low forward speed and heading of approx. 275°. During landing roll, as a result of deceleration caused by the dynamic increase in the plane angle of the rotating rotor, the main rotor blades collided with the tail boom and cut off its rear part together with the fenestron. Those elements were located approx. 5 m away from the helicopter fuselage.

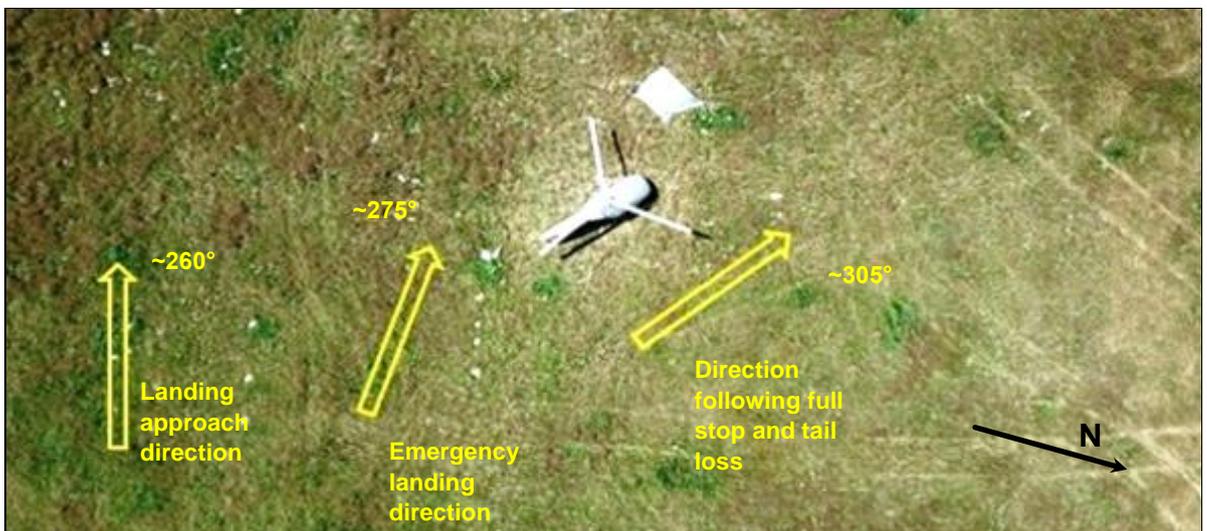
Fig. 11. Helicopter view at the occurrence site [source: ACSL LAW, background: Google Earth]

None of the helicopter parts separated prior to touchdown. The aircraft damage resulted from the cut-off of the tail boom by the main rotor blades and the destructive action of the separated fenestron drive shaft and the fenestron blade pitch control cable. The Bowden cable ruptured the fuselage skin and got entangled in the main rotor hub which was destroyed.
