# FINAL REPORT

OCCURRENCE NO – 2020/1766

AIRCRAFT – Tecnam P2006T, SP-KEY

DATE AND PLACE OF OCCURENCE – 14 July 2020, EPBY

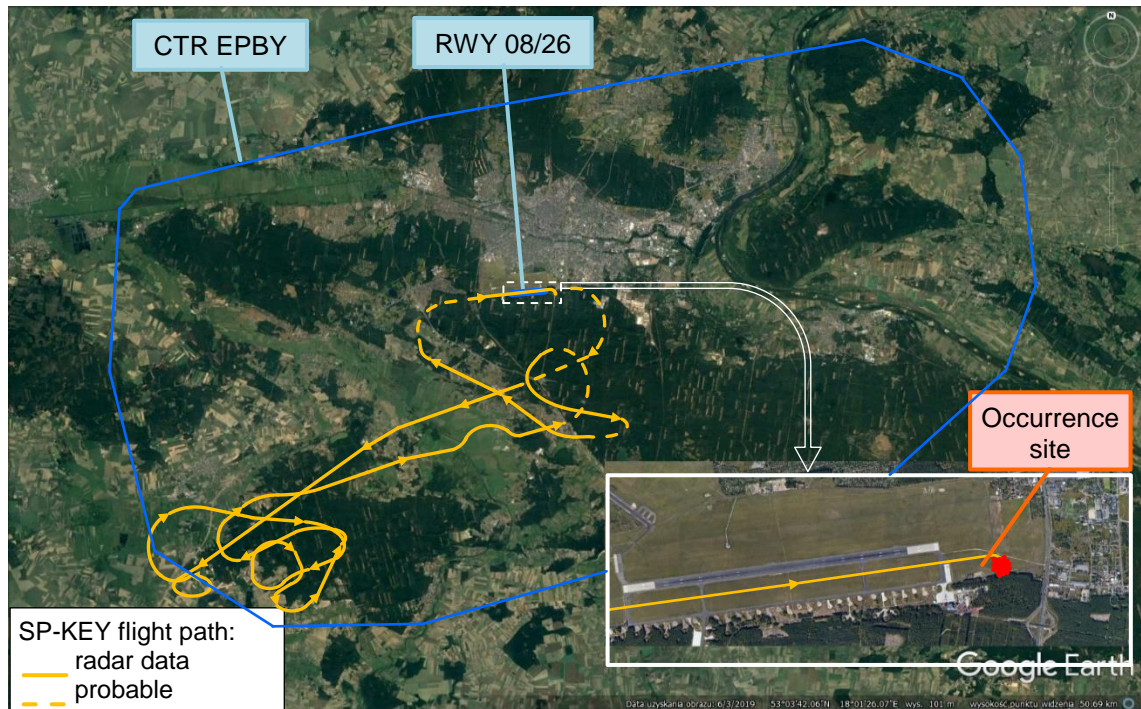
Fig. 9. SP-KEY flight path recreated by radar data [source: PKBWL]

The flight path of the aircraft from take-off to collision with the ground is graphically presented in Fig. 9.
