# PRELIMINARY REPORT

2023-0046

**Aeroklub Warszawski, training flight**  
**Cessna Aircraft Company, Cessna Grand**  
**Caravan 208B, SP-WAW**  
**Chrcynno airfield (EPNC), 17 July 2023**

Warszawa, 16th August 2023

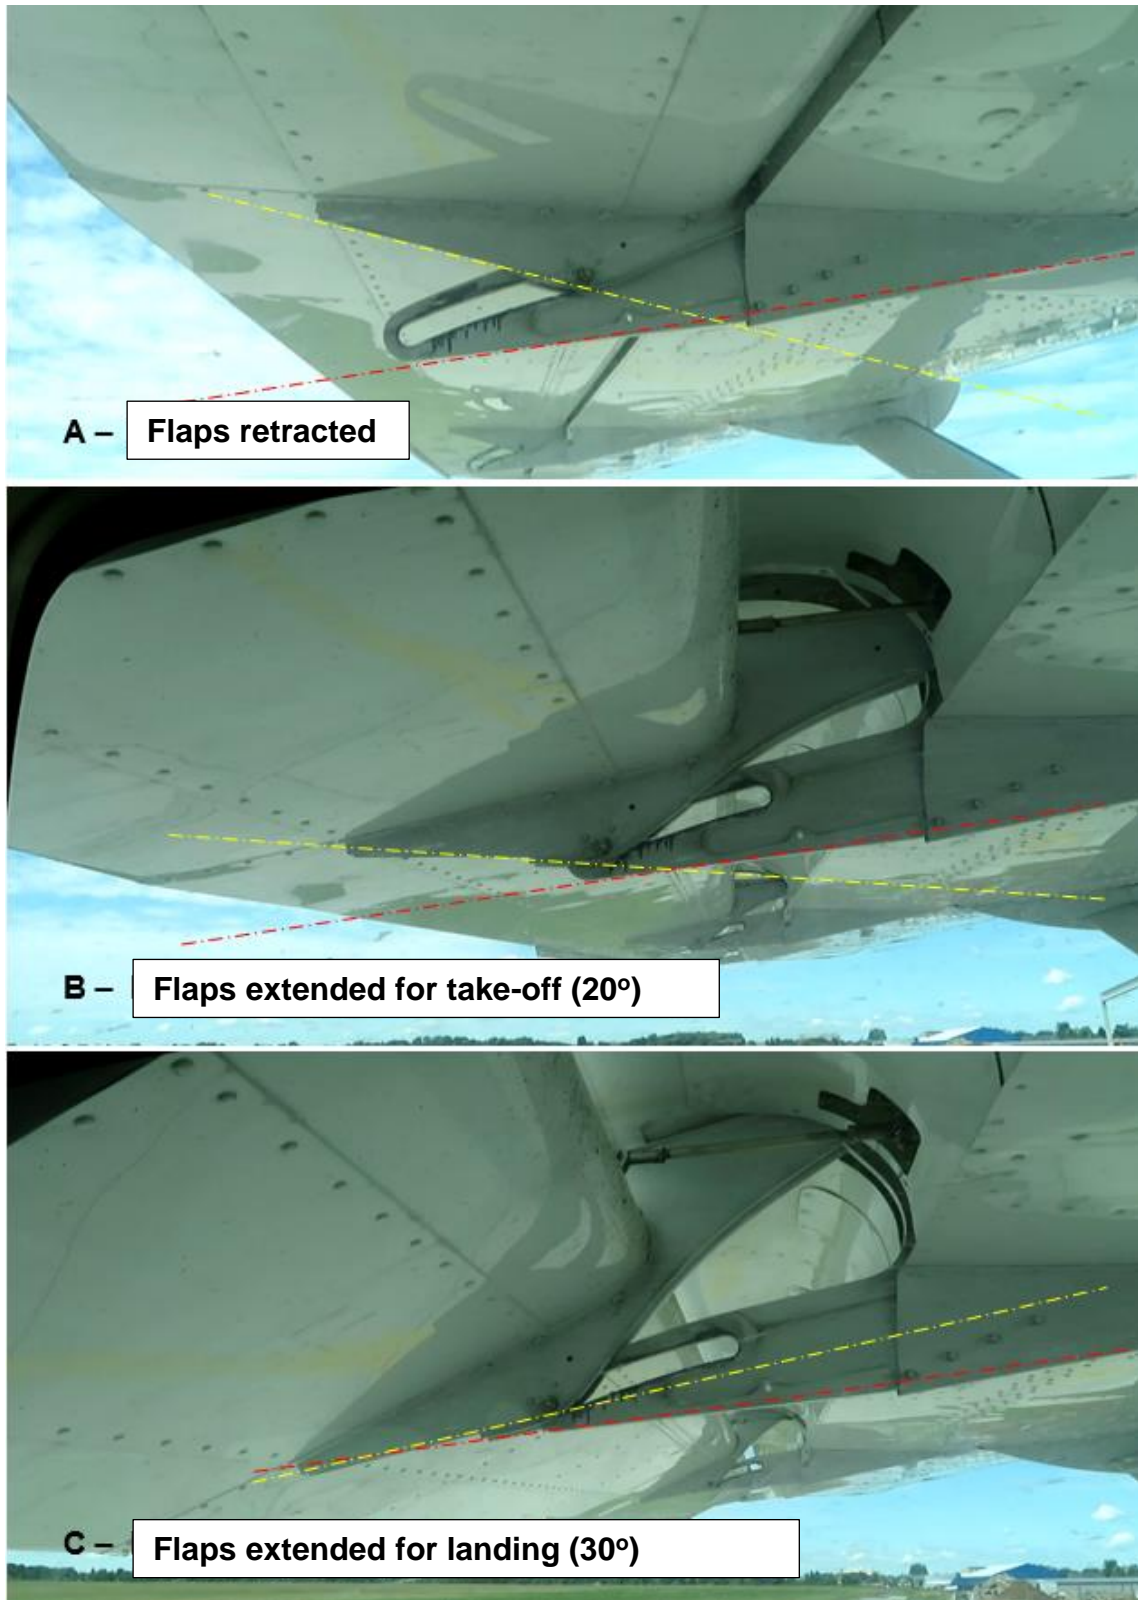
In order to perform a comparative analysis, the mechanism of wing flap extension on another Cessna 208B aircraft was studied (see Figures 14 and 15).

The above comparison shows that during the accident, the wing flaps of the aircraft were extended to an angle of 20°.

Fig. 14. Cessna 208B D-FLLY – mechanization of wing flaps. A - flaps retracted, B - flaps extended for take-off and C - flaps extended for landing. Auxiliary lines show: red line - extension of the edge of the flap track, yellow line - extension of the edge of the flap support assembly.
